# University City Hall Annex Building Facility Assessment + Feasibility Study

*Completed in Collaboration with Department of Public Works + Police Department*

September 9, 2019

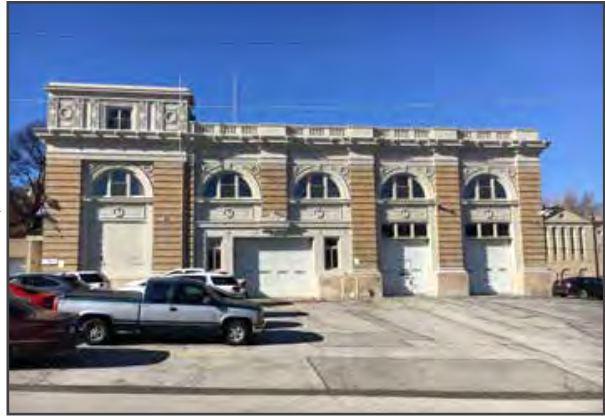
04.08 MASONRY INFILL

Image showing example of one location where Issue noted below is applicable; reference Appendix for additional locations

Recommendation: Evaluate future space needs to determining if openings are still needed in the current configuration. If needed, consider more appropriate overhead doors. If not needed, restore openings to original configurations as allowable by program needs.

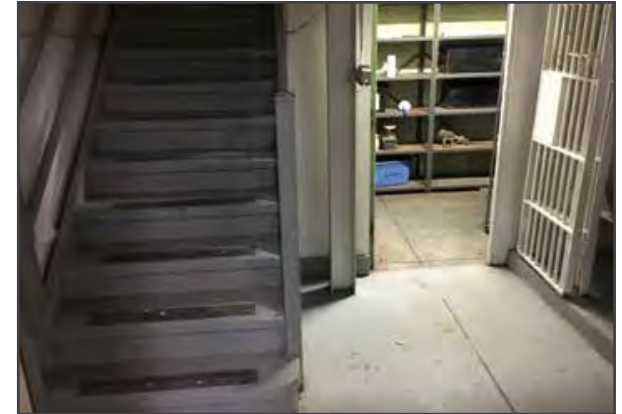
03.00 CONCRETE  
*Exposed Slab on Grade*

Exposed concrete slabs are mainly confined to the basement and hi-bay areas. In general, slabs were found to be in good condition with adequate crack control joints. Concrete coatings and finishes ranged from none to painted

Recommendation: Evaluate moisture content of concrete at basement level for suitability of adhesives and floor finishes. Remove loose and unsound finishes and clean and prepare surface for new floor finishes.

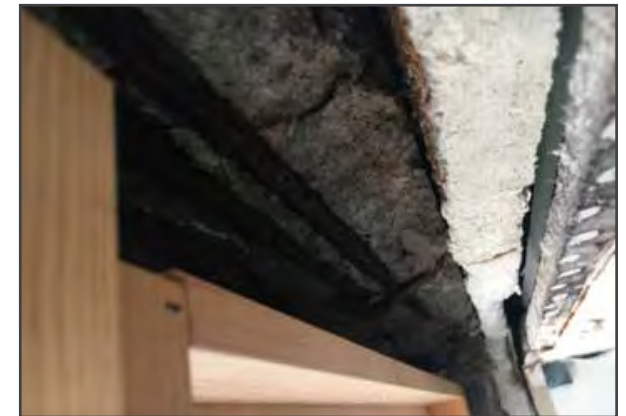
03.00 CONCRETE  
*Deteriorated Lintel*

Several cast in place reinforced concrete lintels along the south elevation have been compromised by water infiltration. Rust pack on reinforcing steel has spalled the lower half of the lintel.

Recommendation: Remove window and see structural assessment for further information.

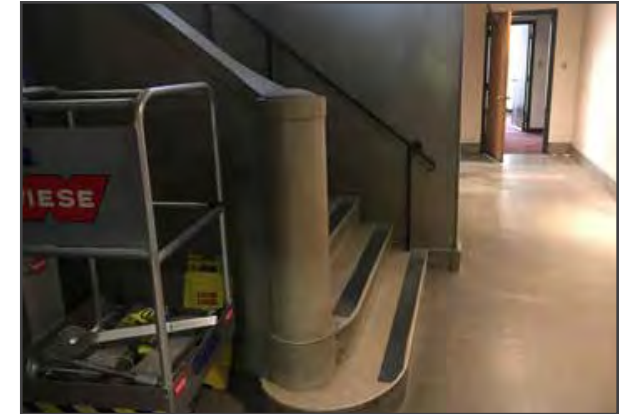
04.01 INTERIOR MASONRY CLEANING  
*Stone Railings/Wainscoting*

Existing stair elements including the railings, newelpost, wainscoting, base, treads, and risers are natural or synthetic plaster based stone. They are a central character defining feature and preservation shall be prioritized. In general, elements are in good albeit soiled condition. Joint sealants/mortars should be evaluated for toxic and/or toxic materials.

Recommendation: Clean with gentlest means possible to remove atmospheric and biological staining.

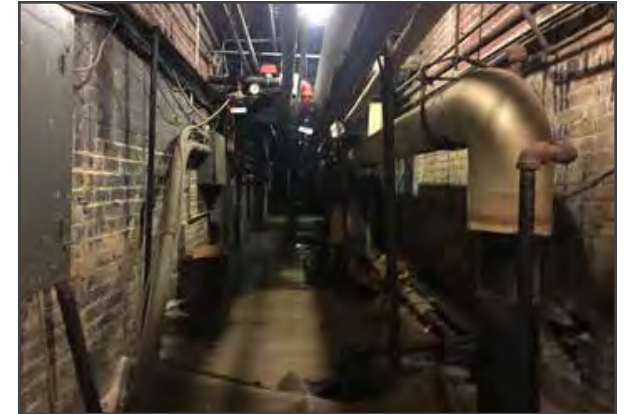
#### 04.03 INTERIOR BRICK RE-POINTING

A brick mechanical tunnel connects utilities between the City Hall and Annex building. The brick is lower quality and softer brick. However it is in good condition. Toxic and hazardous material testing should be performed due to the extent of pipe wraps and coating used in the space. It is unclear if there have been water infiltration problems in this subterranean space.

Recommendation: Spot re-point as needed. Perform hazardous material testing. Apply crystalline coating if water infiltration is problematic in the space.

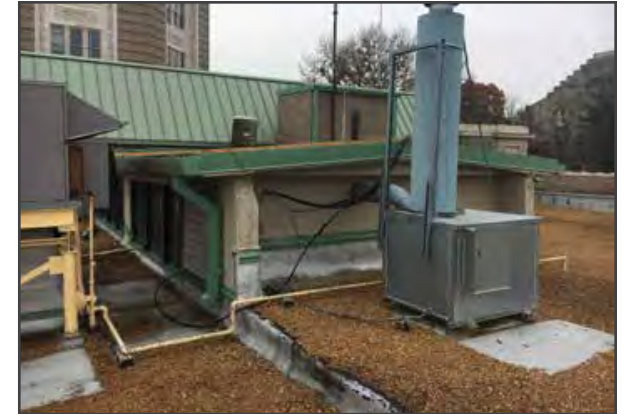
07.01 GUTTERS & DOWNSPOUTS

Pre-finished flashing and downspouts are in good condition. In general, most are not visible from historic elevations. Majority of gutters utilize internally draining leaders. Quantity and redundancy of drain inlets seemed to be lacking. Internal leaders were concealed in many locations and not evaluated

Recommendation: Remove and replace as needed with installation of new roof systems.

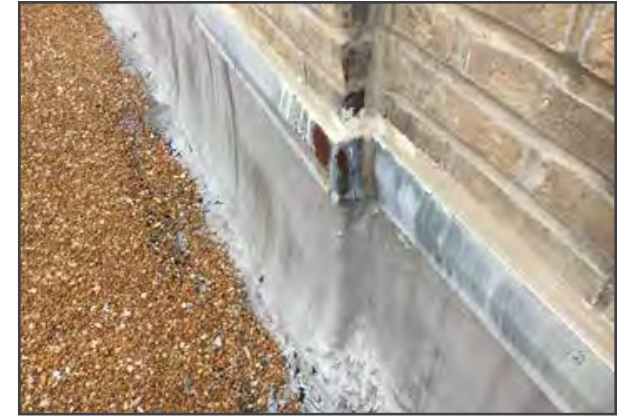
07.02 METAL FLASHINGS

Galvanized metal counter flashing was in fair condition. The flashings were serviceable but in some locations had begun rusting.

Recommendation: Remove and replace with a stainless steel counterflashing when new roofing systems are installed

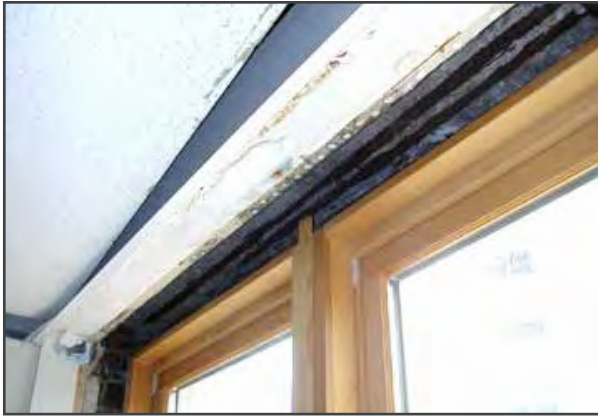
03.03 RUSTED REBAR AT WINDOW LINTELS  
*Natural Seams*

Lintels consist of reinforced concrete. Moisture damage has saturated the concrete in the past and has caused the reinforcing steel to rust and expand, resulting in spalled concrete. Exposed conditions exist on the third-floor south elevation on the west side. Other latent but not visible conditions could exist at other locations with flat window heads.

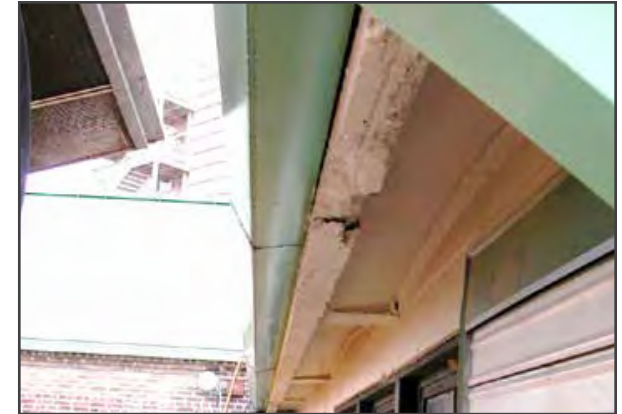
03.03 SPALLED CONCRETE COVER AT  
MONITOR ROOF  
*Spalling*

The monitor roof construction consists of reinforced concrete. Concrete has spalled at the gutter line exposing the reinforcing steel bars to the elements. Long term exposure will cause deterioration to the reinforcing steel.

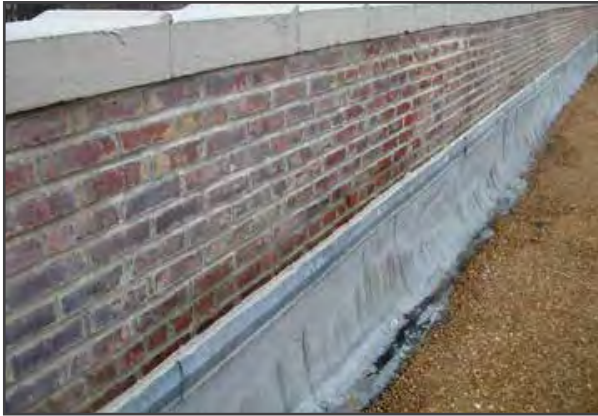
04.03 POINTING AT PARAPET

The masonry facade was re-pointed 2 to 3 years ago. In general, the masonry pointing is in very good condition, as the back side of the parapets show. The condition of the exterior masonry facade for the entire building is very good.

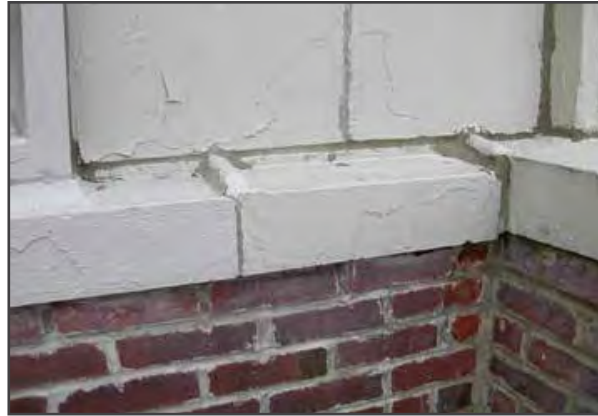
04.03 POINTING AT THIRD FLOOR CORNICE

The masonry facade was re-pointed 2 to 3 years ago. In general, the masonry pointing is in very good condition, as the north side of the third-floor cornice shows. The terracotta on the building appears to have also been painted and sealed. The condition of the exterior masonry facade for the entire building is very good.
