**CITY HALL ANNEX - FACILITY ASSESSMENT REPORT**

PREPARED FOR UNIVERSITY CITY  
PREPARED BY TRIVERS  
2019.08.07

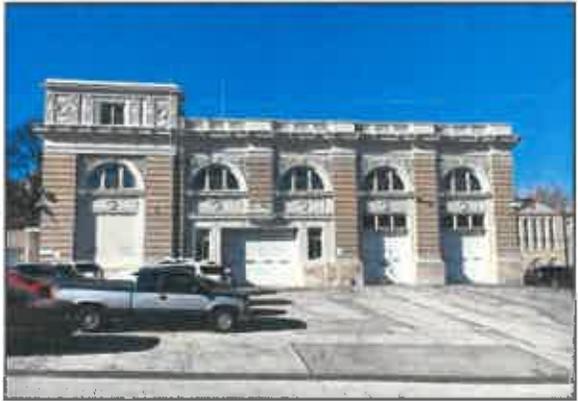
**04.08 MASONRY INFILL**  
*Modified Openings*

Specific issue

Recommendation: Evaluate future space needs to determining if openings are still needed in the current configuration. If needed, consider more appropriate overhead doors. If not needed, restore openings to original configurations as allowable by program needs.

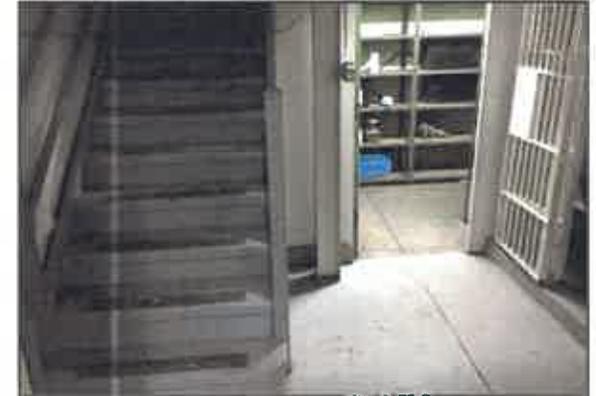
**03.00 CONCRETE**  
*Exposed Slab on Grade*

Exposed concrete slabs are mainly confined to the basement and hi-bay areas. In general, slabs were found to be in good condition with adequate crack control joints. Concrete coatings and finishes ranged from none to painted

Recommendation: Evaluate moisture content of concrete at basement level for suitability of adhesives and floor finishes. Remove loose and unsound finishes and clean and prepare surface for new floor finishes.

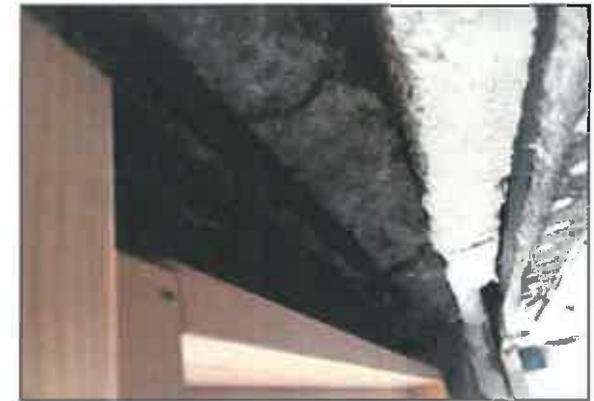
**03.00 CONCRETE**  
*Deteriorated Lintel*

Several cast in place reinforced concrete lintels along the south elevation have been compromised by water infiltration. Rust pack on reinforcing steel has spalled the lower half of the lintel.

Recommendation: Remove window and see structural assessment for further information.

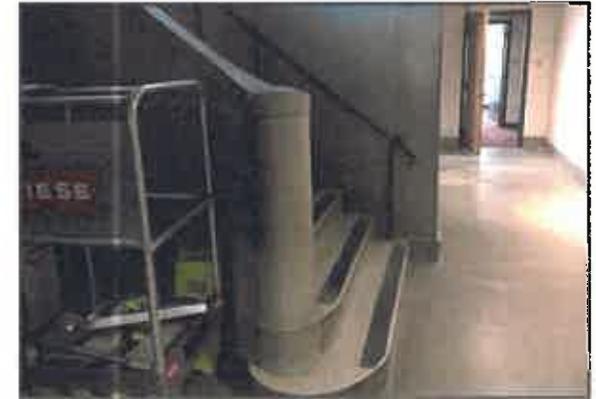
**04.01 INTERIOR MASONRY CLEANING**  
*Stone Railings/Wainscoting*

Existing stair elements including the railings, newelpost, wainscoting, base, treads, and risers are natural or synthetic plaster based stone. They are a central character defining feature and preservation shall be prioritized. In general, elements are in good albeit soiled condition. Joint sealants/mortars should be evaluated for toxic and/or toxic materials.

Recommendation: Clean with gentlest means possible to remove atmospheric and biological staining.

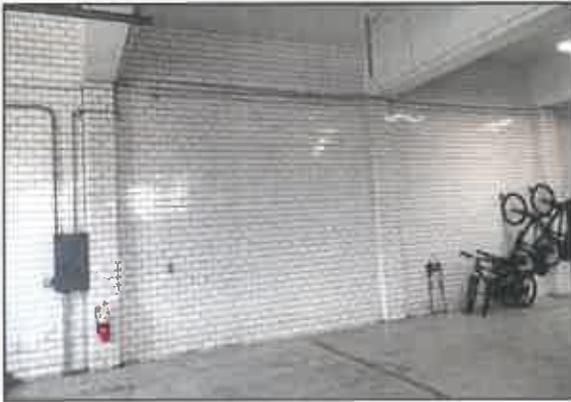
**04.01 INTERIOR MASONRY CLEANING**  
*Atmospheric Staining*

Glazed brick was likely added to the building when converted to the police/fire department. Brick condition is in good condition and while not original, may be beneficial to future space usage needs. Mortar is stained especially along the floor and high against the ceiling. Both are likely a result of idling emissions and/or washdown protocols.

Recommendation: Identify what extent brick may be exposed in new spaces. Remove, and re-point mortar and clean with the appropriate masonry cleaners with the gentlest means possible.

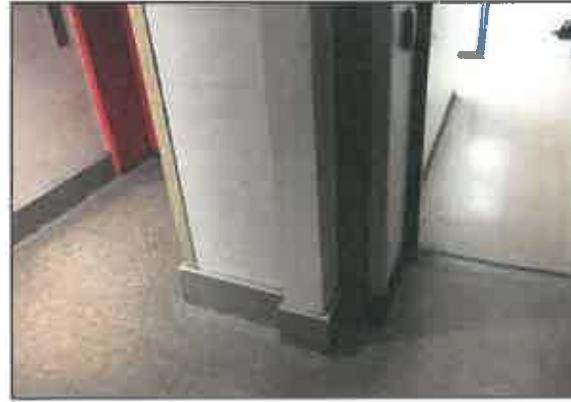
**04.02 INTERIOR STONE**  
*Base Trim*

Stair landing rooms have base trim that are natural or synthetic plaster based stone. They are a central character defining feature and preservation shall be prioritized. In general, elements are in good albeit soiled condition. Joint sealants/mortars should be evaluated for toxic and/or toxic materials.

Recommendation: Clean with gentlest means possible to remove atmospheric and biological staining.

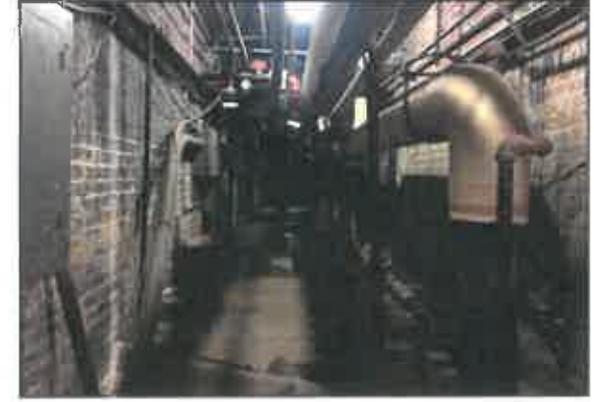
**04.03 INTERIOR BRICK RE-POINTING**  
*Mechanical Tunnel*

A brick mechanical tunnel connects utilities between the City Hall and Annex building. The brick is lower quality and softer brick. However it is in good condition. Toxic and hazardous material testing should be performed due to the extent of pipe wraps and coating used in the space. It is unclear if there have been water infiltration problems in this subterranean space.

Recommendation: Spot re-point as needed. Perform hazardous material testing. Apply crystalline coating if water infiltration is problematic in the space.

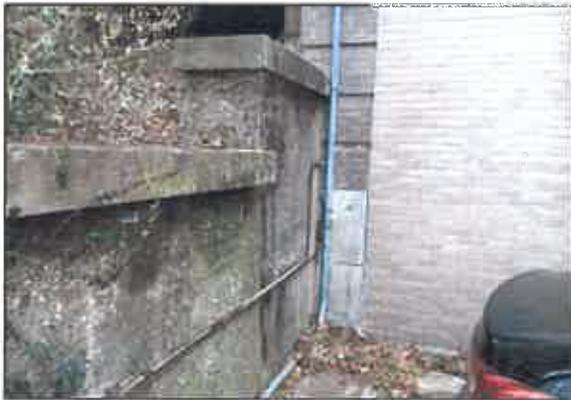
**04.04 EXTERIOR MASONRY CLEANING**  
*Site Walls*

Site retaining walls concrete with extensive biological and atmospheric staining. The walls are unsightly and located adjacent to Annex Building entrances.

Recommendation: Apply biological and atmospheric cleaners.

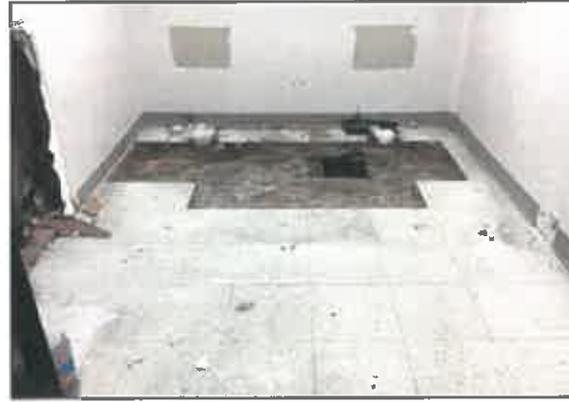
**06.01 MAINTENANCE OF WOOD, PLASTICS & COMPOSITES**

Newer restrooms have been inserted at the 2nd floor. Raised flooring has been constructed which makes the restrooms inaccessible to disabled visitors/employees. In addition, plumbing fixtures had multiple leaks which resulted in significant wood rot and conditions conducive to mold growth.

Recommendation: Remove all restroom partitions and overbuilt floor materials down to historic fabric. Consider new locations and configure spaces for maximum inclusiveness.

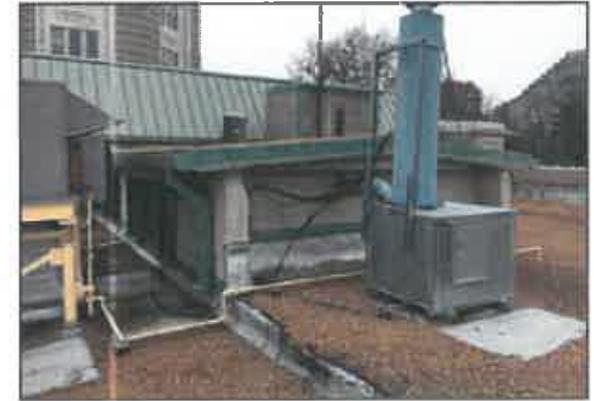
**07.01 GUTTERS & DOWNSPOUTS**

Pre-finished flashing and downspouts are in good condition. In general, most are not visible from historic elevations. Majority of gutters utilize internally draining leaders. Quantity and redundancy of drain inlets seemed to be lacking. Internal leaders were concealed in many locations and not evaluated

Recommendation: Remove and replace as needed with installation of new roof systems.

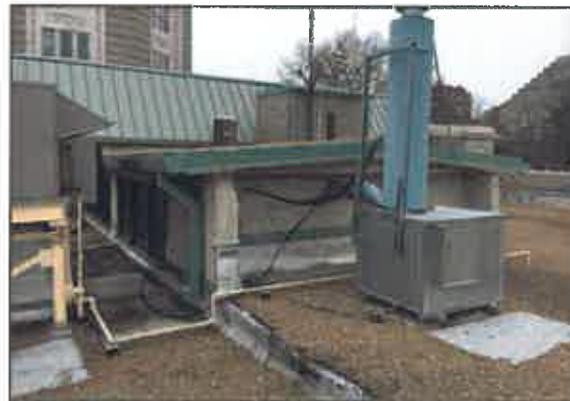
**07.02 METAL FLASHINGS**  
*Typical Condition*

Pre-finished metal flashings were in good condition, securely attached and colorfast

Recommendation: Remove and replace as required when installing new roofing systems

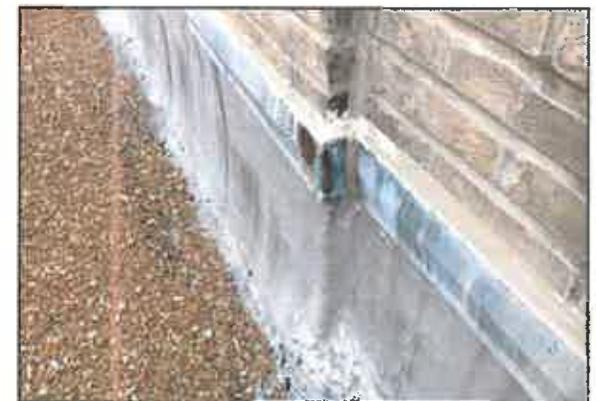
**07.02 METAL FLASHINGS**  
*Counterflashing*

Galvanized metal counter flashing was in fair condition. The flashings were serviceable but in some locations had begun rusting.

Recommendation: Remove and replace with a stainless steel counterflashing when new roofing systems are installed

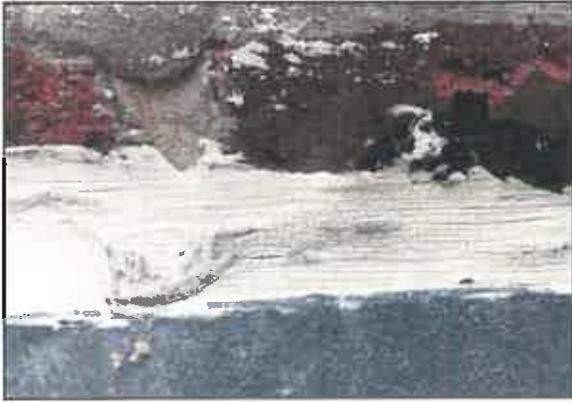
**07.03 JOINT SEALANTS**  
*Adhesion Failure*

Most joint sealants were serviceable but show signs of repeated stress and UV degradation.

Recommendation: Replace areas where sealants have failed. Evaluate sealants on a periodic basis and remove and replace accordingly.

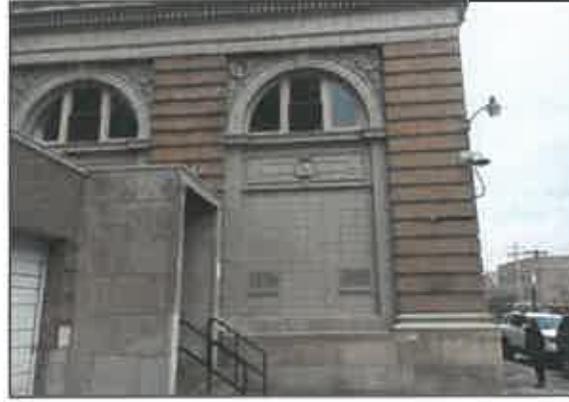
**07.04 WATERPROOF COATINGS**  
*Typical Condition*

It is assumed the original glazed coating of the extensive terracotta work have been compromised beyond repair. A fluid applied coating now conceals all historic terracotta. In general, the coating was in good condition and the color selection looks to be an appropriate color for the building. Additional information is needed to evaluate the longterm suitability of the coating.

Recommendation: Evaluate coatings on a periodic basis and remove and replace accordingly.

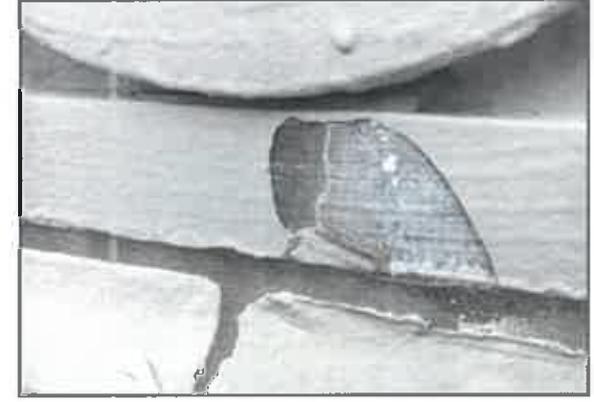
**07.04 WATERPROOF COATINGS**  
*Adhesion Failure*

Some locations of the terracotta coating have been compromised. This allows for possible further deteriorations as moisture is allowed into the system and the breathability of the coating is likely non-porous

Recommendation: Remove unsound and loose materials to substrate. Reapply coating.

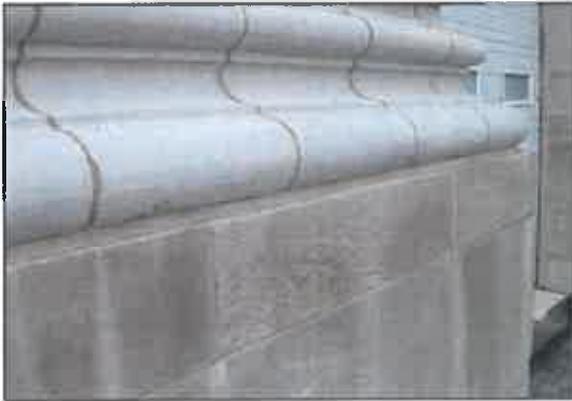
**04.03 SPALLING PAINT ON TERRACOTTA**  
*Spalling*

Terracotta was painted and sealed 2 to 3 years ago during the masonry restoration project. The paint is beginning to spall and peel on the water table on the east elevation. The condition shown occurs randomly around the building. The paint will continue to peel allowing moisture infiltration inside the terracotta eventually causing freeze-thaw damage.

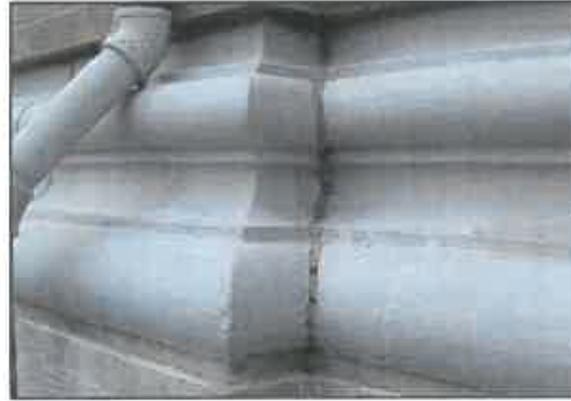
**04.03 SPALLING RE-POINTING MORTAR**  
*Spalling*

The masonry facade was re-pointed 2 to 3 years ago during the masonry restoration project. The re-pointing mortar is starting to spall on the water table on the east elevation. The condition shown occurs randomly around the building. The mortar will continue to spall allowing moisture infiltration inside the mortar joints eventually causing freeze-thaw damage.
