Storm Water Commission  
6801 Delmar Boulevard, University City, Missouri 63130,  
Phone: (314) 505-8560, Fax: (314) 862-0694

## MINUTES OF THE STORMWATER COMMISSION April 4, 2023

TO: Darren Girdler, Director of Public Works  
 Mirela Celaj, CFM, Assistant Director of Public Works  
 FROM: Stormwater Master Plan Team (HR Green and Reitz & Jens)  
 SUBJECT: University City Stormwater Master Plan  
*Public versus Private – Recommended Definition* Scope of work Task 2.2  
 DATE: February 28, 2023

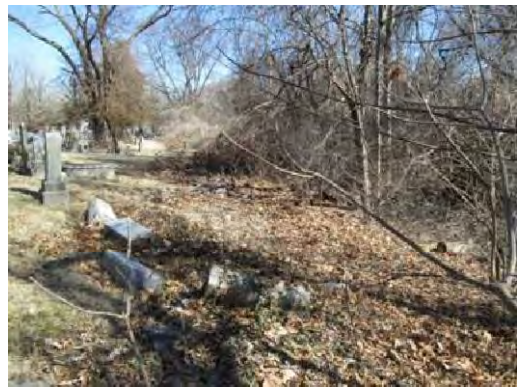
Gravestones at the B'Nai Amoona cemetery along the top of the creek bank have been damaged possibly as a result of bank erosion.

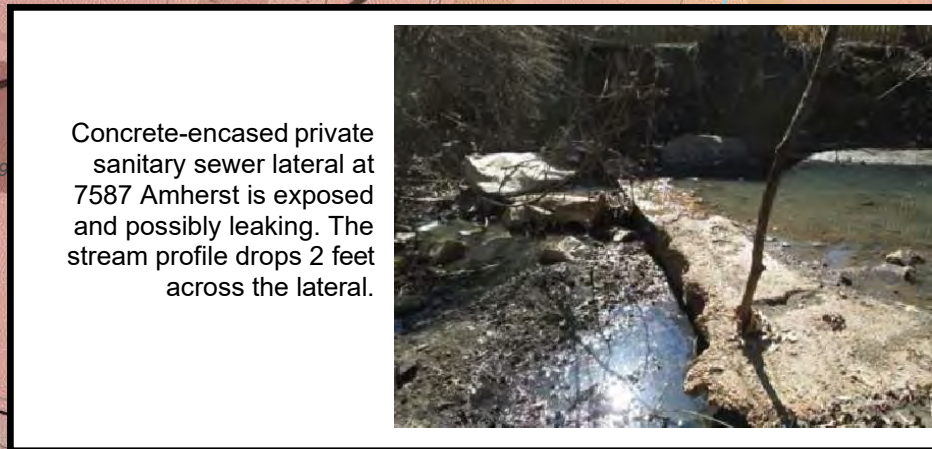
Creek erosion along 7587 Amherst is undermining their fence. The erosion rating at 7587 Amherst is considered a threat to the home (V/H=0.25).

Concrete-encased private sanitary sewer lateral at 7587 Amherst is exposed and possibly leaking. The stream profile drops 2 feet across the lateral.

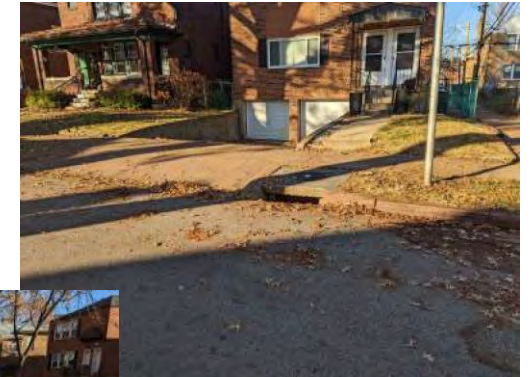
Grated drains were observed near each garage door. It is likely that each of these are connected into the nearby combined sewer. Therefore, it is possible the flooding is due to backup from the combined sewer main.

The driveway at 7101 Amherst Ave.

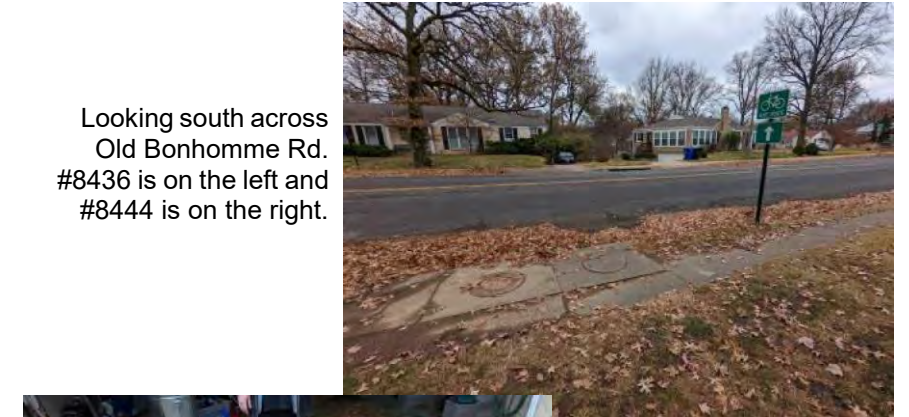
MSD has studied the problem and identified storm sewer upsizing as a solution. It may also be beneficial to investigate other opportunities for improvement, such as: A) increase inlet capacity at the street by adding inlets east of the triple inlet, B) raise a portion of the driveway at 8436 to keep water in the street, or C) provide a conveyance path down driveway and towards the at the property corner between #8436 and 940/932 Alanson Dr.

Looking south across Old Bonhomme Rd. #8436 is on the left and #8444 is on the right.

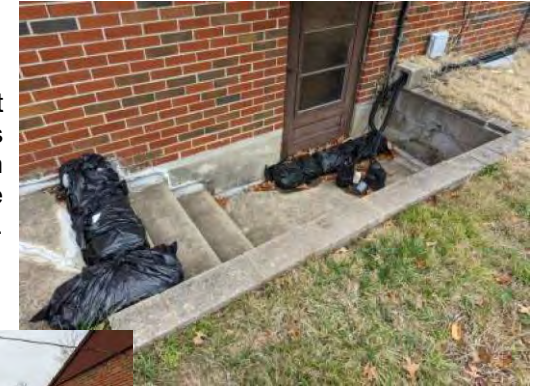
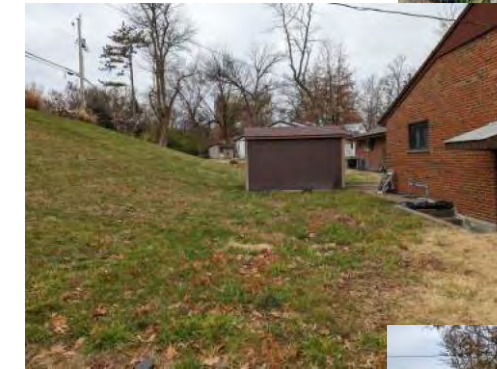
The homes on Stanford Avenue sit about 18 feet higher than the homes on Balson Ave. Between the houses is at a 3:1 slope. The flow path from the backyards to the front yards on Balson Ave is inadequate, causing frequent flooding to at least two of the homes on Balson Ave. The drainage area to the back of the homes is about 1.3 acres.

The basement stairwell at 7838 Balson Ave. Sand bags and sump pumps have been added to try to keep the basement from flooding.

Looking west in the backyard of 7838 Balson Ave. The house is on the right.

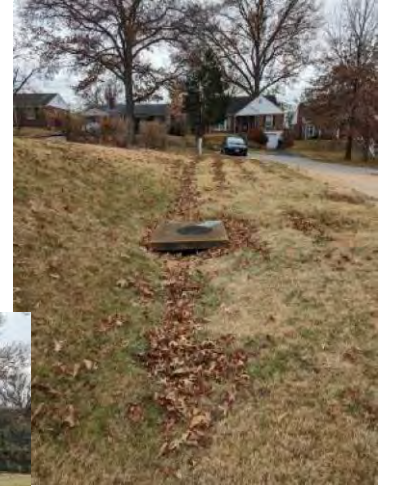
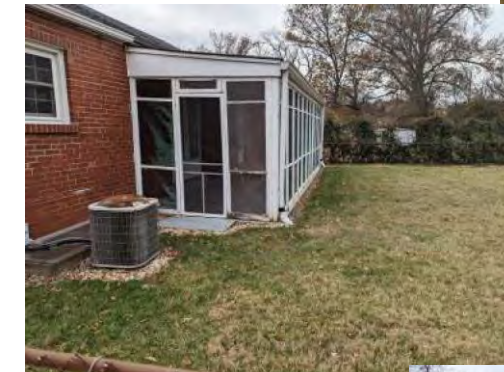
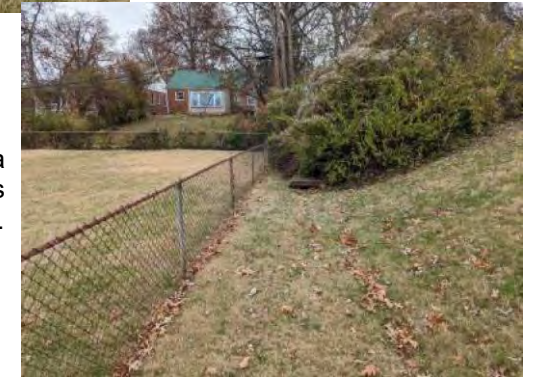
About 3 acres of drainage flows to the backyard at 7353 Milan Ave. An area inlet just east of the backyard clogs easily and may also have inadequate capacity. Water backs up, flooding the entire yard until it can flow east. Water has nearly reached the threshold of the back door to the house. The basement has flooded from both seepage and overland flow in 2014, 2015, and 2022.

Looking south along the property line between #7353 and 7339.

Looking towards the back patio at #7353. Ponded water has nearly reached the threshold of the door into the house (not the door to the screened in patio).

Looking north towards the area inlet in the backyards. #7353's backyard is on the left.

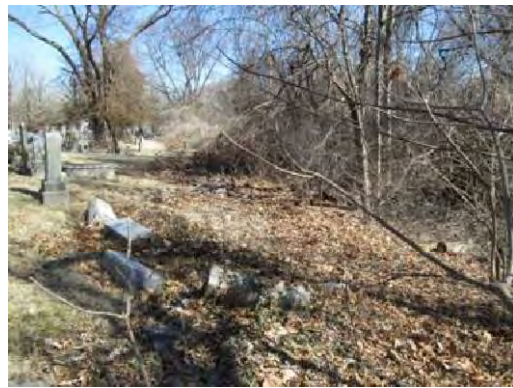
Gravestones at the B'Nai Amoona cemetery along the top of the creek bank have been damaged possibly as a result of bank erosion.

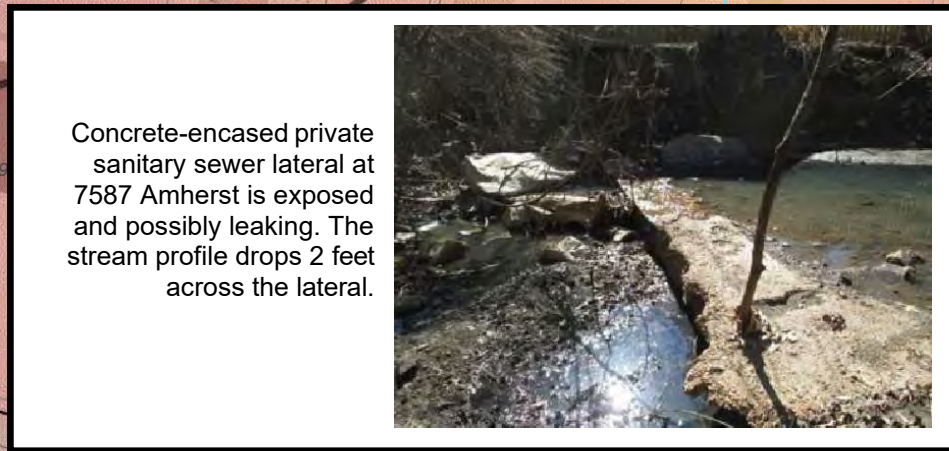
Creek erosion along 7587 Amherst is undermining their fence. The erosion rating at 7587 Amherst is considered a threat to the home (V/H=0.25).

Concrete-encased private sanitary sewer lateral at 7587 Amherst is exposed and possibly leaking. The stream profile drops 2 feet across the lateral.

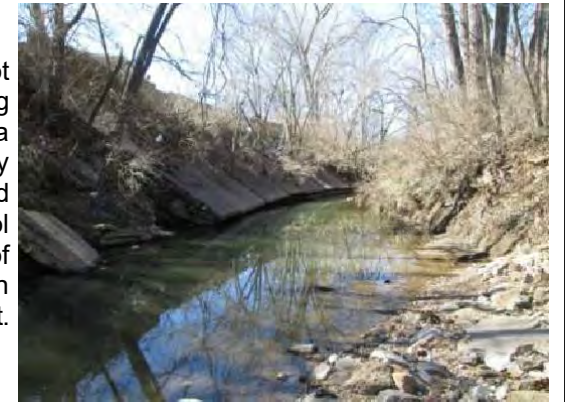
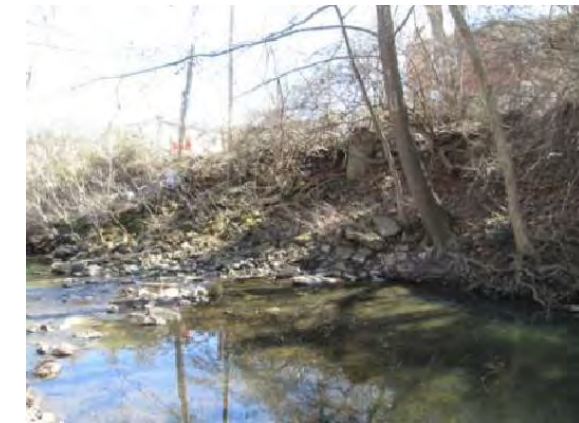
An approximately 175-foot reach of the right-descending river bank is lined with a concrete slab, but the integrity of the concrete is compromised by a 3-foot deep scour pool along the toe of bank. Failure of slab will likely cause failure in the parking lot.

MSD infrastructure along the right-descending river bank is threatened by bank erosion including a combined sewer manhole, a combined sewer overflow (CSO) structure, and a storm sewer outflow structure.

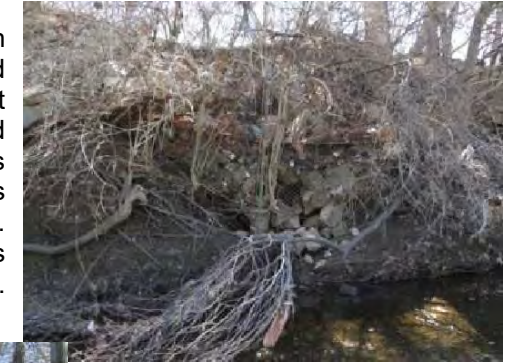
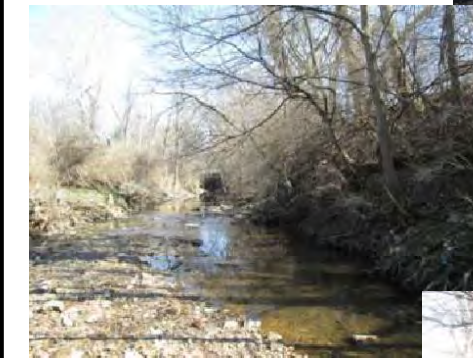
The foundation of a 6-foot high mid-slope fence is eroded and the fence is collapsing. It appears that riprap was added from the top of slope to address an area of gulley erosion, but this riprap is sliding down the bank. The weight of this riprap is contributing to the fence failure.

On the right descending bank are the eroding bank, collapsing fence, and sliding riprap.

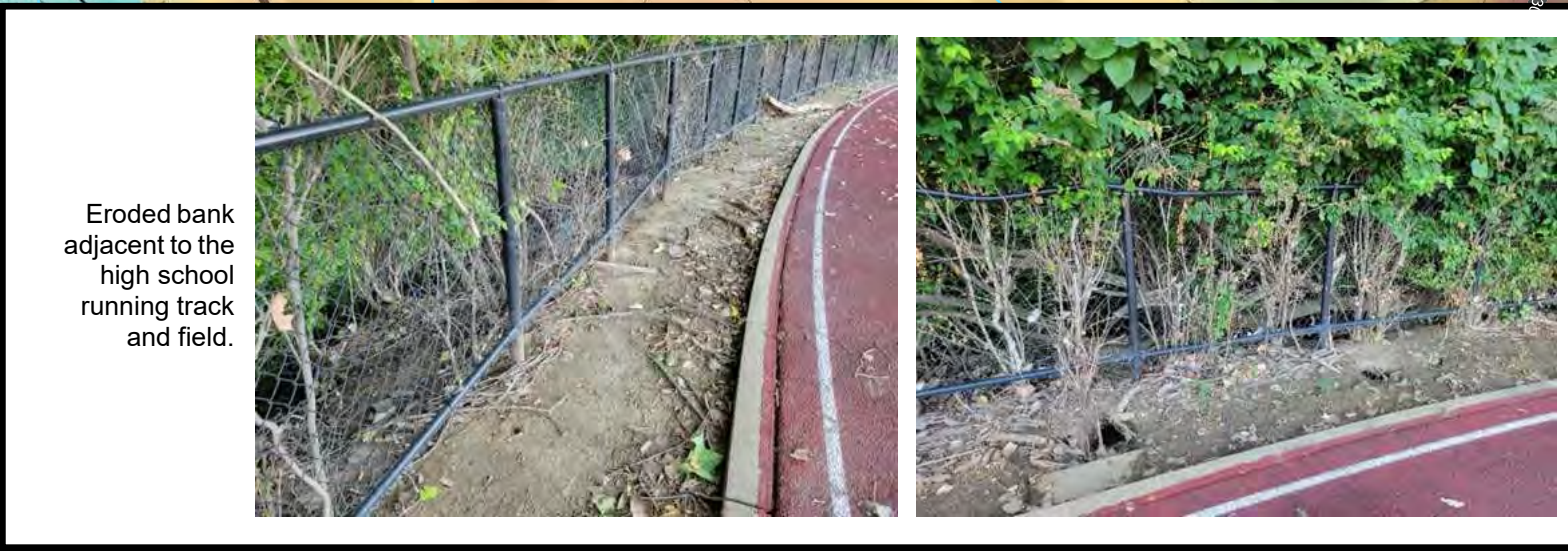
Eroded bank adjacent to the high school running track and field.

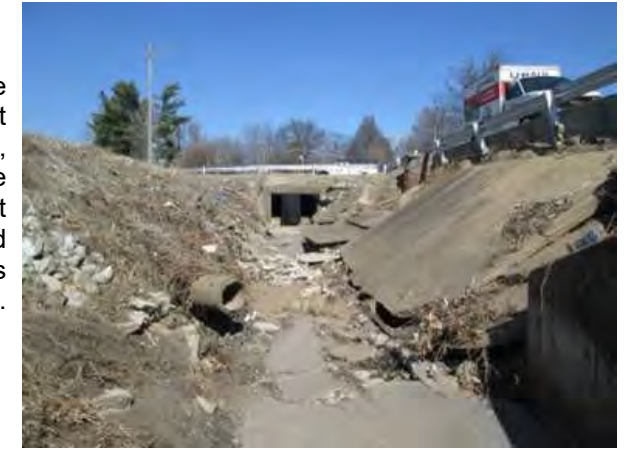
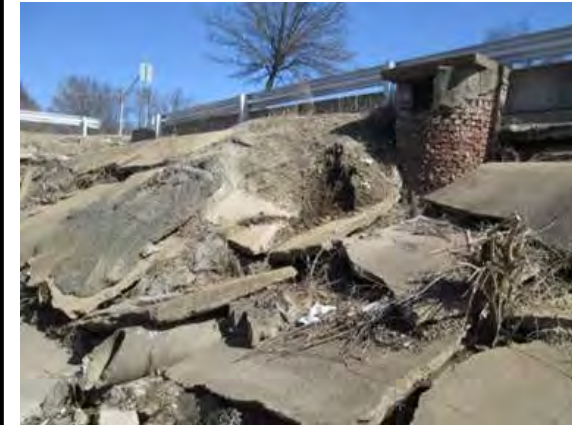
Undermined concrete slabs with adjacent at-risk infrastructure, looking upstream. The concrete box culvert under Olive Boulevard (background) appears stable.

Exposed foundation of the adjacent parking lot.

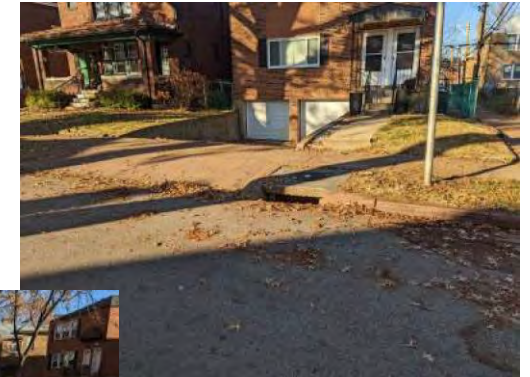
The driveway at 7101 Amherst Ave.

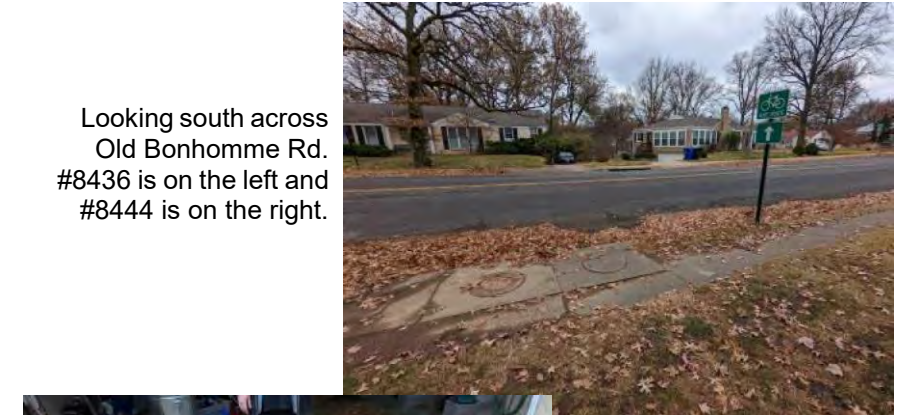
MSD has studied the problem and identified storm sewer upsizing as a solution. It may also be beneficial to investigate other opportunities for improvement, such as: A) increase inlet capacity at the street by adding inlets east of the triple inlet, B) raise a portion of the driveway at 8436 to keep water in the street, or C) provide a conveyance path down driveway and towards the at the property corner between #8436 and 940/932 Alanson Dr.

Looking south across Old Bonhomme Rd. #8436 is on the left and #8444 is on the right.

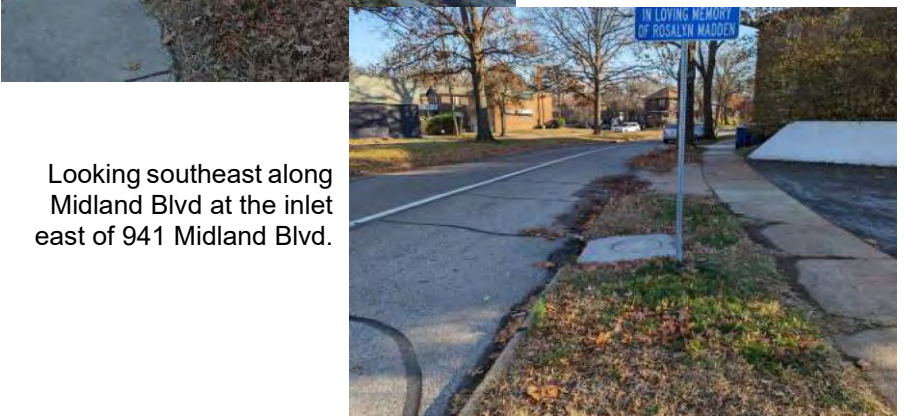
**Problem Description:**  
 The commercial building at 941 Midland Blvd has been flooded by ponded water in the street. The owner indicated that when this happens, the inlets won't drain. Investigation is necessary to determine if the flooding issue is due to inlet capacity, pipe capacity, or high tailwater from the River Des Peres, or a combination of these issues.

Looking north towards the inlet at the southwest corner of Midland Blvd and Balson Ave.

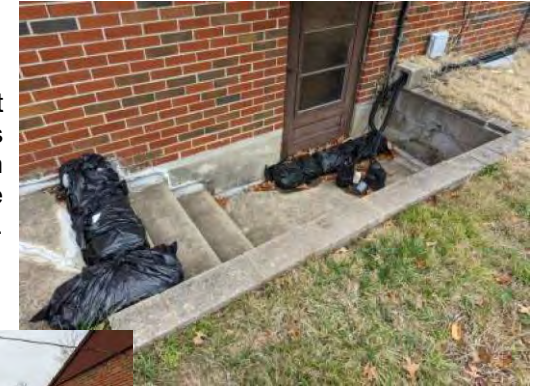
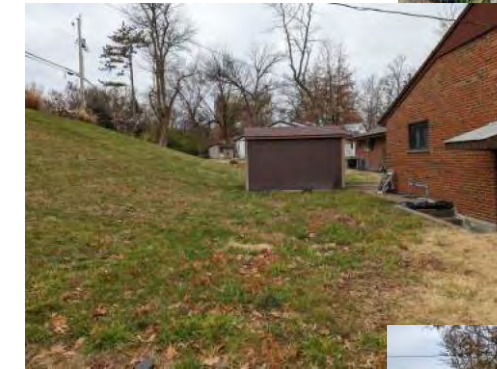
The basement stairwell at 7838 Balson Ave. Sand bags and sump pumps have been added to try to keep the basement from flooding.

Looking west in the backyard of 7838 Balson Ave. The house is on the right.

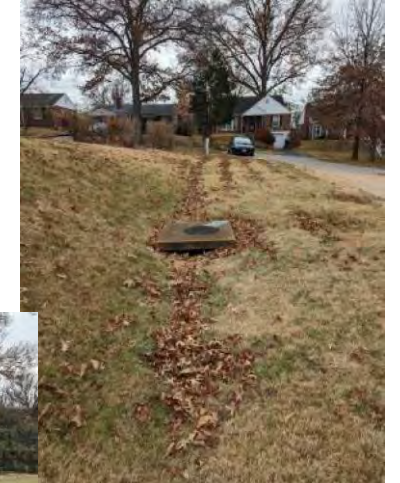
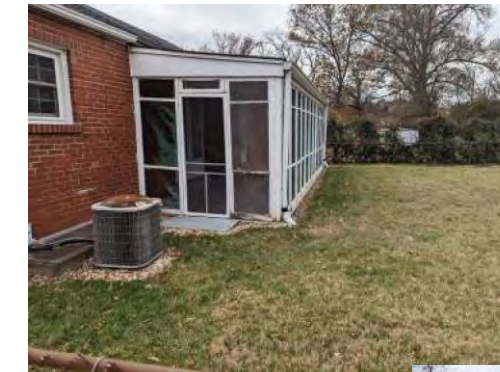
**Problem Description:**  
 About 3 acres of drainage flows to the backyard at 7353 Milan Ave. An area inlet just east of the backyard clogs easily and may also have inadequate capacity. Water backs up, flooding the entire yard until it can flow east. Water has nearly reached the threshold of the back door to the house. The basement has flooded from both seepage and overland flow in 2014, 2015, and 2022.

Looking south along the property line between #7353 and 7339.

Looking towards the back patio at #7353. Ponded water has nearly reached the threshold of the door into the house (not the door to the screened in patio).

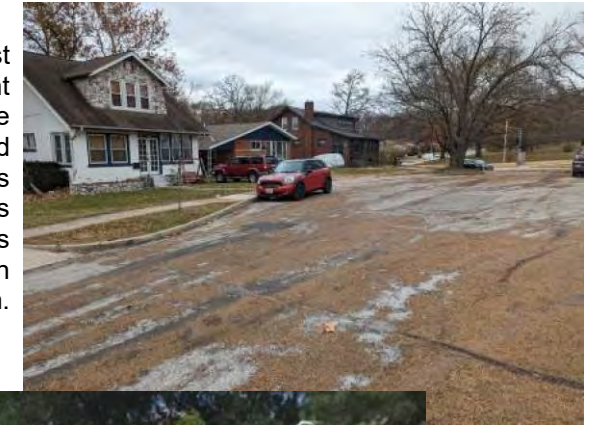
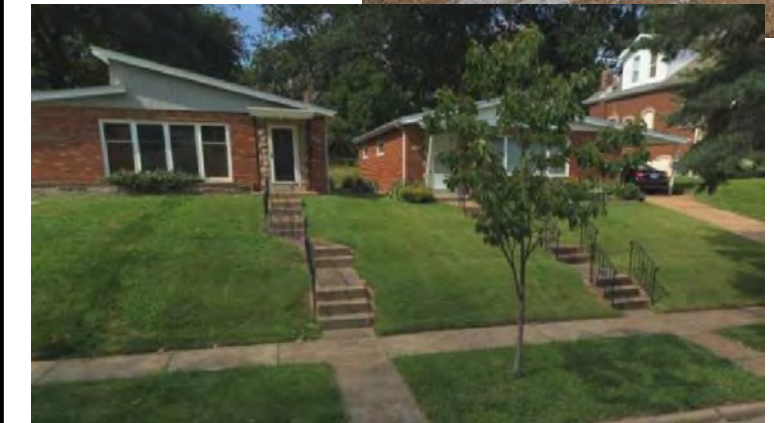
Looking southwest towards the low point on Carleton Ave. The low point is near the red car; this area ponds until it overflows towards the backyards of the houses on Wellington.

Looking north between #7423 (on the left) and #7419 (on the right). The space between houses may convey some of the runoff from the backyards, but the grading and available space is insufficient.

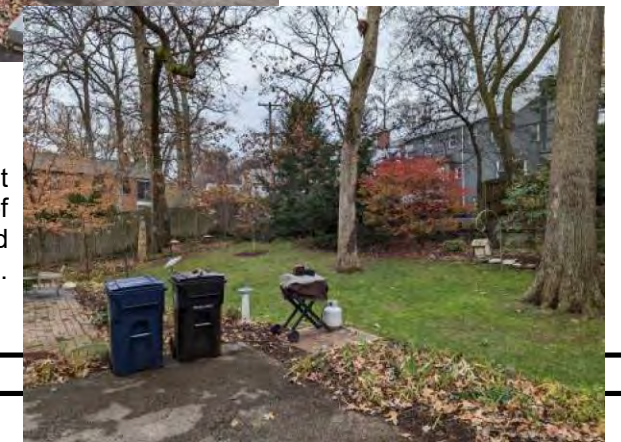
Looking southeast towards the backyard of 8128. The yard is sloped towards the house.
