MINUTES OF THE STORMWATER COMMISSION May 16, 2023

University City Stormwater Master Plan
Suggested Problems for Detailed Study

5/1/2023

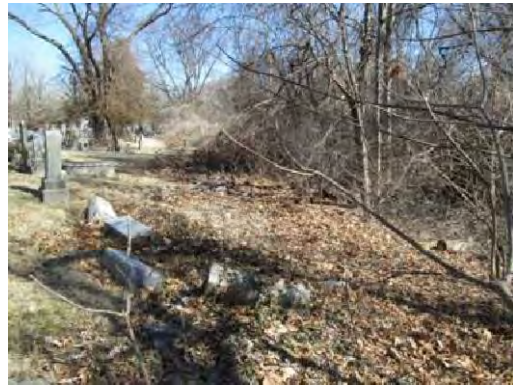
Gravestones at the B'Nai Amoona cemetery along the top of the creek bank have been damaged possibly as a result of bank erosion.

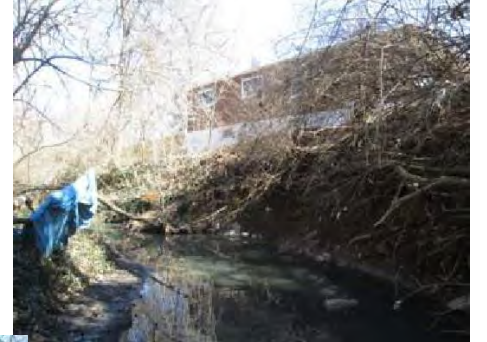
The 13-foot high eroding bank at 7591 Amherst is 20 feet from the home (measured from the toe of bank), and has not advanced significantly since 2006, but is considered severe by MSD's bank erosion rating (V/H=1.46). The July 26, 2022 flood was above the basement floor of 7591 Amherst and collapsed their fence.

The 13-foot high eroding bank at 7591 Amherst is 9 feet from the home (measured from the top of bank).

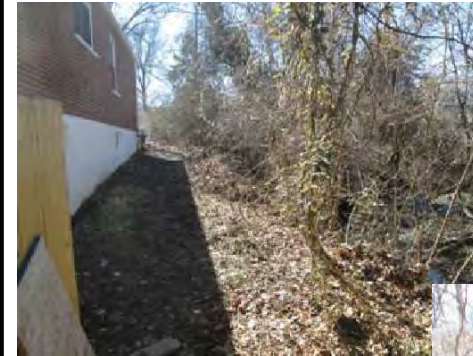
Creek erosion along 7587 Amherst is undermining their fence. The erosion rating at 7587 Amherst is considered a threat to the home (V/H=0.25).

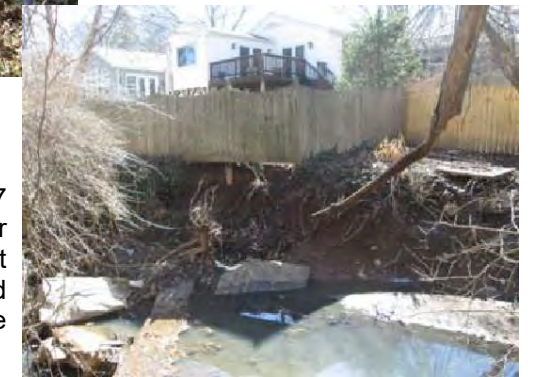
Concrete-encased private sanitary sewer lateral at 7587 Amherst is exposed and possibly leaking. The stream profile drops 2 feet across the lateral.

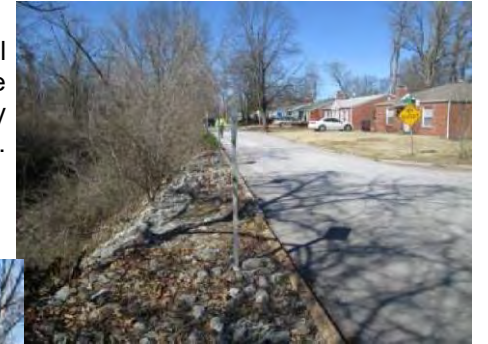
Over-steepened channel banks, and the remains of riprap placed by MSD that has since eroded and slid off the bank.

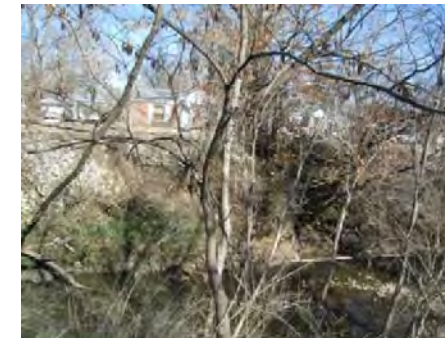
Channel bottom contains riprap, some of which slid off the bank from a previously installed MSD project.

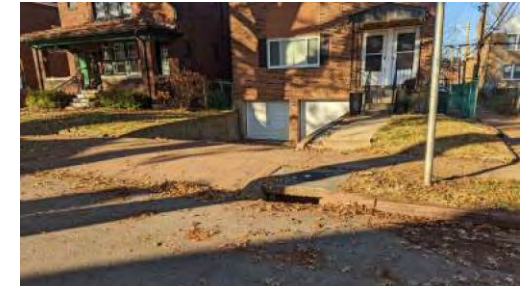
Although not all of these residents responded, it is likely that 7101, 7059, 7055, 7053, and 7037 Amherst Ave have frequent basement flooding due to water escaping the street and flowing down the driveway.

The driveway at 7101 Amherst Ave.

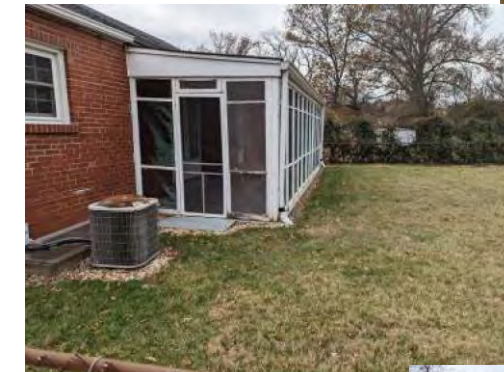
Looking towards the back patio at #7353. Ponded water has nearly reached the threshold of the door into the house (not the door to the screened in patio).

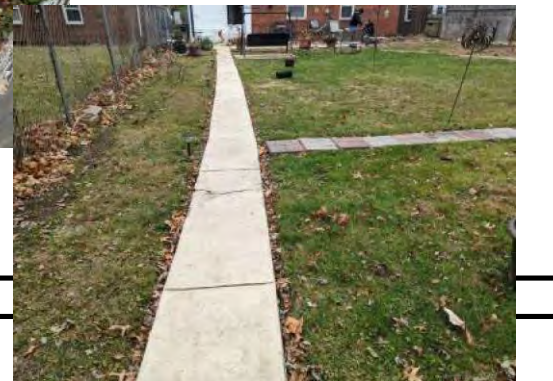
There is an inlet behind 1561, but only about half of a side is able to accept water due to grading issues. Note the inlet appears to be in a strip of ROW between the houses and business.

Looking towards the inlet north of #1561. Due to grading, the inlet does not appear to collect much runoff.

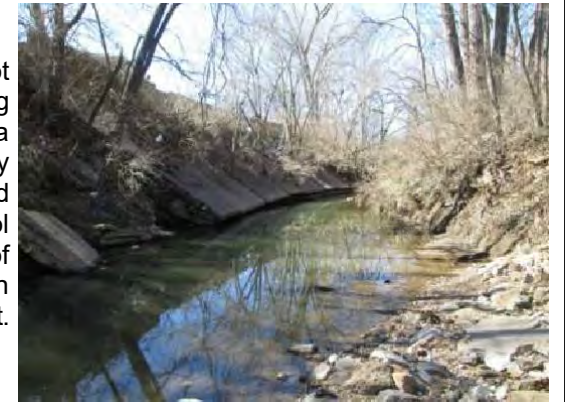
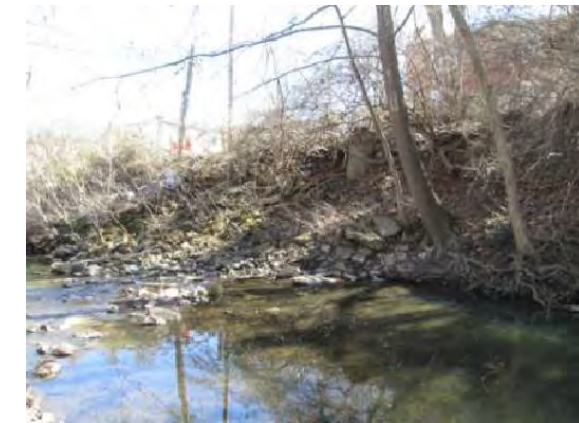
An approximately 175-foot reach of the right-descending river bank is lined with a concrete slab, but the integrity of the concrete is compromised by a 3-foot deep scour pool along the toe of bank. Failure of slab will likely cause failure in the parking lot.

MSD infrastructure along the right-descending river bank is threatened by bank erosion including a combined sewer manhole, a combined sewer overflow (CSO) structure, and a storm sewer outflow structure.

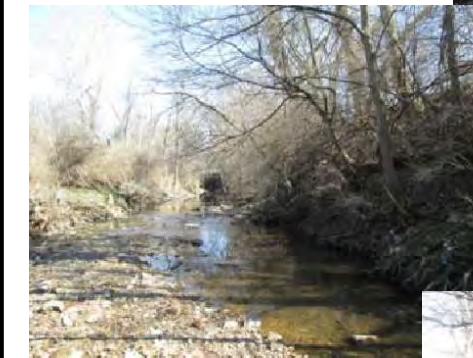
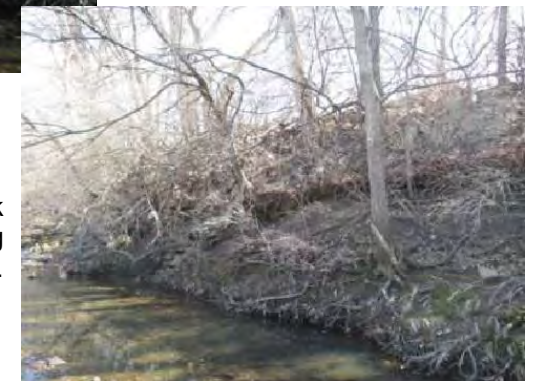
The foundation of a 6-foot high mid-slope fence is eroded and the fence is collapsing. It appears that riprap was added from the top of slope to address an area of gulley erosion, but this riprap is sliding down the bank. The weight of this riprap is contributing to the fence failure.

On the right descending bank are the eroding bank, collapsing fence, and sliding riprap.

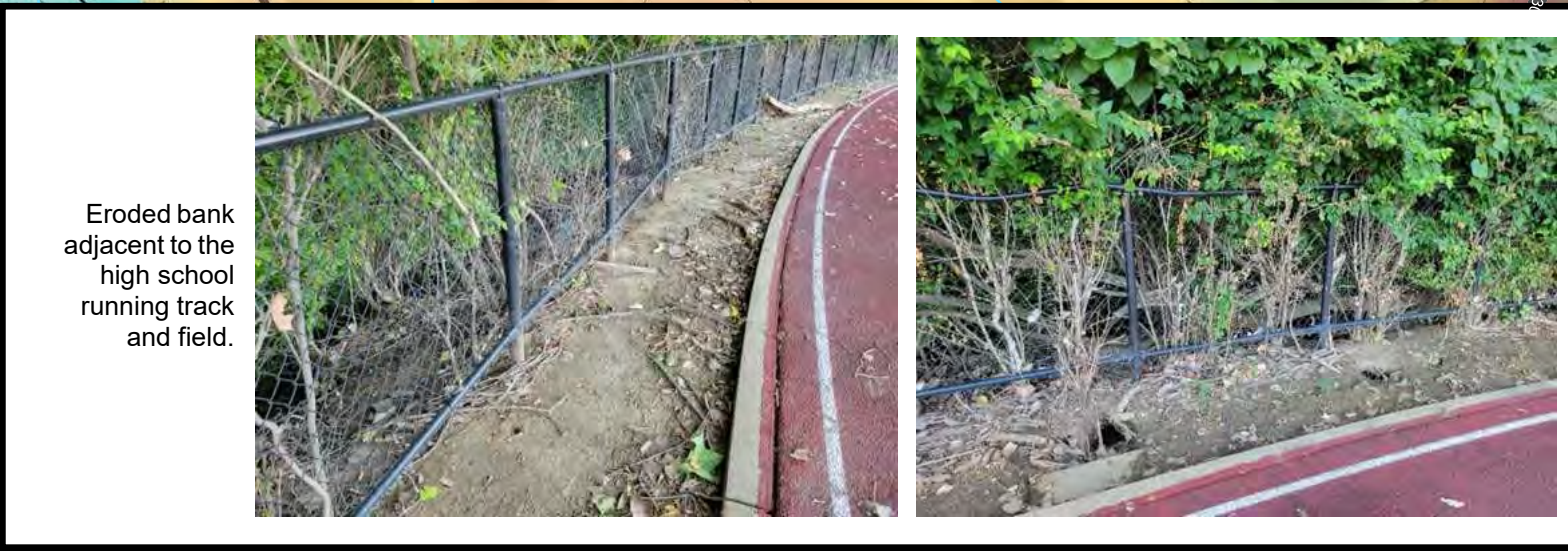
Eroded bank adjacent to the high school running track and field.

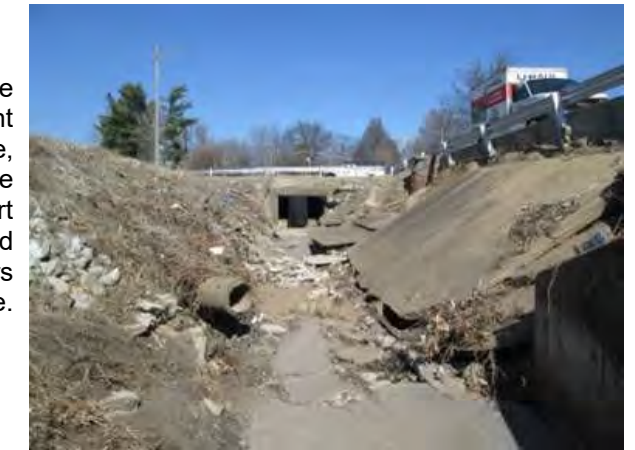
Undermined concrete slabs with adjacent at-risk infrastructure, looking upstream. The concrete box culvert under Olive Boulevard (background) appears stable.

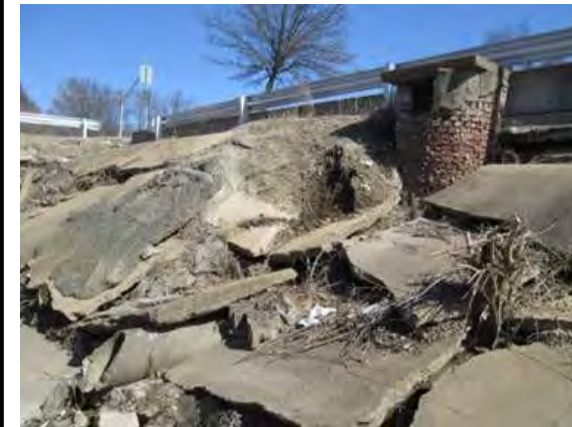
Exposed foundation of the adjacent parking lot.

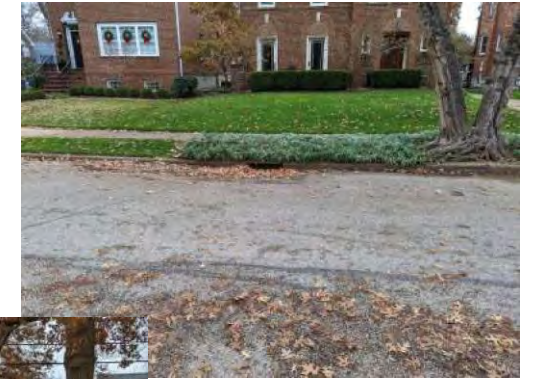
Looking towards the grated curb inlet with side intake between #416 and 414. The side intake is rather narrow and the grate is clogged with leaves.

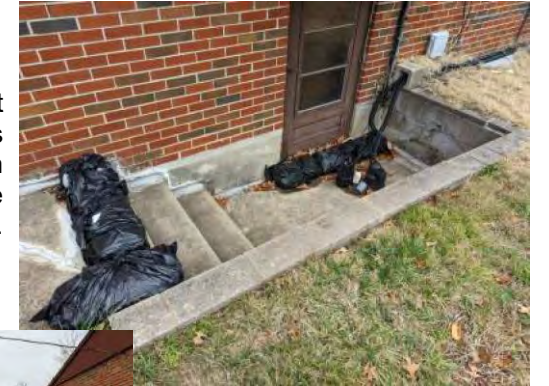
The basement stairwell at 7838 Balson Ave. Sand bags and sump pumps have been added to try to keep the basement from flooding.

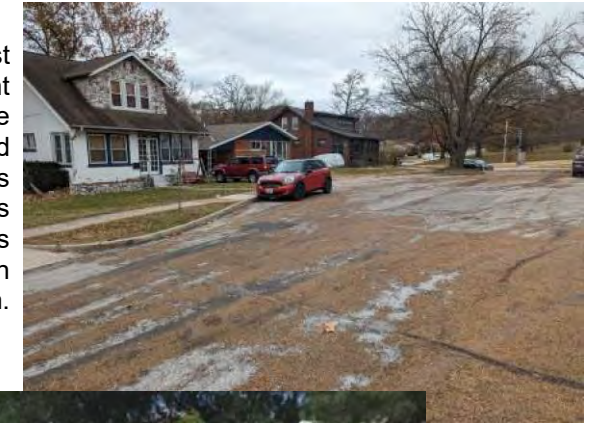
Looking southwest towards the low point on Carleton Ave. The low point is near the red car; this area ponds until it overflows towards the backyards of the houses on Wellington.

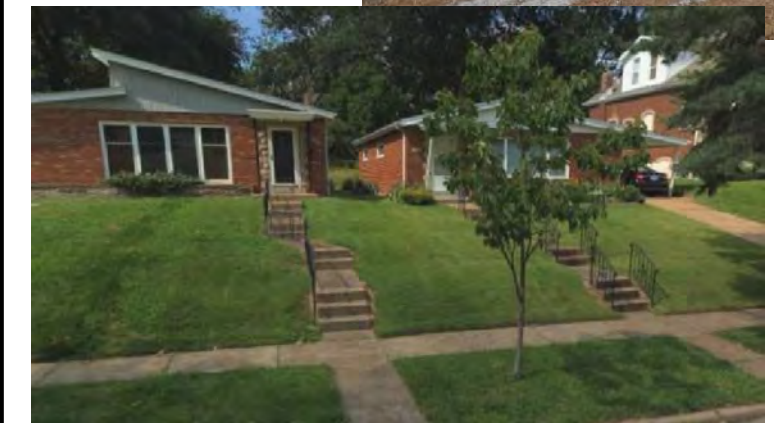
Looking north between #7423 (on the left) and #7419 (on the right). The space between houses may convey some of the runoff from the backyards, but the grading and available space is insufficient.

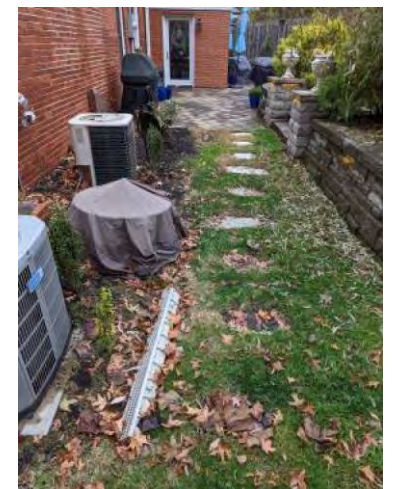
Looking east along the back of 7924 Lafon Pl. A yard drain was installed in an attempt to reduce ponding near the house.

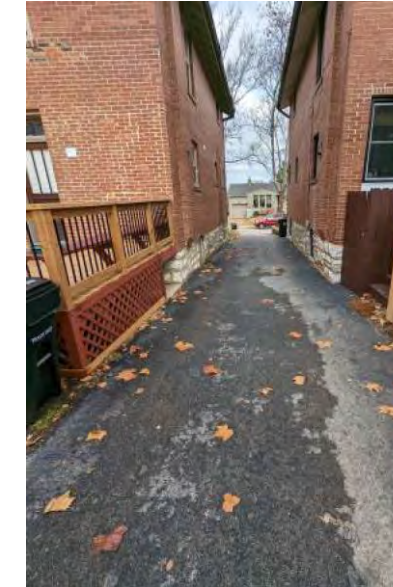
Looking north between #7252 (on the left) and #7250 (on the right). Basement windows are within 1-3 inches of the driveway - a potential source of flooding to the basements.

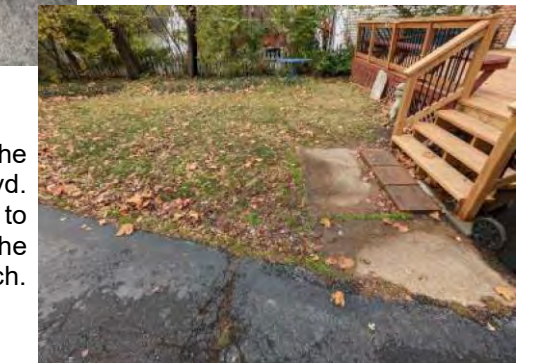
Looking west towards the backyard at 7252 Lindell Blvd. Ponding occurs near the steps to the patio. There is a stairwell to the basement under the porch.

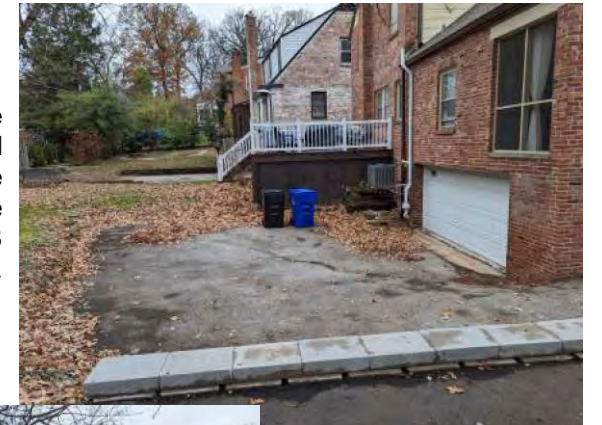
Looking towards the backyard of 8132 Cornell Ct; the basement garage has flooded since it is the low point of about 1.8 acres.

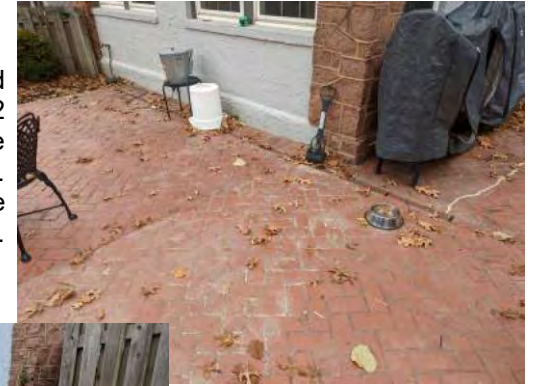
A slotted drain was installed by the homeowner at 7232 Northmoor Dr to reduce ponding against the house. This type of private drainage is common in the area.

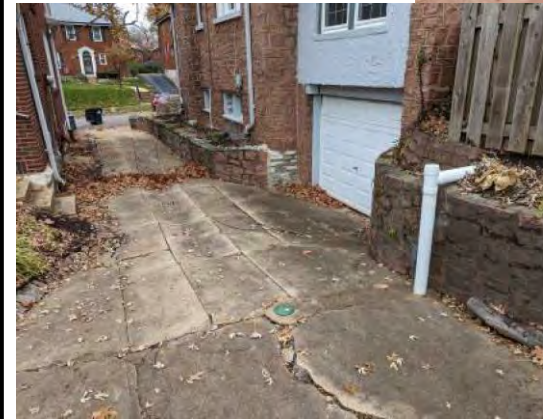
Looking north between #7236 (on the left) and #7232 (on the right). The tuck-under garage is at risk of flooding since the main flow path for water in the backyards is to flow down this driveway.

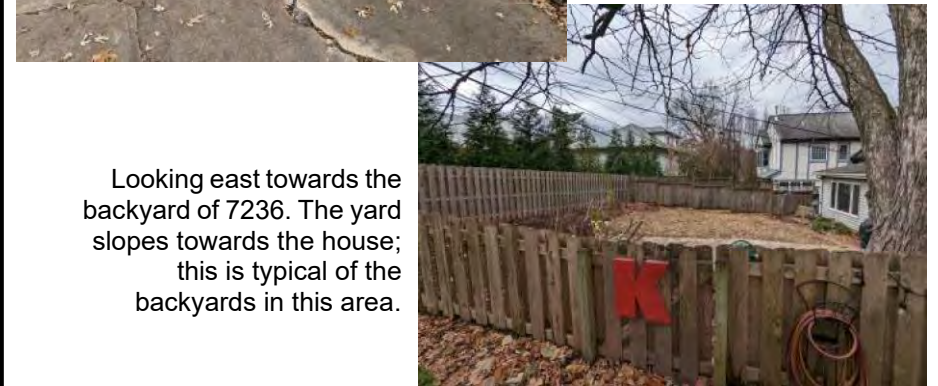
Looking east towards the backyard of 7236. The yard slopes towards the house; this is typical of the backyards in this area.
