AGENDA
COMMISSION ON STORM WATER ISSUES MEETING
HEMAN PARK COMMUNITY CENTER
975 PENNSYLVANIA
Tuesday, March 7, 2023,
6:30 PM

Draft: MINUTES OF THE STORMWATER COMMISSION
February 7, 2023

TO: Darren Girdler, Director of Public Works
 Mirela Celaj, CFM, Assistant Director of Public Works
 FROM: Stormwater Master Plan Team (HR Green and Reitz & Jens)
 SUBJECT: University City Stormwater Master Plan
Public versus Private – Recommended Definition Scope of work Task 2.2
 DATE: February 28, 2023

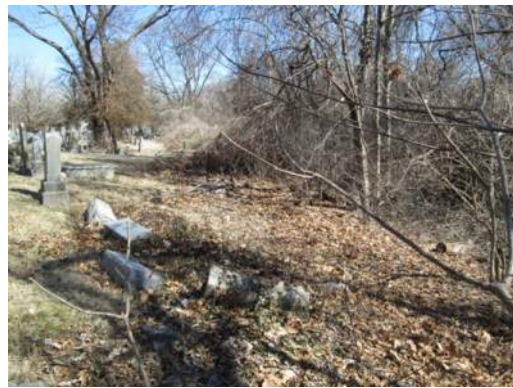
Gravestones at the B'Nai Amoona cemetery along the top of the creek bank have been damaged possibly as a result of bank erosion.

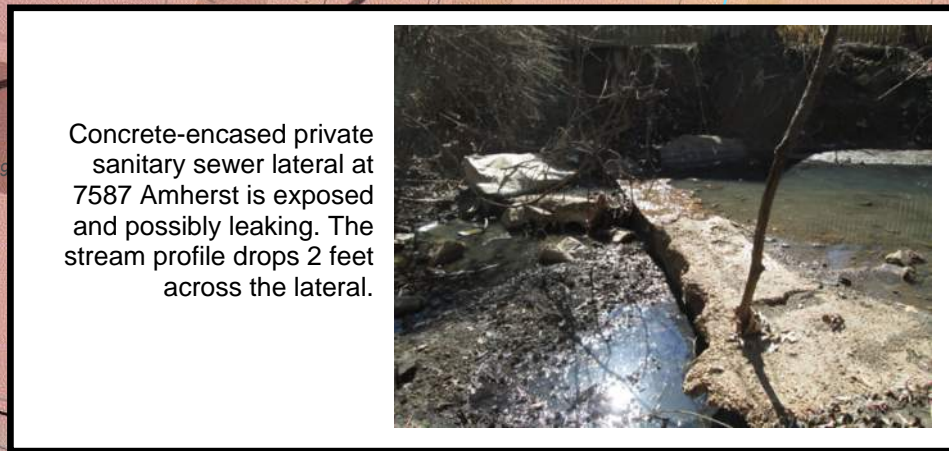
Concrete-encased private sanitary sewer lateral at 7587 Amherst is exposed and possibly leaking. The stream profile drops 2 feet across the lateral.

Creek erosion along 7587 Amherst is undermining their fence. The erosion rating at 7587 Amherst is considered a threat to the home (V/H=0.25).

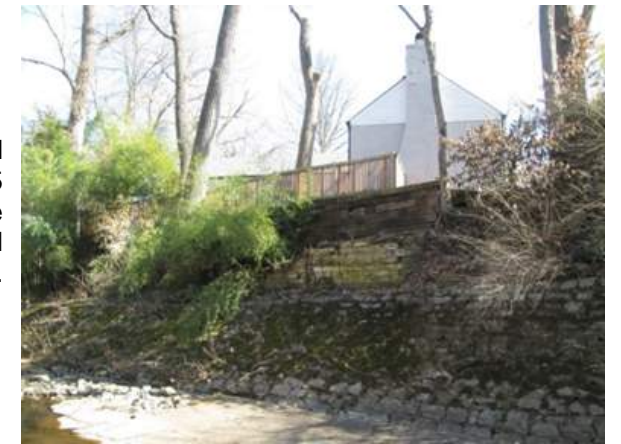
A 16-foot high bank with a combination of public and private walls is compromised and a house located only 7 feet from the top of wall is at risk. The wood tie wall is compromised, but the lower 6-feet of the bank of the Rider des Peres at this location is a WPA hand-placed stone wall, which appears stable.

Wood tie wall and WPA block wall. 7425 Shaftesbury Ave is the house behind the wall in the photo.

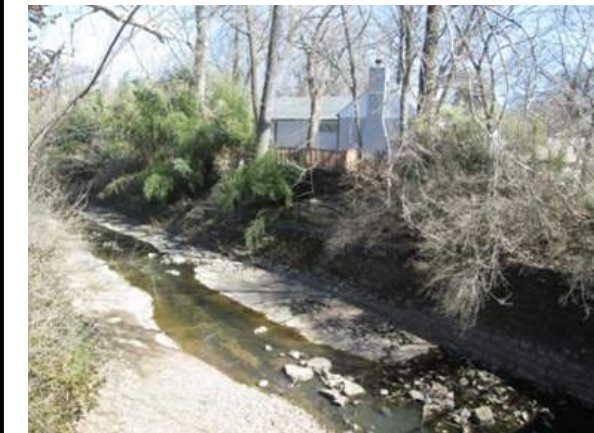
Wood tie wall and WPA block wall, looking downstream.

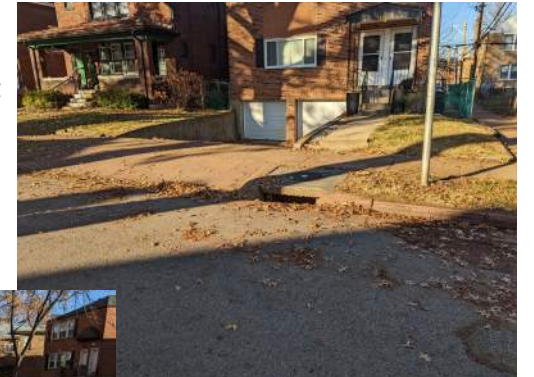
Although not all of these residents responded, it is likely that 7101, 7059, 7055, 7053, and 7037 Amherst Ave have frequent basement flooding due to water escaping the street and flowing down the driveway.

Grated drains were observed near each garage door. It is likely that each of these are connected into the nearby combined sewer. Therefore, it is possible the flooding is due to backup from the combined sewer main.

The driveway at 7101 Amherst Ave.

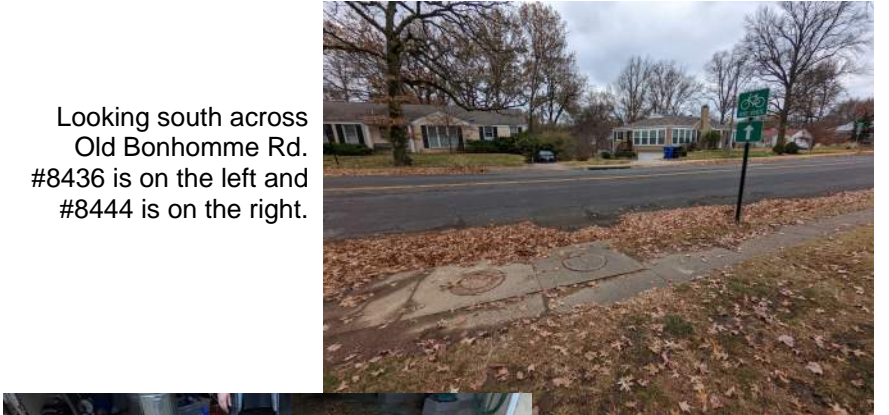
Basement garages at 8444 and 8436 Old Bonhomme Rd flood frequently from water which comes down the driveway at 8436 from the street. There is a triple curb inlet in front of 8436 Old Bonhomme Rd which accepts water from about 1,200 feet of Old Bonhomme Rd. The downstream pipe is 24" in diameter.

Looking south across Old Bonhomme Rd. #8436 is on the left and #8444 is on the right.

MSD has studied the problem and identified storm sewer upsizing as a solution. It may also be beneficial to investigate other opportunities for improvement, such as: A) increase inlet capacity at the street by adding inlets east of the triple inlet, B) raise a portion of the driveway at 8436 to keep water in the street, or C) provide a conveyance path down driveway and towards the at the property corner between #8436 and 940/932 Alanson Dr.

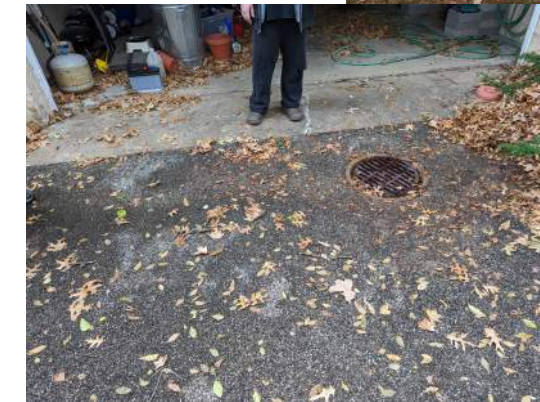
Looking at the ground in front of the driveway at 8436 Old Bonhomme Rd.

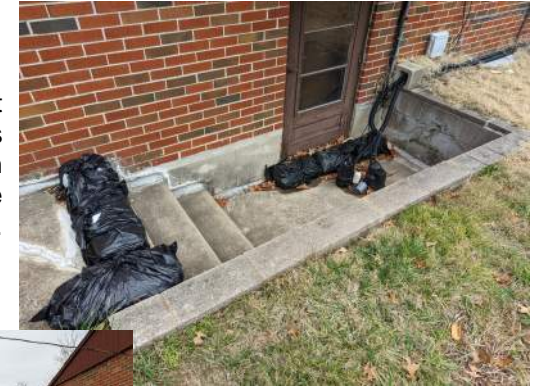
The basement stairwell at 7838 Balson Ave. Sand bags and sump pumps have been added to try to keep the basement from flooding.

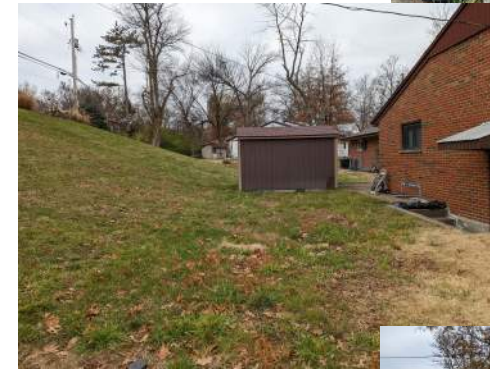
Looking west in the backyard of 7838 Balson Ave. The house is on the right.

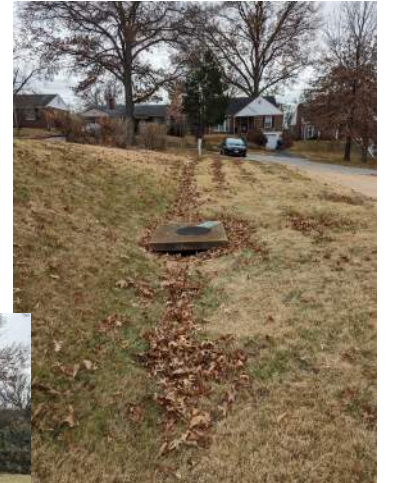
About 3 acres of drainage flows to the backyard at 7353 Milan Ave. An area inlet just east of the backyard clogs easily and may also have inadequate capacity. Water backs up, flooding the entire yard until it can flow east. Water has nearly reached the threshold of the back door to the house. The basement has flooded from both seepage and overland flow in 2014, 2015, and 2022.

Looking south along the property line between #7353 and 7339.

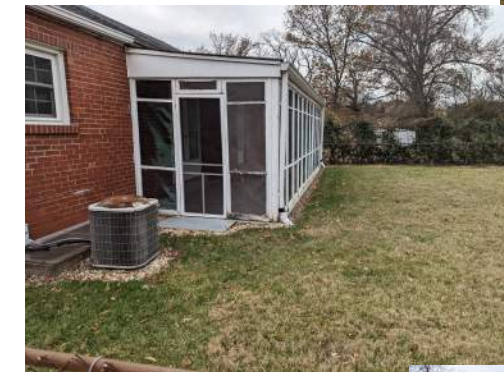
Looking towards the back patio at #7353. Ponded water has nearly reached the threshold of the door into the house (not the door to the screened in patio).

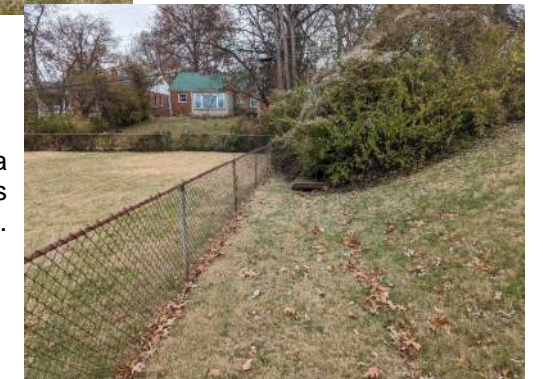
Looking north towards the area inlet in the backyards. #7353's backyard is on the left.

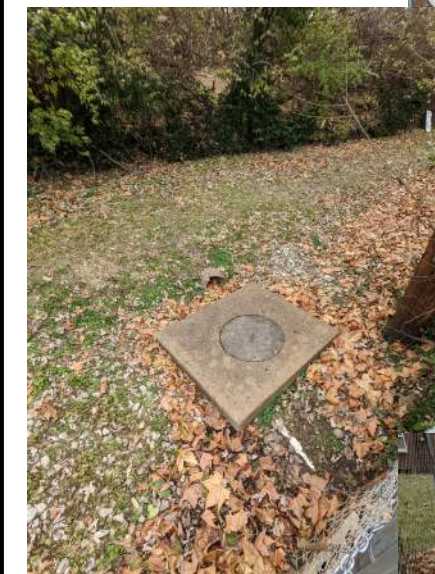
Looking towards the inlet north of #1561. Due to grading, the inlet does not appear to collect much runoff.

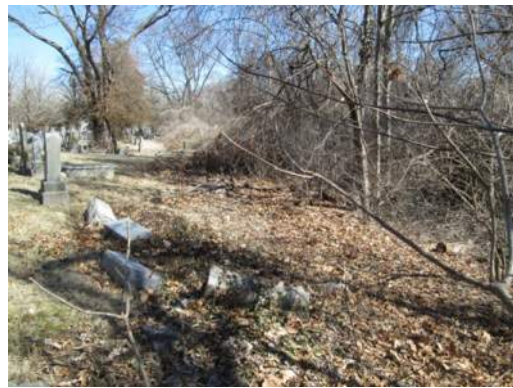
Gravestones at the B'Nai Amoona cemetery along the top of the creek bank have been damaged possibly as a result of bank erosion.

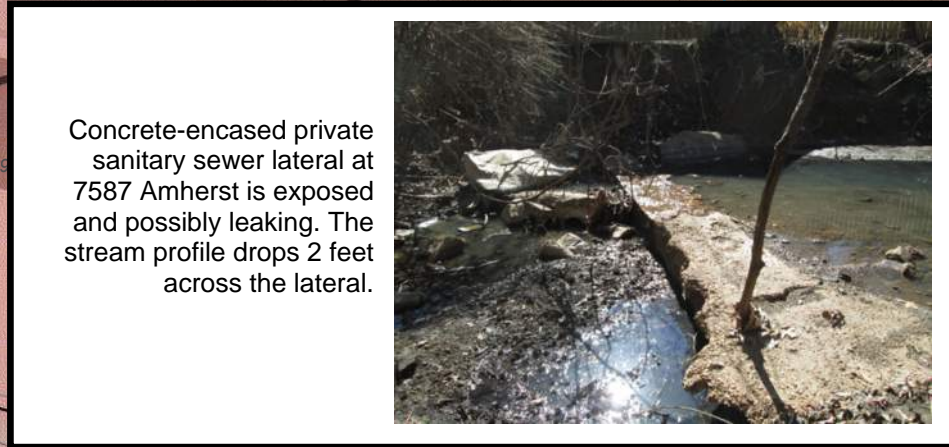
Concrete-encased private sanitary sewer lateral at 7587 Amherst is exposed and possibly leaking. The stream profile drops 2 feet across the lateral.

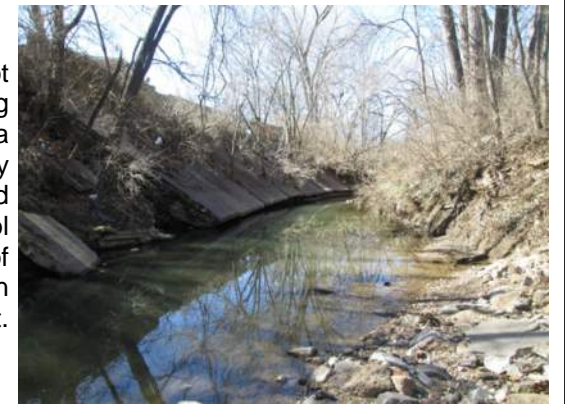
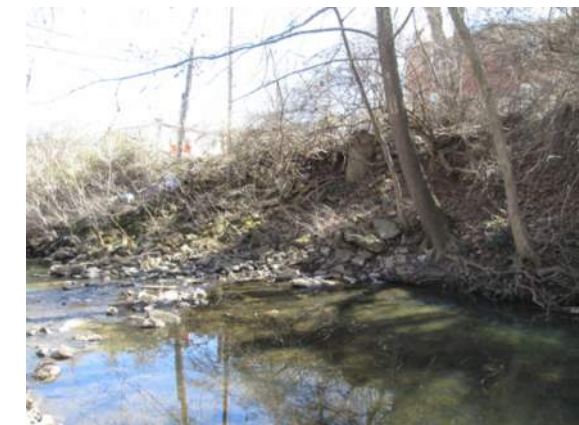
An approximately 175-foot reach of the right-descending river bank is lined with a concrete slab, but the integrity of the concrete is compromised by a 3-foot deep scour pool along the toe of bank. Failure of slab will likely cause failure in the parking lot.

MSD infrastructure along the right-descending river bank is threatened by bank erosion including a combined sewer manhole, a combined sewer overflow (CSO) structure, and a storm sewer outflow structure.

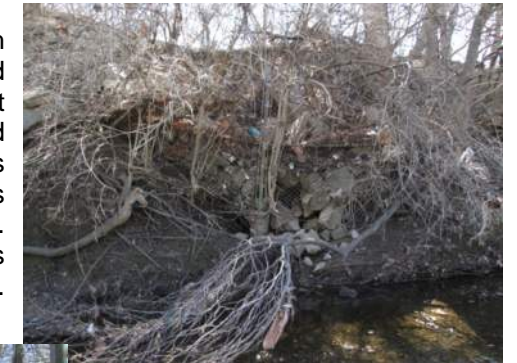
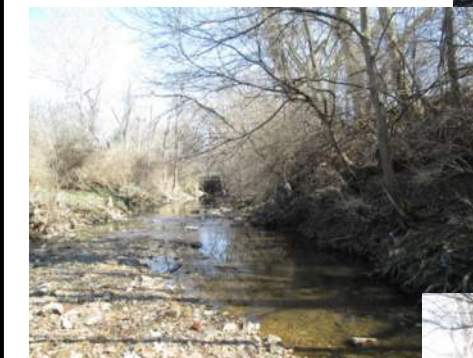
The foundation of a 6-foot high mid-slope fence is eroded and the fence is collapsing. It appears that riprap was added from the top of slope to address an area of gulley erosion, but this riprap is sliding down the bank. The weight of this riprap is contributing to the fence failure.

On the right descending bank are the eroding bank, collapsing fence, and sliding riprap.

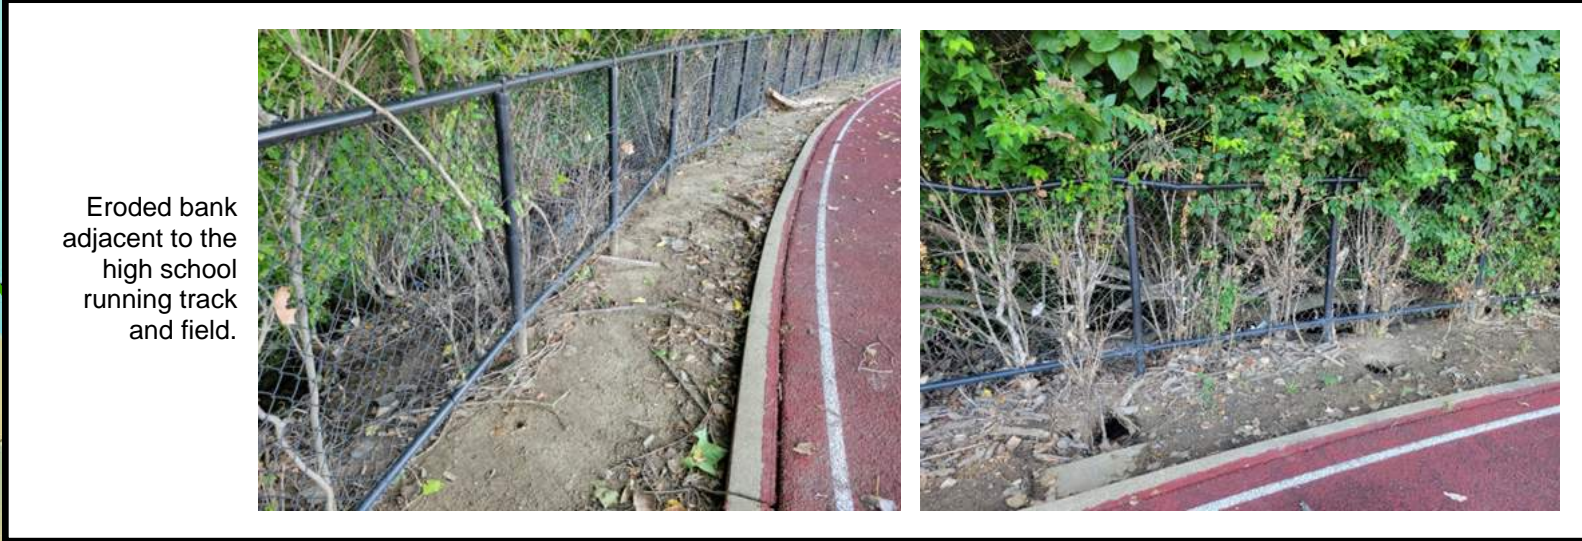
Eroded bank adjacent to the high school running track and field.

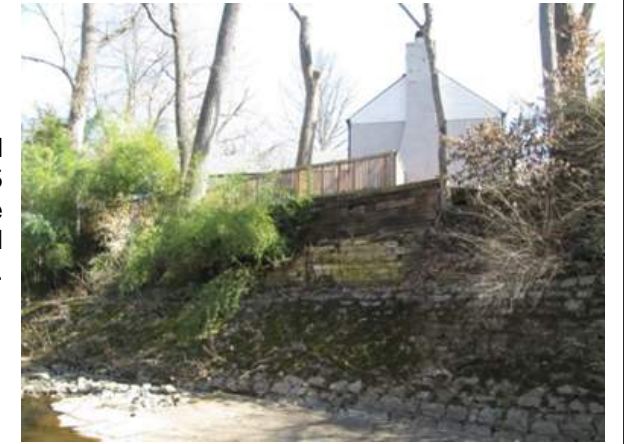
Problem Description:
 A 16-foot high bank with a combination of public and private walls is compromised and a house located only 7 feet from the top of wall is at risk. The wood tie wall is compromised, but the lower 6-feet of the bank of the Rider des Peres at this location is a WPA hand-placed stone wall, which appears stable.

Wood tie wall and WPA block wall. 7425 Shaftesbury Ave is the house behind the wall in the photo.

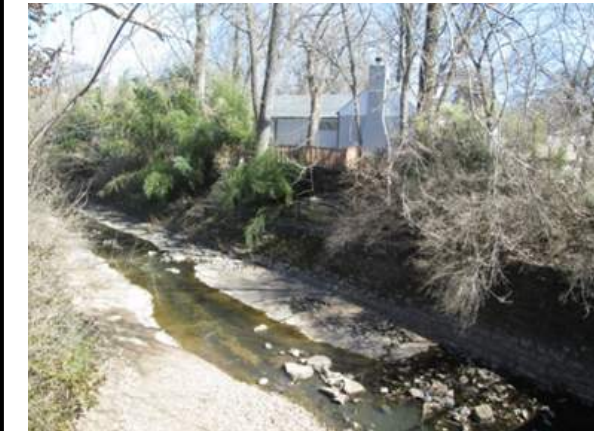
Wood tie wall and WPA block wall, looking downstream.

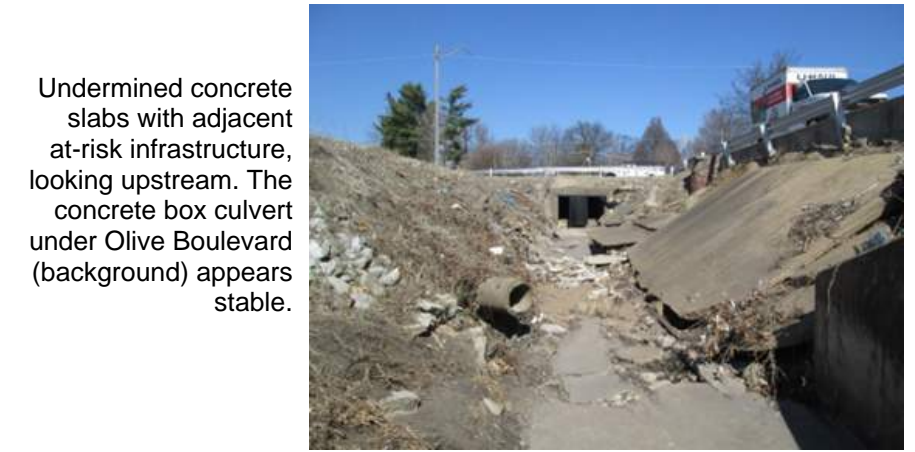
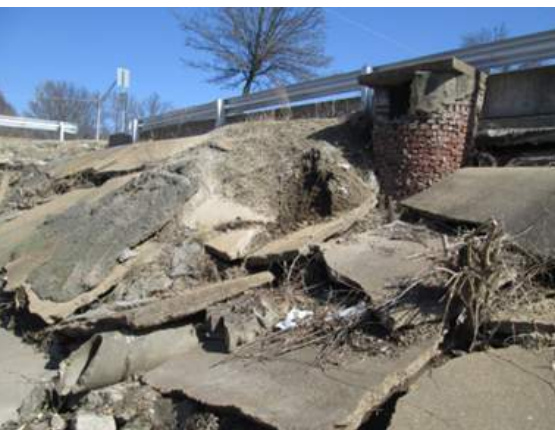
Problem Description:
Concrete slabs lining a tributary to the River des Peres are undermined and have failed, looking upstream. The foundation of the concrete-curb adjacent U-Haul parking lot is exposed on the east side of the channel. At-risk infrastructure includes the commercial parking lot, an inlet manhole, and a pipe outfall.

Undermined concrete slabs with adjacent at-risk infrastructure, looking upstream. The concrete box culvert under Olive Boulevard (background) appears stable.

Exposed foundation of the adjacent parking lot.

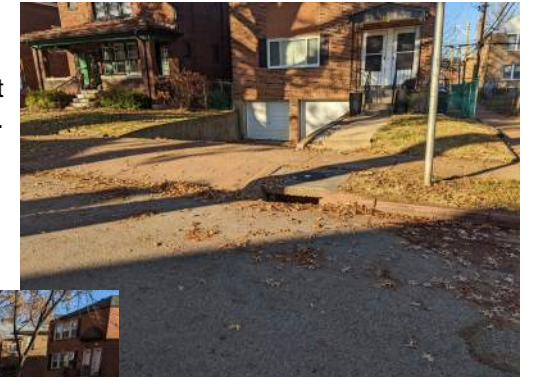
Grated drains were observed near each garage door. It is likely that each of these are connected into the nearby combined sewer. Therefore, it is possible the flooding is due to backup from the combined sewer main.

The driveway at 7101 Amherst Ave.

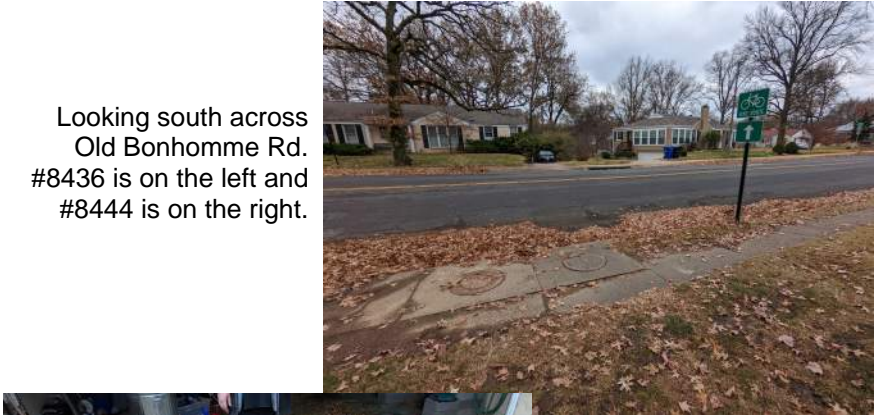
Looking south across Old Bonhomme Rd. #8436 is on the left and #8444 is on the right.

MSD has studied the problem and identified storm sewer upsizing as a solution. It may also be beneficial to investigate other opportunities for improvement, such as: A) increase inlet capacity at the street by adding inlets east of the triple inlet, B) raise a portion of the driveway at 8436 to keep water in the street, or C) provide a conveyance path down driveway and towards the at the property corner between #8436 and 940/932 Alanson Dr.

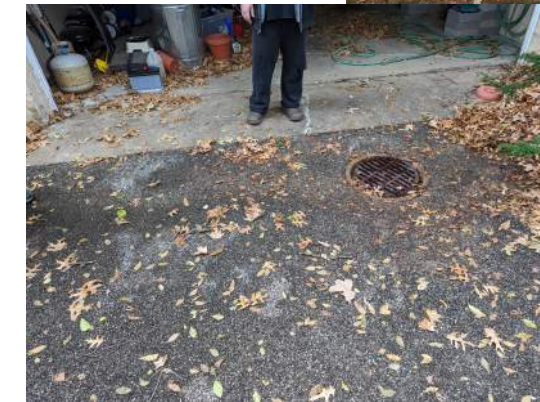
Looking at the ground in front of the driveway at 8436 Old Bonhomme Rd.

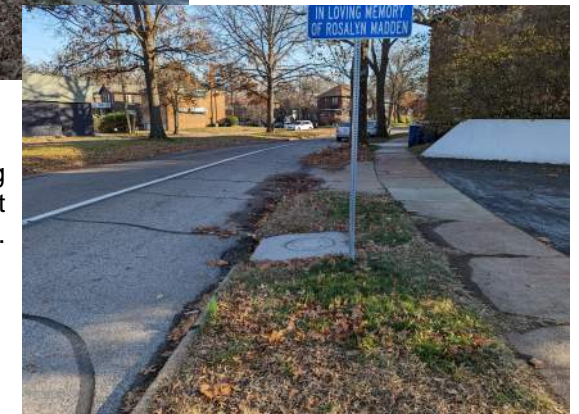
Looking southeast along Midland Blvd at the inlet east of 941 Midland Blvd.

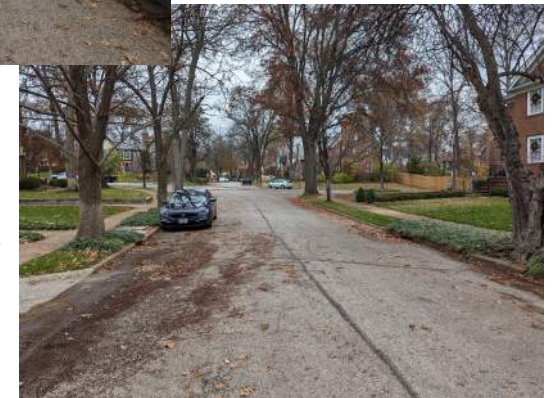
Looking south towards the inlets in front of #414 and 415. Both of these inlets are grated with a side intake.

Looking north towards the northern two inlets on W Point Ct. Both are grated inlets with side intakes.

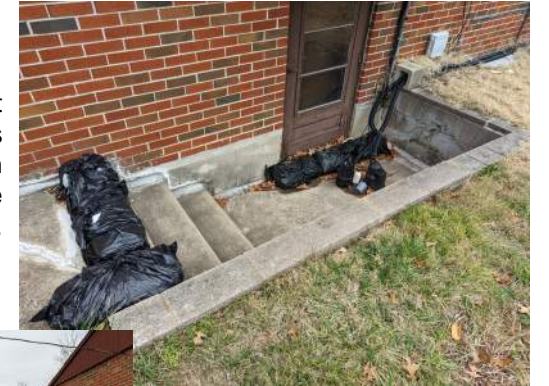
The basement stairwell at 7838 Balson Ave. Sand bags and sump pumps have been added to try to keep the basement from flooding.

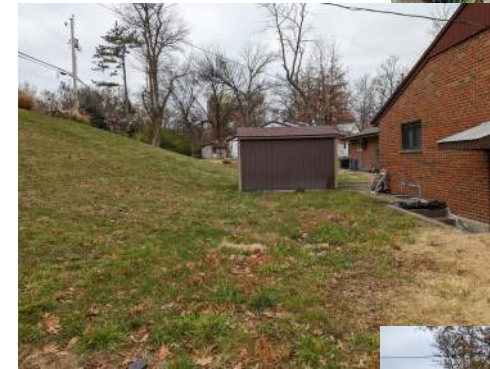
Looking west in the backyard of 7838 Balson Ave. The house is on the right.

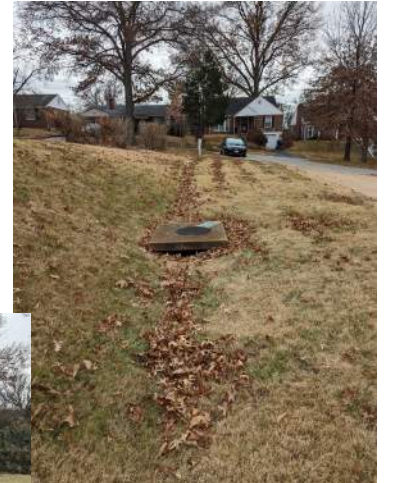
Looking south along the property line between #7353 and 7339.

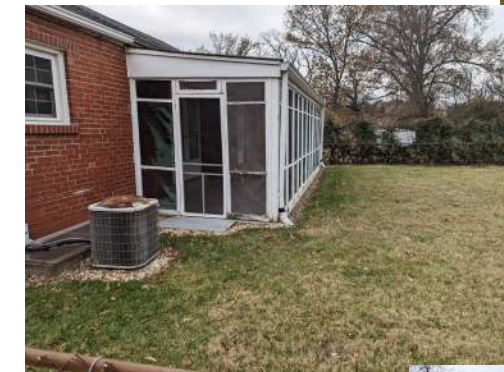
Looking towards the back patio at #7353. Ponded water has nearly reached the threshold of the door into the house (not the door to the screened in patio).

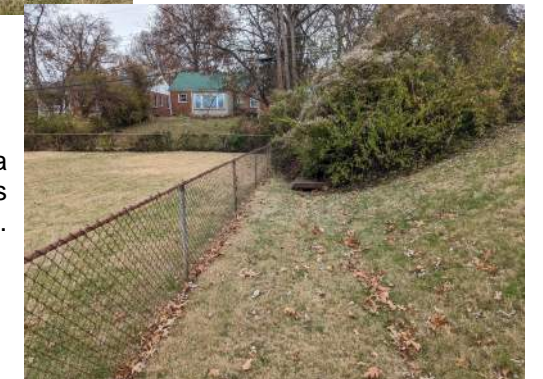
Looking north towards the area inlet in the backyards. #7353's backyard is on the left.

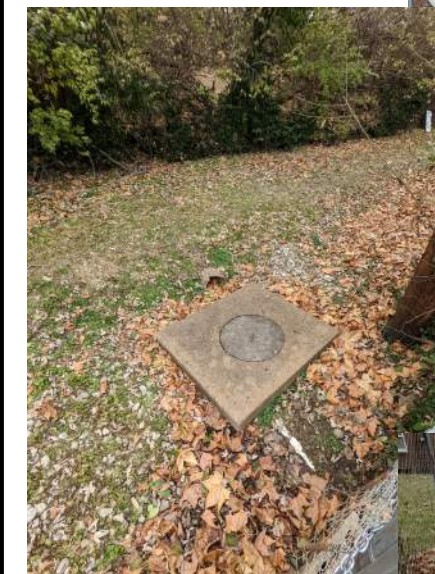
Looking towards the inlet north of #1561. Due to grading, the inlet does not appear to collect much runoff.

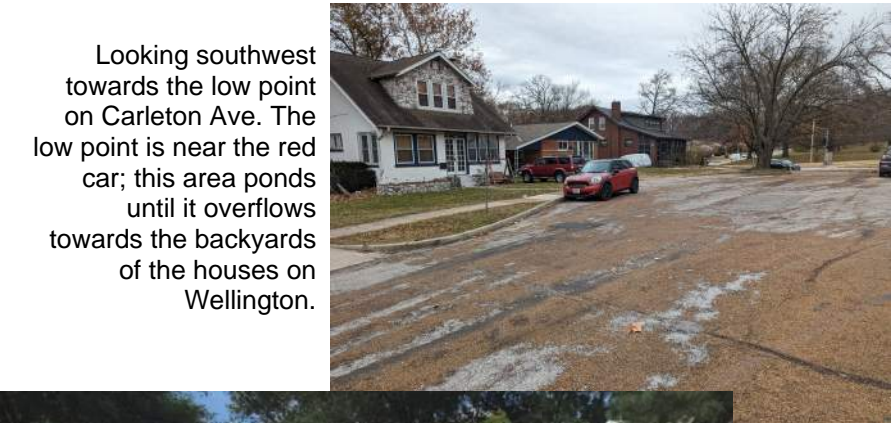
Looking southwest towards the low point on Carleton Ave. The low point is near the red car; this area ponds until it overflows towards the backyards of the houses on Wellington.

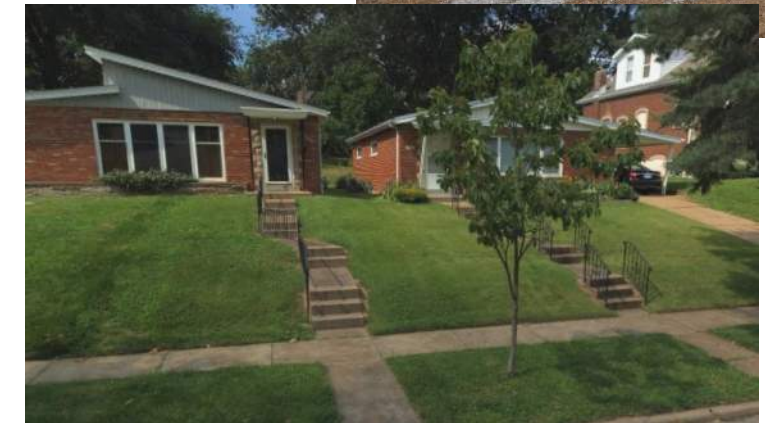
Looking north between #7423 (on the left) and #7419 (on the right). The space between houses may convey some of the runoff from the backyards, but the grading and available space is insufficient.

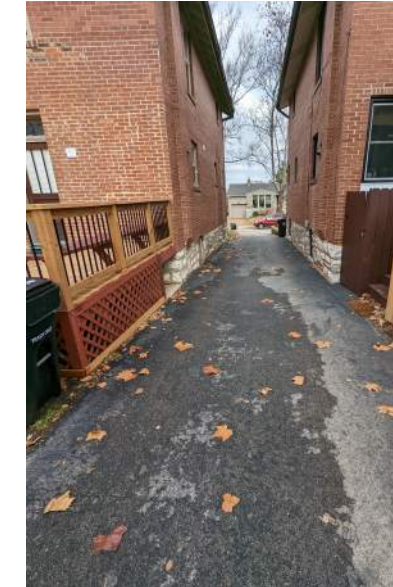
Looking north between #7252 (on the left) and #7250 (on the right). Basement windows are within 1-3 inches of the driveway - a potential source of flooding to the basements.

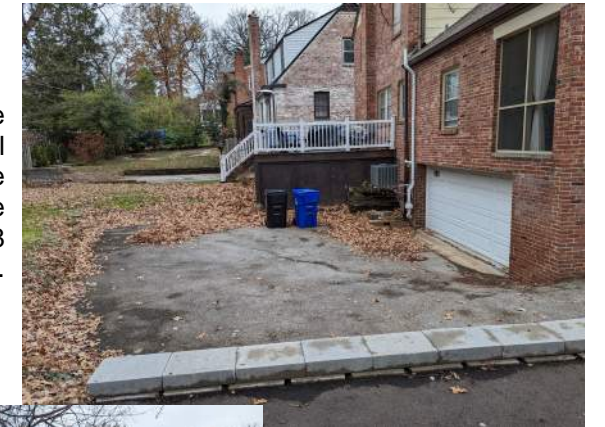
Looking towards the backyard of 8132 Cornell Ct; the basement garage has flooded since it is the low point of about 1.8 acres.

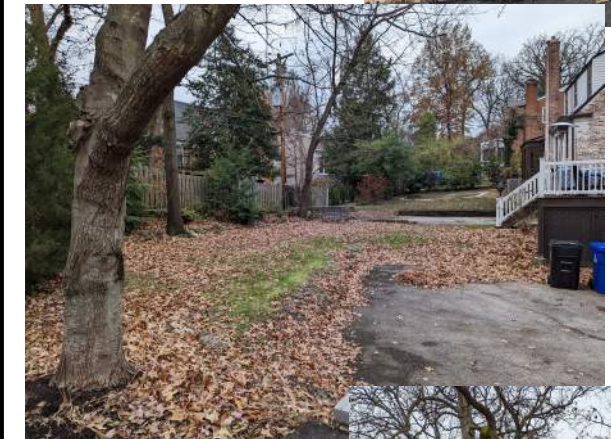
Looking west towards the backyard of #8132.

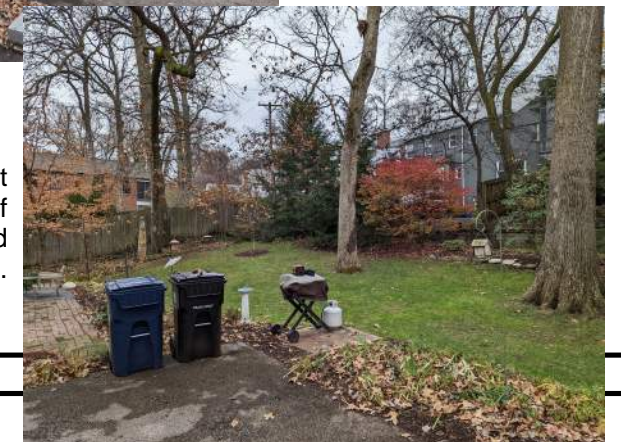
Looking southeast towards the backyard of 8128. The yard is sloped towards the house.

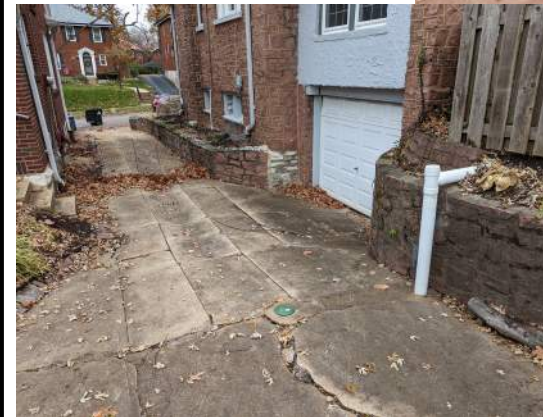
A slotted drain was installed by the homeowner at 7232 Northmoor Dr to reduce ponding against the house. This type of private drainage is common in the area.
