AGENDA
COMMISSION ON STORM WATER ISSUES
SPECIAL MEETING
HEMAN PARK COMMUNITY CENTER
975 PENNSYLVANIA
Tuesday, March 21, 2023,
3:00 PM

SUBJECT: University City Stormwater Master Plan
City Code – Review and Suggest Improvements Scope of work Task 2.5

TO: Darren Girdler, Director of Public Works
 Mirela Celaj, CFM, Assistant Director of Public Works
 FROM: Stormwater Master Plan Team (HR Green and Reitz & Jens)
 SUBJECT: University City Stormwater Master Plan
Public versus Private – Recommended Definition Scope of work Task 2.2
 DATE: February 28, 2023

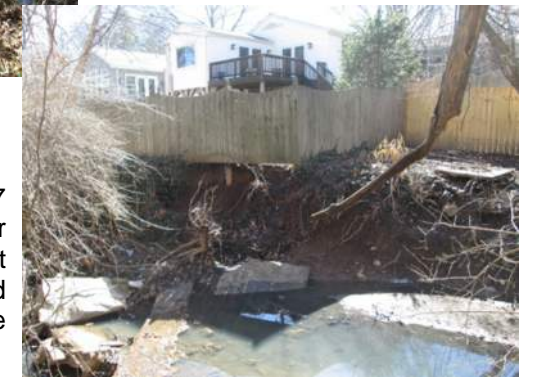
Creek erosion along 7587 Amherst is undermining their fence. The erosion rating at 7587 Amherst is considered a threat to the home (V/H=0.25).

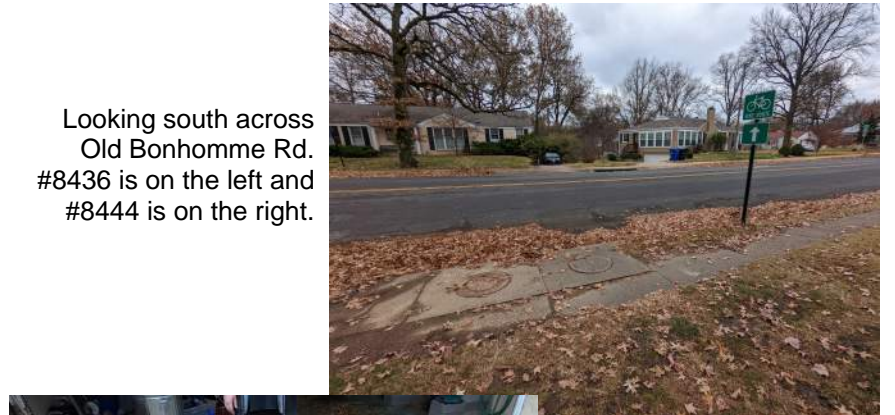
Basement garages at 8444 and 8436 Old Bonhomme Rd flood frequently from water which comes down the driveway at 8436 from the street. There is a triple curb inlet in front of 8436 Old Bonhomme Rd which accepts water from about 1,200 feet of Old Bonhomme Rd. The downstream pipe is 24" in diameter.

Looking south across Old Bonhomme Rd. #8436 is on the left and #8444 is on the right.

MSD has studied the problem and identified storm sewer upsizing as a solution. It may also be beneficial to investigate other opportunities for improvement, such as: A) increase inlet capacity at the street by adding inlets east of the triple inlet, B) raise a portion of the driveway at 8436 to keep water in the street, or C) provide a conveyance path down driveway and towards the at the property corner between #8436 and 940/932 Alanson Dr.

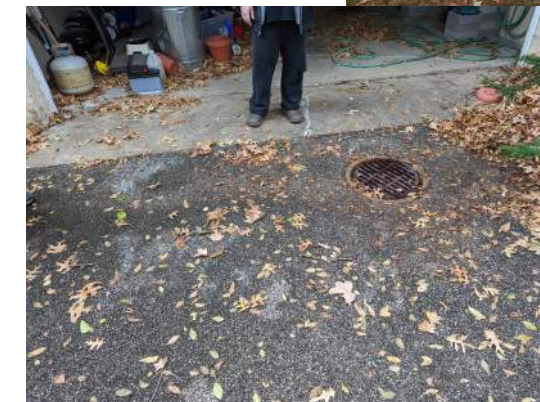
Looking at the ground in front of the driveway at 8436 Old Bonhomme Rd.

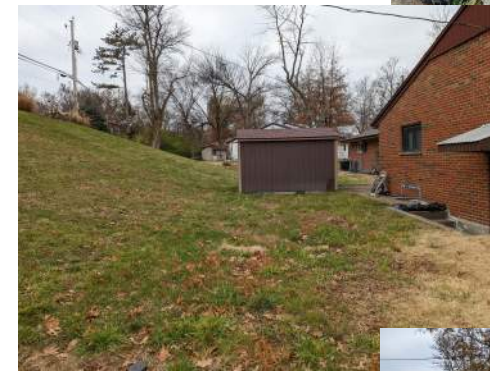
Looking west in the backyard of 7838 Balson Ave. The house is on the right.

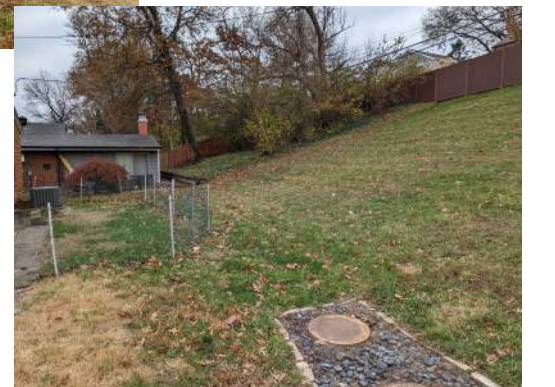
Looking east towards the backyards of two homes; 7832 Balson Ave is the house with the fence and 7828 Balson Ave is the house with the retaining wall.

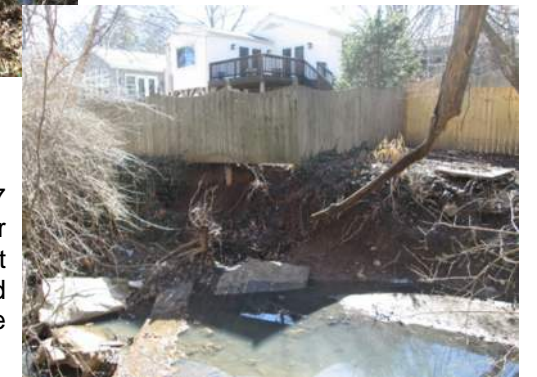
Creek erosion along 7587 Amherst is undermining their fence. The erosion rating at 7587 Amherst is considered a threat to the home (V/H=0.25).

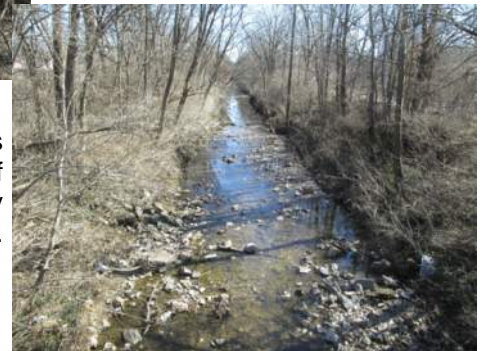
Channel bottom contains riprap, some of which slid off the bank from a previously installed MSD project.

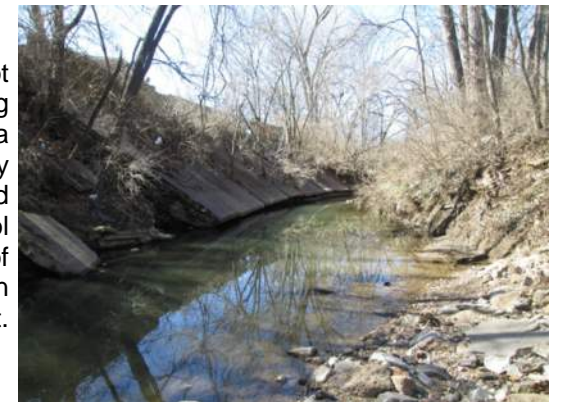
An approximately 175-foot reach of the right-descending river bank is lined with a concrete slab, but the integrity of the concrete is compromised by a 3-foot deep scour pool along the toe of bank. Failure of slab will likely cause failure in the parking lot.

MSD infrastructure along the right-descending river bank is threatened by bank erosion including a combined sewer manhole, a combined sewer overflow (CSO) structure, and a storm sewer outflow structure.

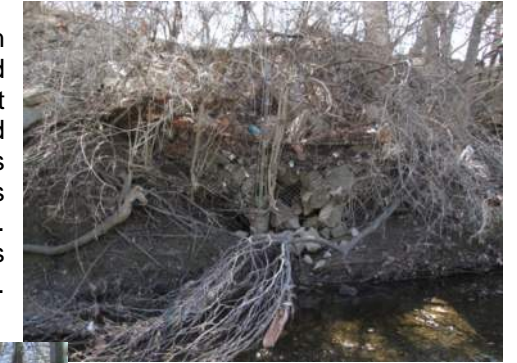
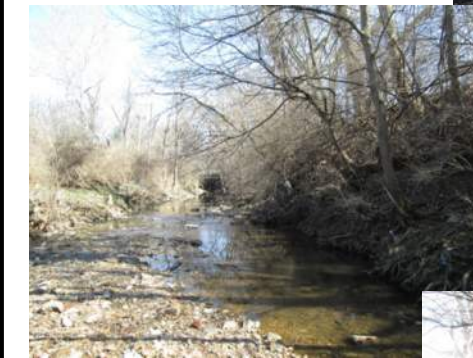
The foundation of a 6-foot high mid-slope fence is eroded and the fence is collapsing. It appears that riprap was added from the top of slope to address an area of gulley erosion, but this riprap is sliding down the bank. The weight of this riprap is contributing to the fence failure.

On the right descending bank are the eroding bank, collapsing fence, and sliding riprap.

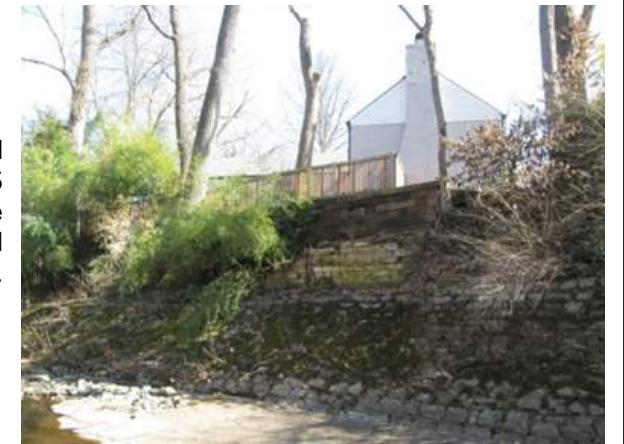
Problem Description:
 A 16-foot high bank with a combination of public and private walls is compromised and a house located only 7 feet from the top of wall is at risk. The wood tie wall is compromised, but the lower 6-feet of the bank of the Rider des Peres at this location is a WPA hand-placed stone wall, which appears stable.

Wood tie wall and WPA block wall. 7425 Shaftesbury Ave is the house behind the wall in the photo.

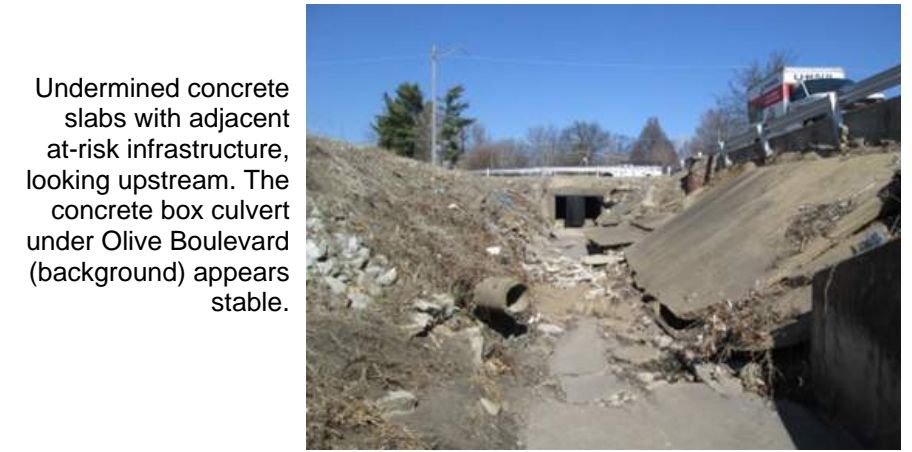
Problem Description:
Concrete slabs lining a tributary to the River des Peres are undermined and have failed, looking upstream. The foundation of the concrete-curb adjacent U-Haul parking lot is exposed on the east side of the channel. At-risk infrastructure includes the commercial parking lot, an inlet manhole, and a pipe outfall.

Undermined concrete slabs with adjacent at-risk infrastructure, looking upstream. The concrete box culvert under Olive Boulevard (background) appears stable.

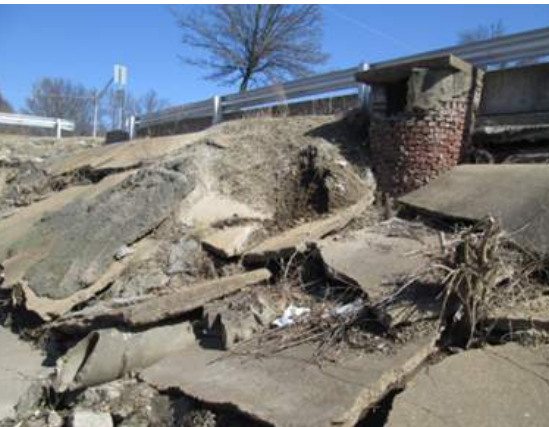
Exposed foundation of the adjacent parking lot.

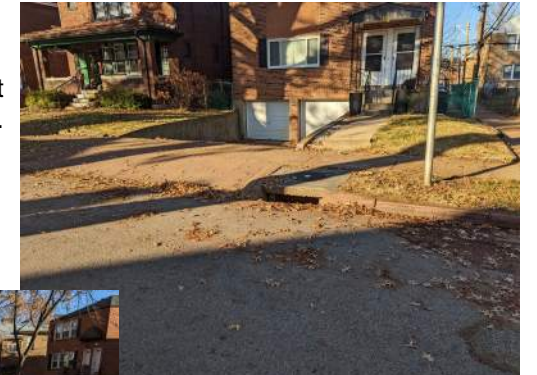
Grated drains were observed near each garage door. It is likely that each of these are connected into the nearby combined sewer. Therefore, it is possible the flooding is due to backup from the combined sewer main.

The driveway at 7101 Amherst Ave.

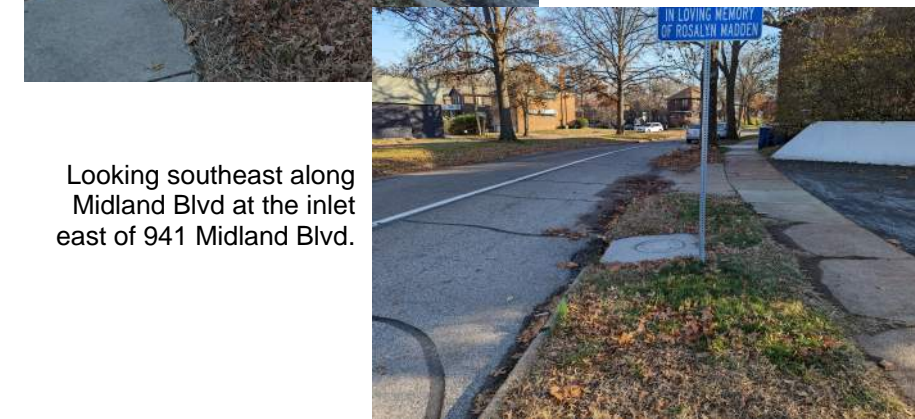
Problem Description:
 The commercial building at 941 Midland Blvd has been flooded by ponded water in the street. The owner indicated that when this happens, the inlets won't drain. Investigation is necessary to determine if the flooding issue is due to inlet capacity, pipe capacity, or high tailwater from the River Des Peres, or a combination of these issues.

Looking southeast along Midland Blvd at the inlet east of 941 Midland Blvd.

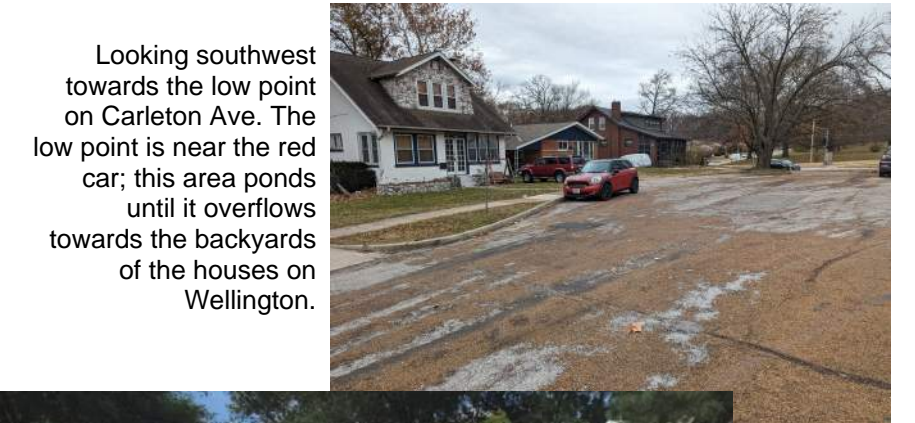
It should be noted that there is a low point on the south end of the cul-de-sac for Carleton Ave which contributes to the drainage area; however, this area is not as significant as the contributing drainage area which includes the yards and homes of the surrounding properties.

Looking southwest towards the low point on Carleton Ave. The low point is near the red car; this area ponds until it overflows towards the backyards of the houses on Wellington.

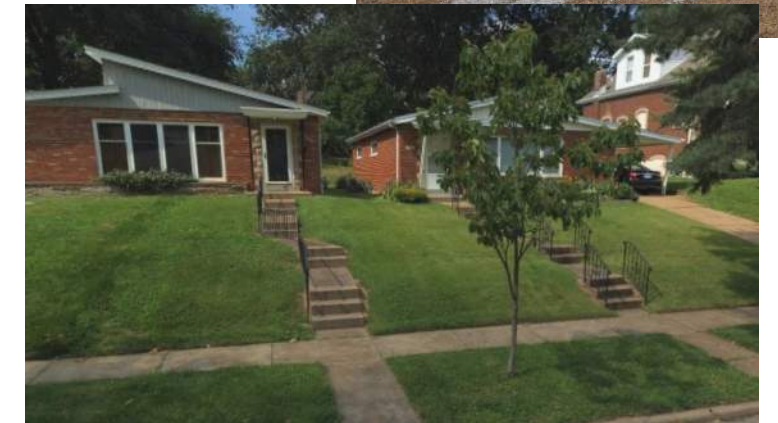
Looking north between #7423 (on the left) and #7419 (on the right). The space between houses may convey some of the runoff from the backyards, but the grading and available space is insufficient.

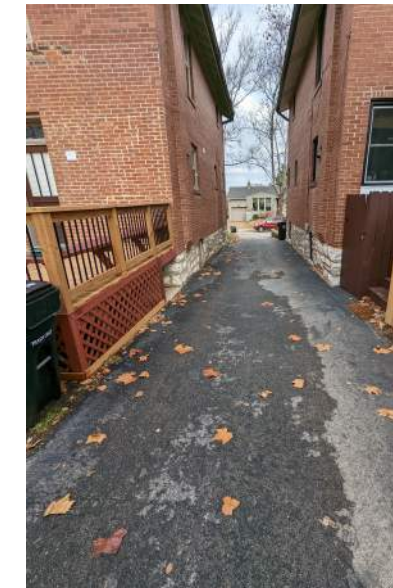
Looking north between #7252 (on the left) and #7250 (on the right). Basement windows are within 1-3 inches of the driveway - a potential source of flooding to the basements.

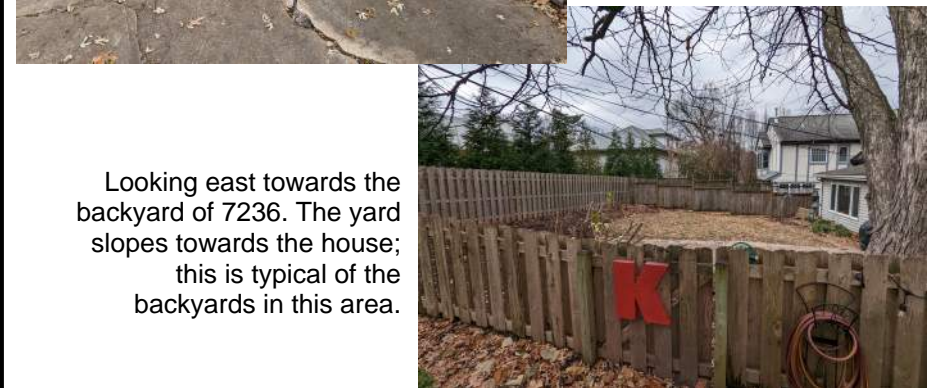
Looking north between #7236 (on the left) and #7232 (on the right). The tuck-under garage is at risk of flooding since the main flow path for water in the backyards is to flow down this driveway.

Looking east towards the backyard of 7236. The yard slopes towards the house; this is typical of the backyards in this area.
