AGENDA
COMMISSION ON STORM WATER ISSUES
SPECIAL MEETING
HEMAN PARK COMMUNITY CENTER
975 PENNSYLVANIA
Tuesday, April 18, 2023,
3:00 PM

TO: City of University City
FROM: Stormwater Management Plan Team
SUBJECT: University City Stormwater Master Plan – *Prioritization Method* Scope of work Task 2.1
DATE: August 25, 2022

TO: Darren Girdler, Director of Public Works
 Mirela Celaj, CFM, Assistant Director of Public Works
 FROM: Stormwater Master Plan Team (HR Green and Reitz & Jens)
 SUBJECT: University City Stormwater Master Plan
Public versus Private – Recommended Definition Scope of work Task 2.2
 DATE: February 28, 2023

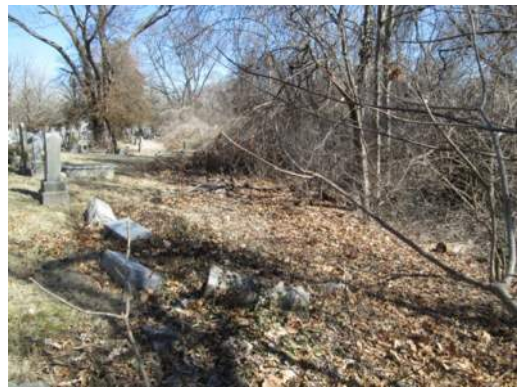
Gravestones at the B'Nai Amoona cemetery along the top of the creek bank have been damaged possibly as a result of bank erosion.

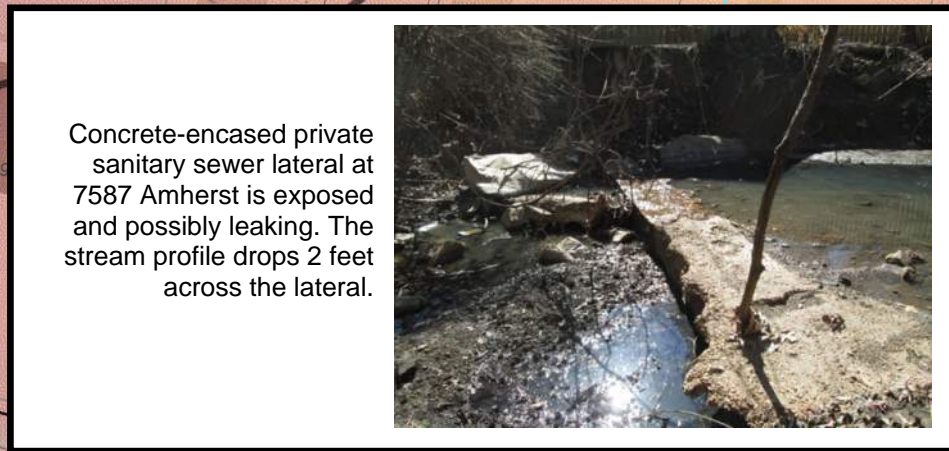
Concrete-encased private sanitary sewer lateral at 7587 Amherst is exposed and possibly leaking. The stream profile drops 2 feet across the lateral.

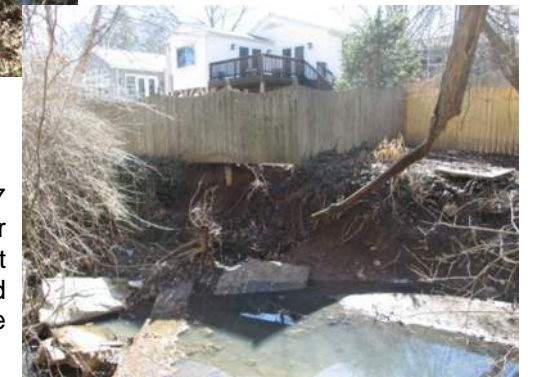
Creek erosion along 7587 Amherst is undermining their fence. The erosion rating at 7587 Amherst is considered a threat to the home (V/H=0.25).

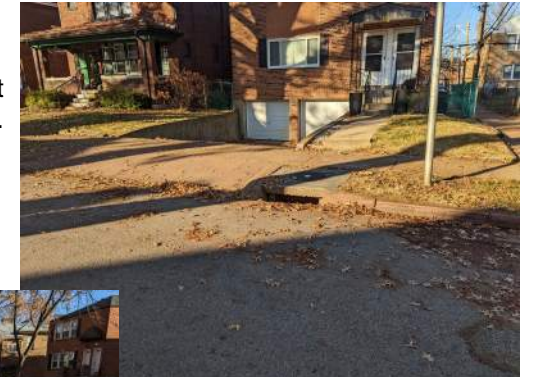
The driveway at 7101 Amherst Ave.

Grated drains were observed near each garage door. It is likely that each of these are connected into the nearby combined sewer. Therefore, it is possible the flooding is due to backup from the combined sewer main.

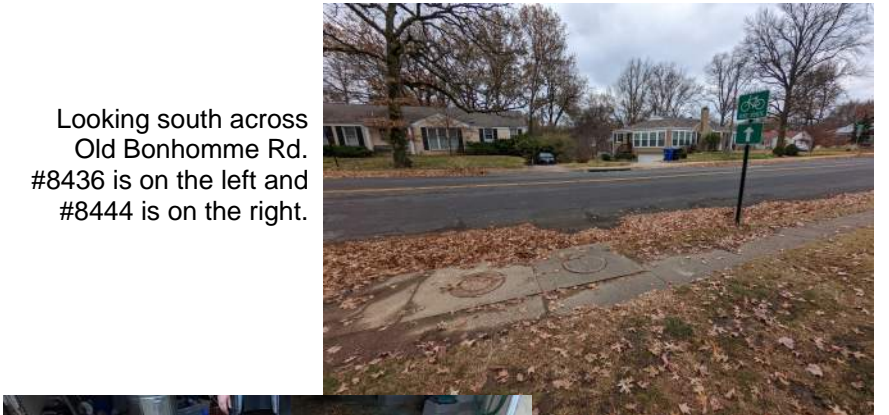
Basement garages at 8444 and 8436 Old Bonhomme Rd flood frequently from water which comes down the driveway at 8436 from the street. There is a triple curb inlet in front of 8436 Old Bonhomme Rd which accepts water from about 1,200 feet of Old Bonhomme Rd. The downstream pipe is 24" in diameter.

Looking south across Old Bonhomme Rd. #8436 is on the left and #8444 is on the right.

MSD has studied the problem and identified storm sewer upsizing as a solution. It may also be beneficial to investigate other opportunities for improvement, such as: A) increase inlet capacity at the street by adding inlets east of the triple inlet, B) raise a portion of the driveway at 8436 to keep water in the street, or C) provide a conveyance path down driveway and towards the at the property corner between #8436 and 940/932 Alanson Dr.

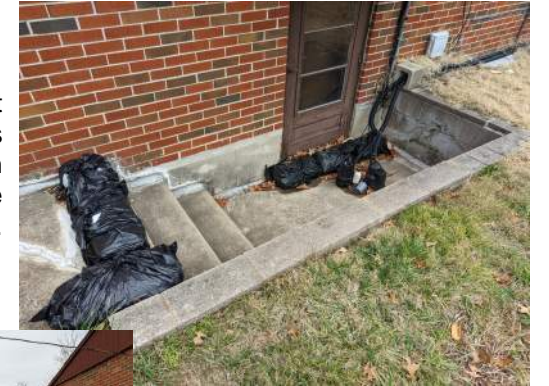
The basement stairwell at 7838 Balson Ave. Sand bags and sump pumps have been added to try to keep the basement from flooding.

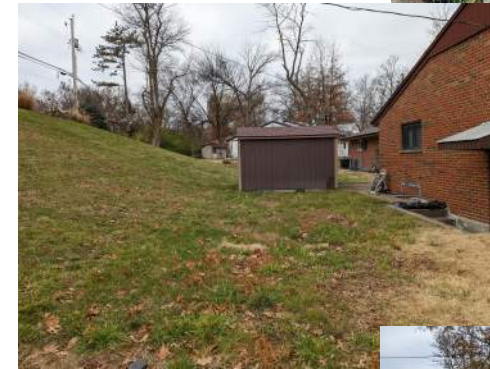
Looking west in the backyard of 7838 Balson Ave. The house is on the right.

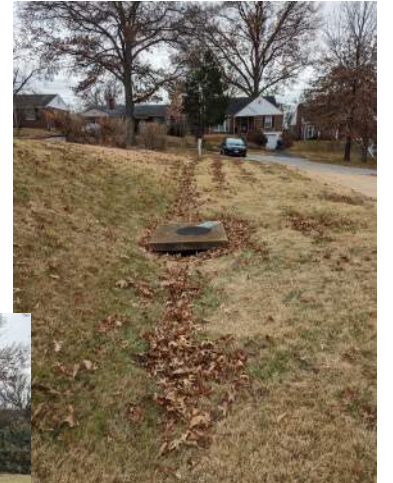
Looking south along the property line between #7353 and 7339.

About 3 acres of drainage flows to the backyard at 7353 Milan Ave. An area inlet just east of the backyard clogs easily and may also have inadequate capacity. Water backs up, flooding the entire yard until it can flow east. Water has nearly reached the threshold of the back door to the house. The basement has flooded from both seepage and overland flow in 2014, 2015, and 2022.

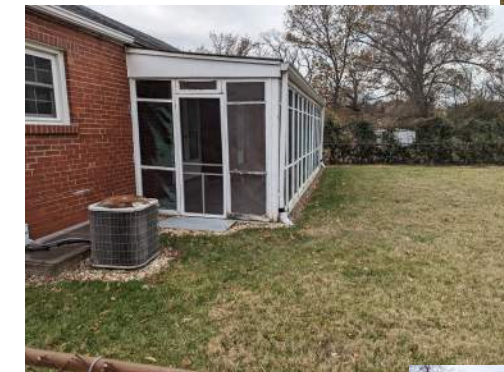
Looking towards the back patio at #7353. Ponded water has nearly reached the threshold of the door into the house (not the door to the screened in patio).

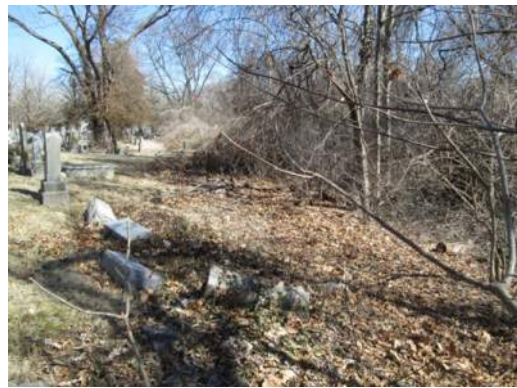
Gravestones at the B'Nai Amoona cemetery along the top of the creek bank have been damaged possibly as a result of bank erosion.

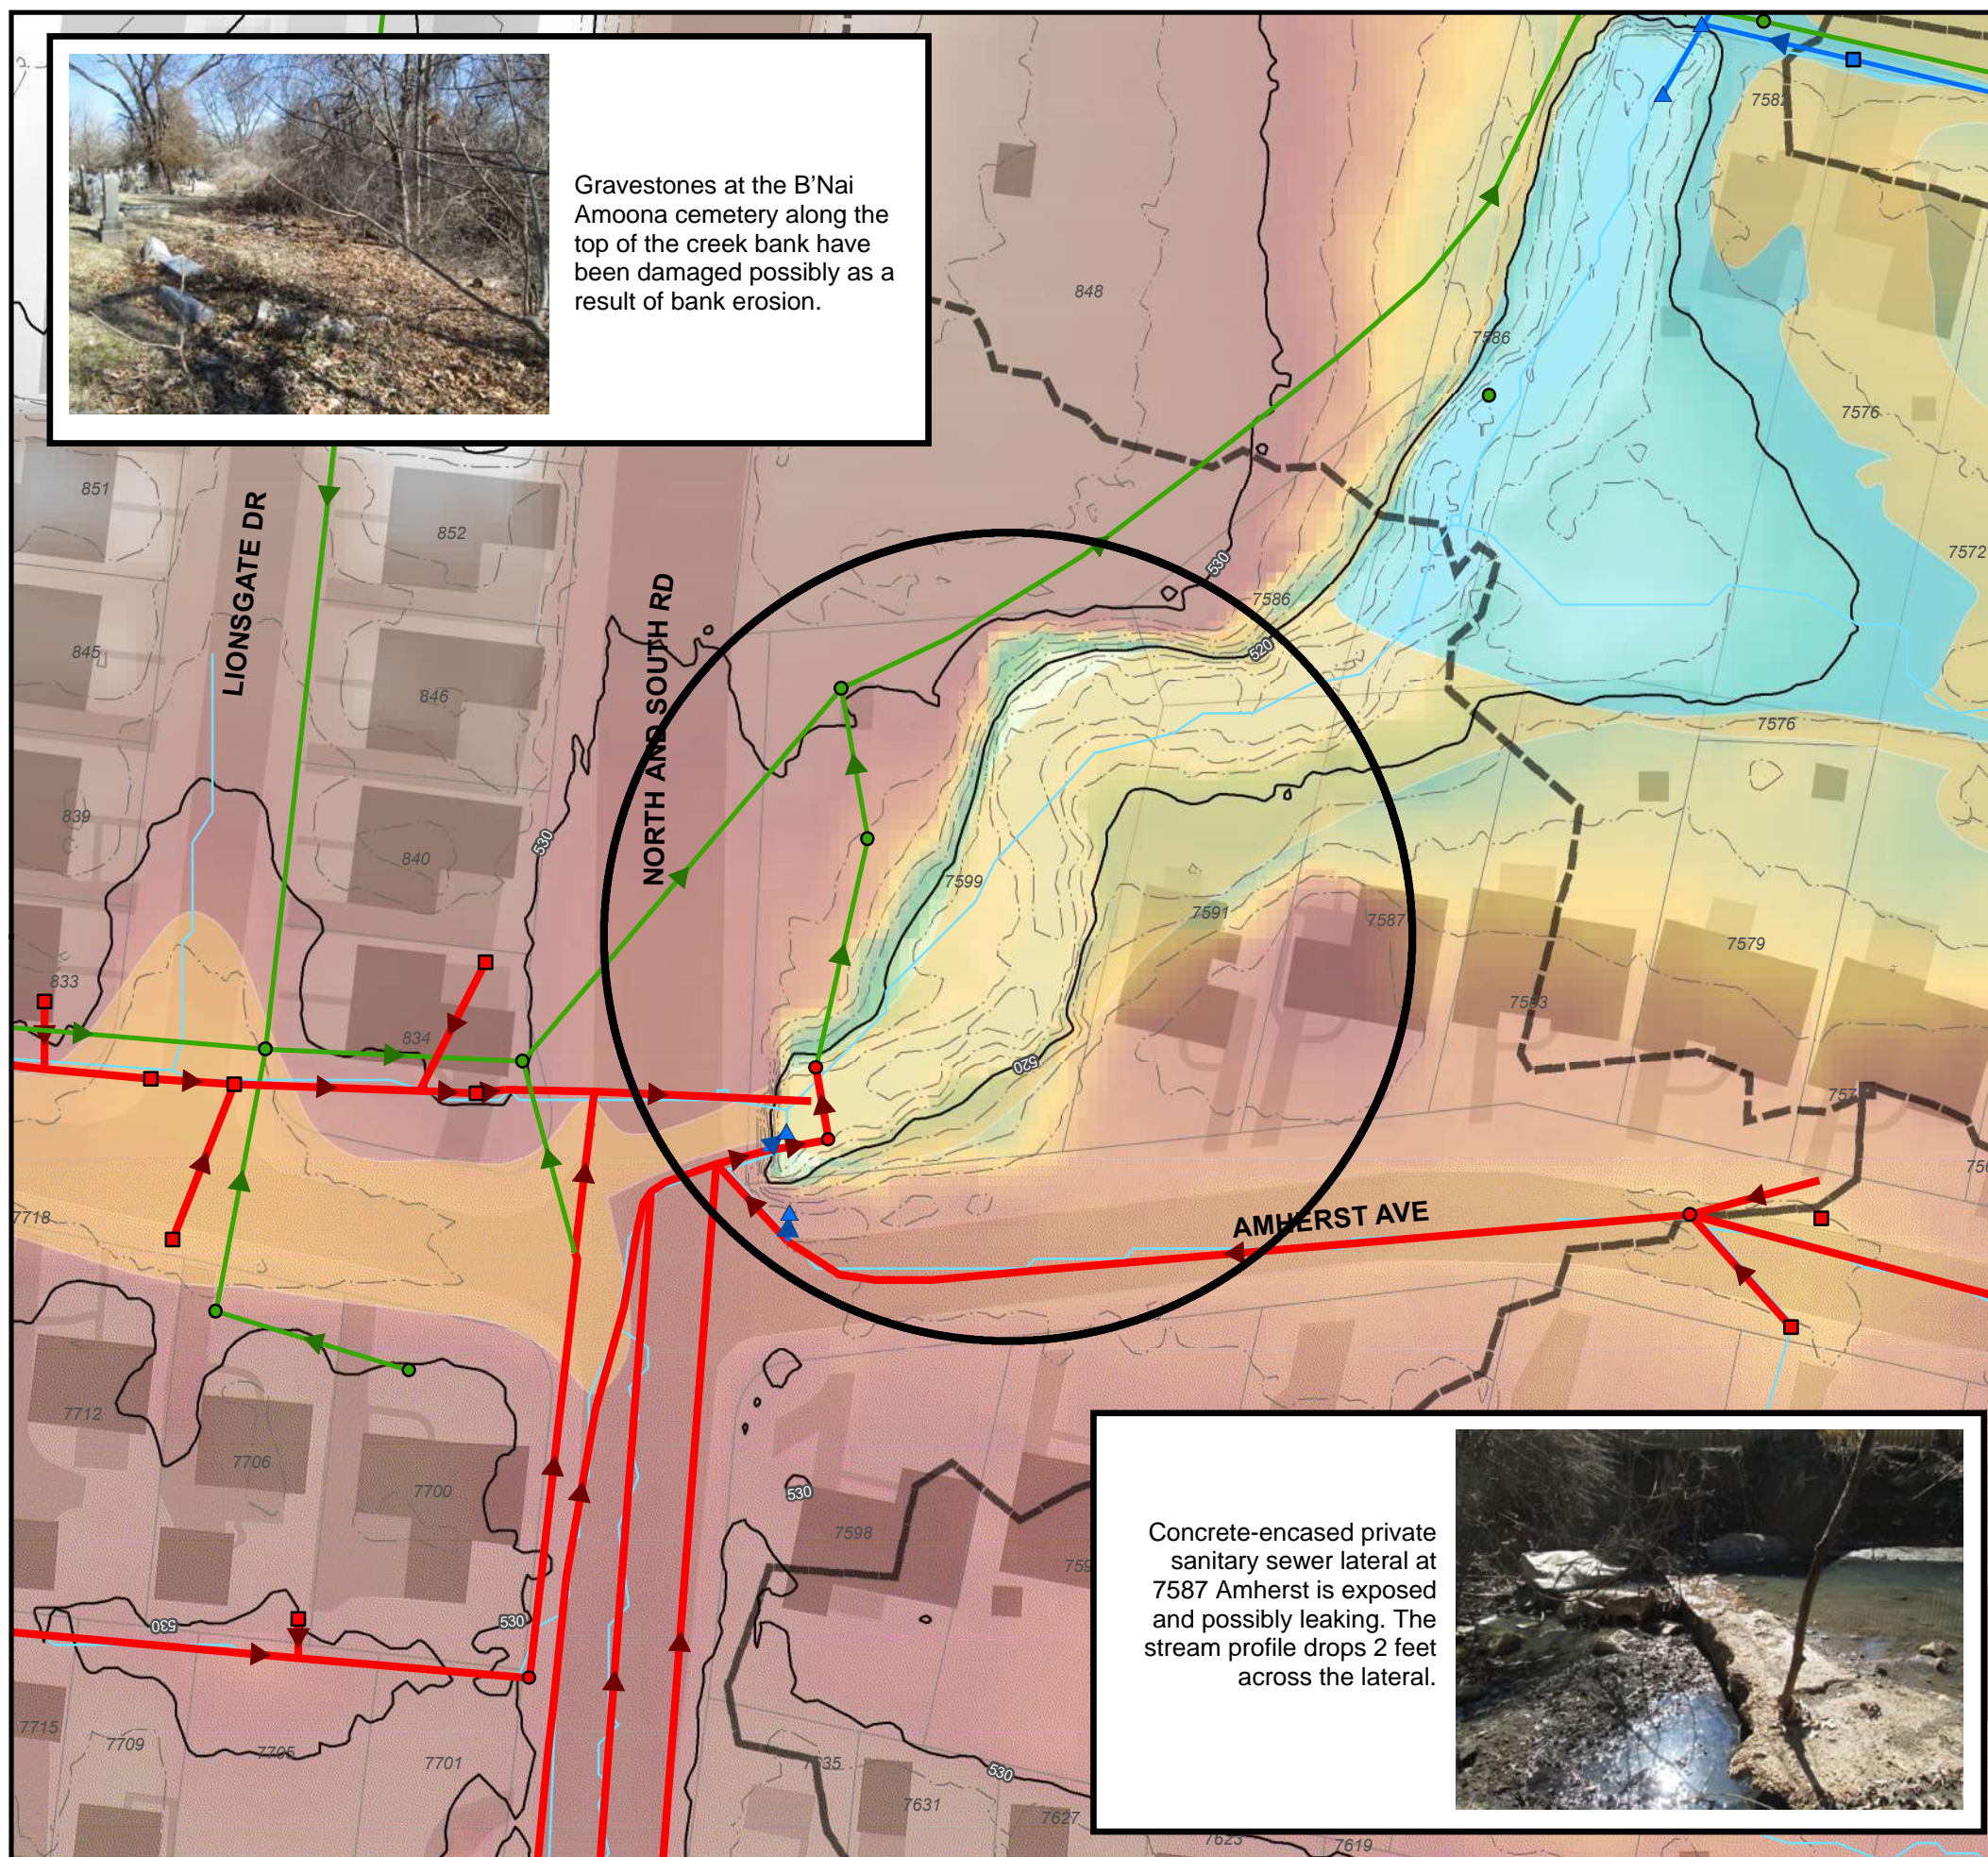
Concrete-encased private sanitary sewer lateral at 7587 Amherst is exposed and possibly leaking. The stream profile drops 2 feet across the lateral.

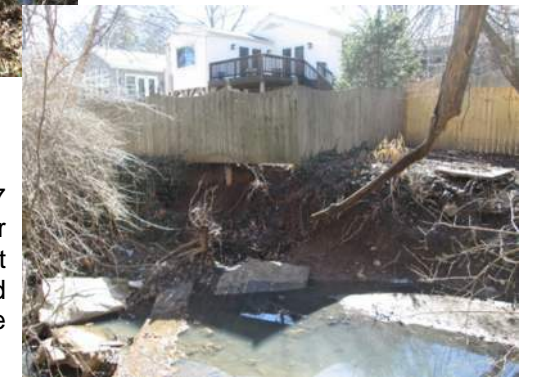
Creek erosion along 7587 Amherst is undermining their fence. The erosion rating at 7587 Amherst is considered a threat to the home (V/H=0.25).

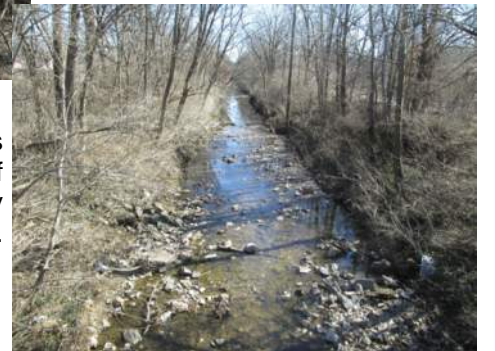
Channel bottom contains riprap, some of which slid off the bank from a previously installed MSD project.

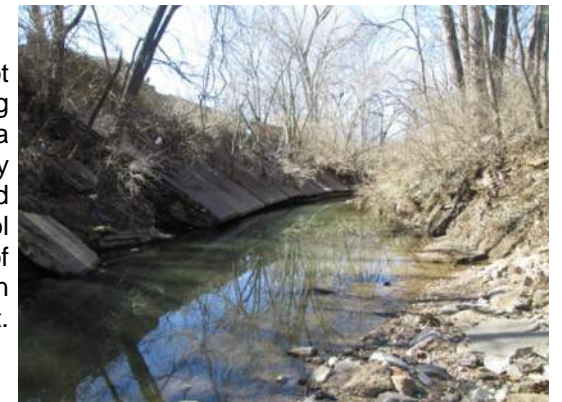
An approximately 175-foot reach of the right-descending river bank is lined with a concrete slab, but the integrity of the concrete is compromised by a 3-foot deep scour pool along the toe of bank. Failure of slab will likely cause failure in the parking lot.

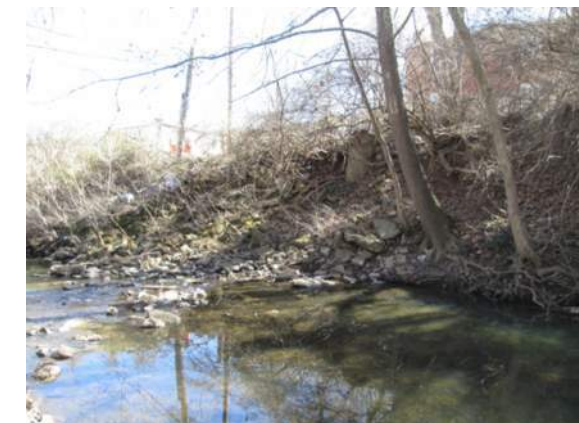
MSD infrastructure along the right-descending river bank is threatened by bank erosion including a combined sewer manhole, a combined sewer overflow (CSO) structure, and a storm sewer outflow structure.

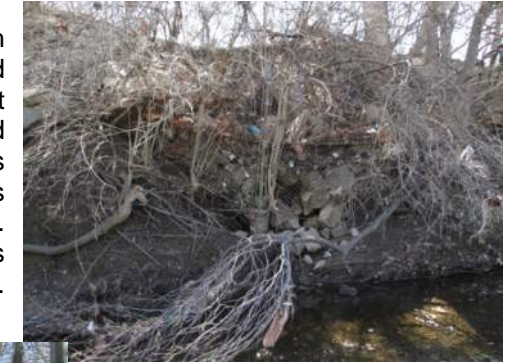
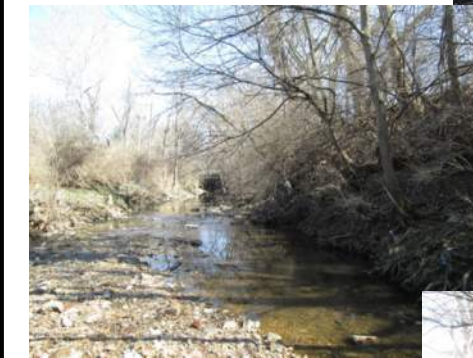
The foundation of a 6-foot high mid-slope fence is eroded and the fence is collapsing. It appears that riprap was added from the top of slope to address an area of gulley erosion, but this riprap is sliding down the bank. The weight of this riprap is contributing to the fence failure.

On the right descending bank are the eroding bank, collapsing fence, and sliding riprap.

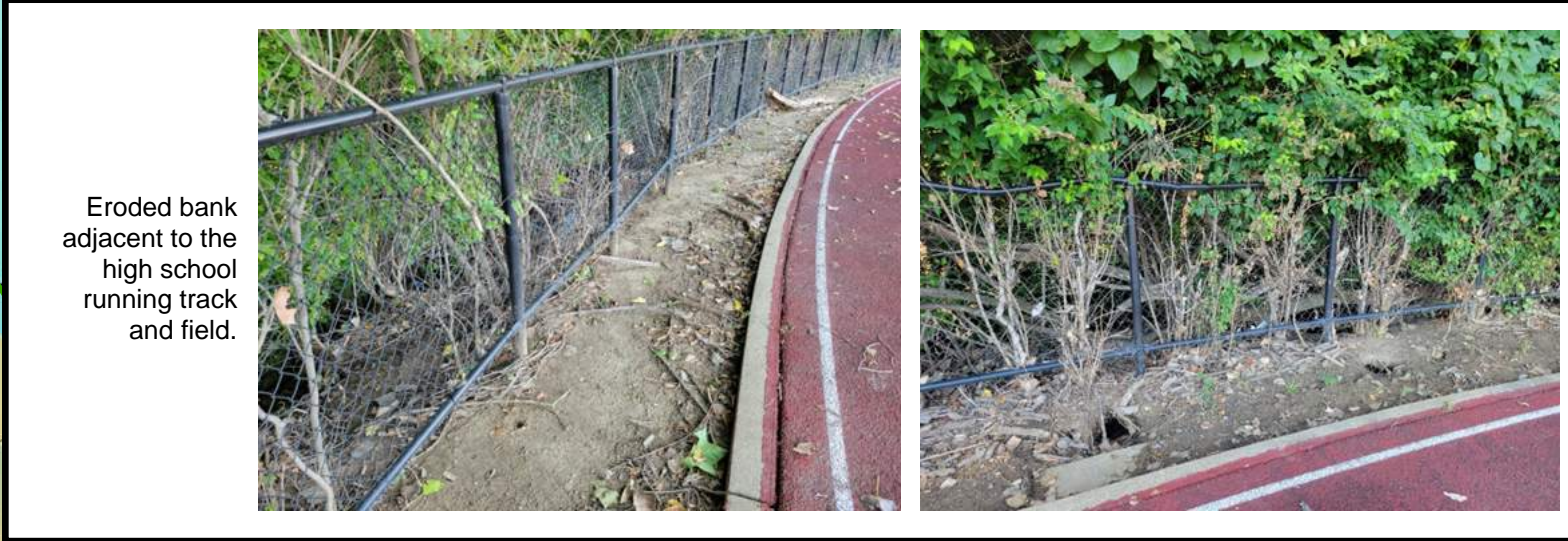
Eroded bank adjacent to the high school running track and field.

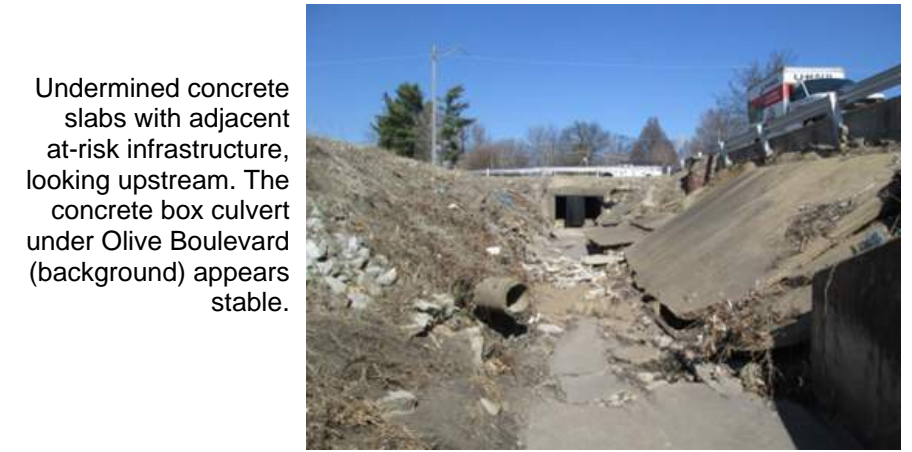
Problem Description:
Concrete slabs lining a tributary to the River des Peres are undermined and have failed, looking upstream. The foundation of the concrete-curb adjacent U-Haul parking lot is exposed on the east side of the channel. At-risk infrastructure includes the commercial parking lot, an inlet manhole, and a pipe outfall.

Undermined concrete slabs with adjacent at-risk infrastructure, looking upstream. The concrete box culvert under Olive Boulevard (background) appears stable.

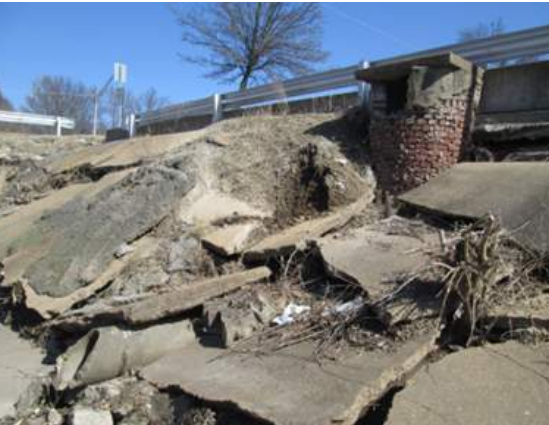
Exposed foundation of the adjacent parking lot.

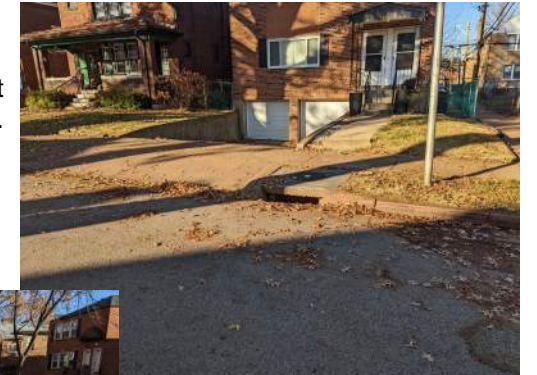
The driveway at 7101 Amherst Ave.

Grated drains were observed near each garage door. It is likely that each of these are connected into the nearby combined sewer. Therefore, it is possible the flooding is due to backup from the combined sewer main.

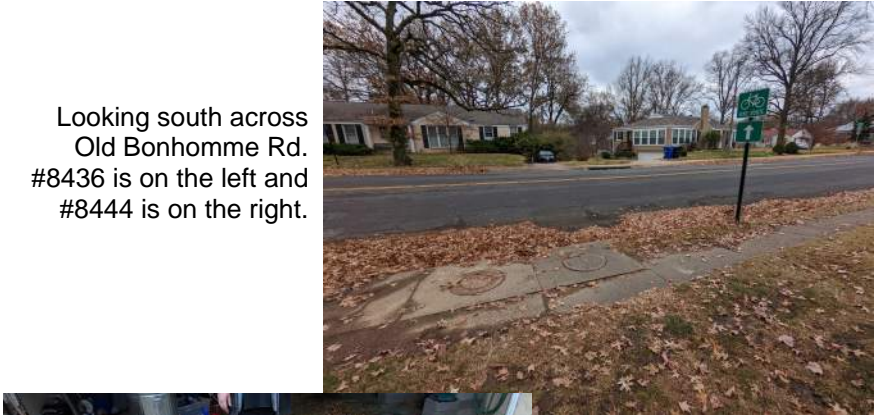
Looking south across Old Bonhomme Rd. #8436 is on the left and #8444 is on the right.

MSD has studied the problem and identified storm sewer upsizing as a solution. It may also be beneficial to investigate other opportunities for improvement, such as: A) increase inlet capacity at the street by adding inlets east of the triple inlet, B) raise a portion of the driveway at 8436 to keep water in the street, or C) provide a conveyance path down driveway and towards the at the property corner between #8436 and 940/932 Alanson Dr.

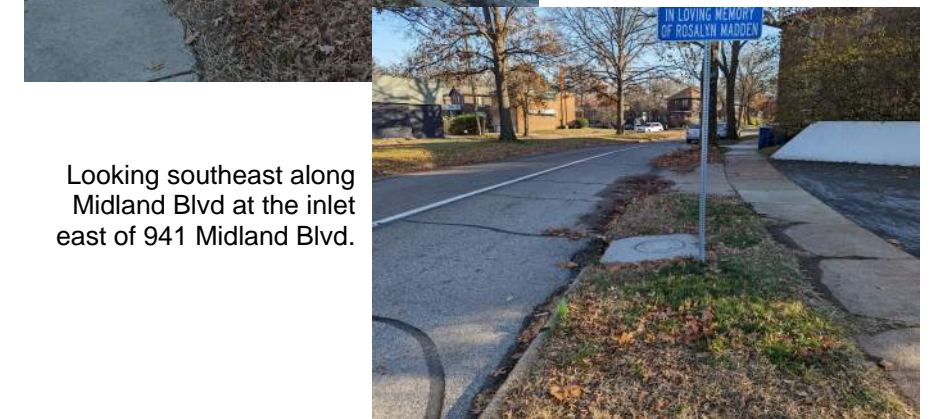
Problem Description:
 The commercial building at 941 Midland Blvd has been flooded by ponded water in the street. The owner indicated that when this happens, the inlets won't drain. Investigation is necessary to determine if the flooding issue is due to inlet capacity, pipe capacity, or high tailwater from the River Des Peres, or a combination of these issues.

Looking north towards the inlet at the southwest corner of Midland Blvd and Balson Ave.

Looking southeast along Midland Blvd at the inlet east of 941 Midland Blvd.

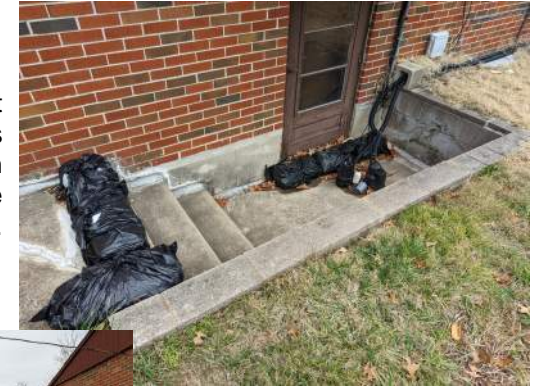
The homes on Stanford Avenue sit about 18 feet higher than the homes on Balson Ave. Between the houses is at a 3:1 slope. The flow path from the backyards to the front yards on Balson Ave is inadequate, causing frequent flooding to at least two of the homes on Balson Ave. The drainage area to the back of the homes is about 1.3 acres.

The basement stairwell at 7838 Balson Ave. Sand bags and sump pumps have been added to try to keep the basement from flooding.

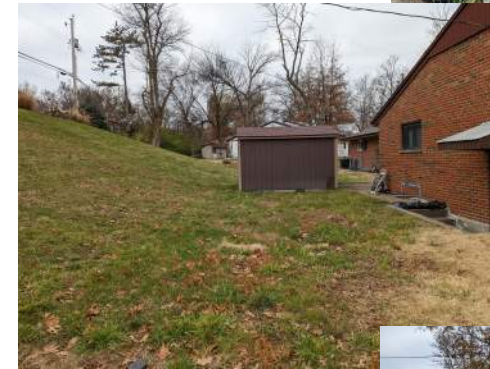
Looking west in the backyard of 7838 Balson Ave. The house is on the right.

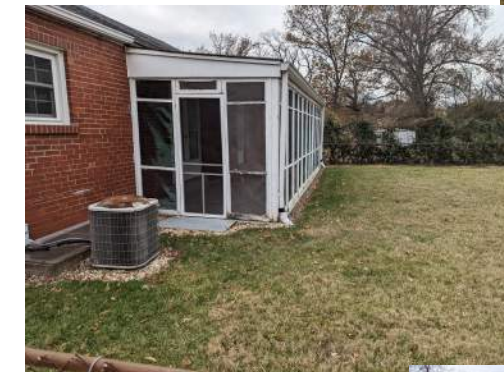
Looking towards the back patio at #7353. Ponded water has nearly reached the threshold of the door into the house (not the door to the screened in patio).

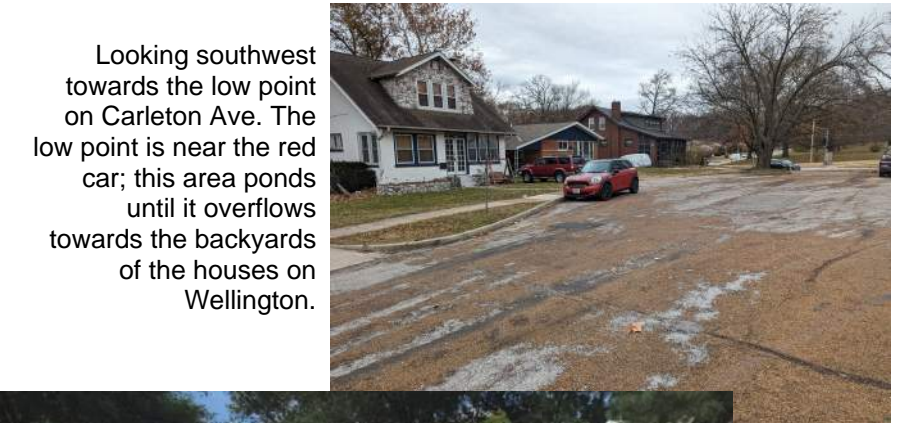
It should be noted that there is a low point on the south end of the cul-de-sac for Carleton Ave which contributes to the drainage area; however, this area is not as significant as the contributing drainage area which includes the yards and homes of the surrounding properties.

Looking southwest towards the low point on Carleton Ave. The low point is near the red car; this area ponds until it overflows towards the backyards of the houses on Wellington.

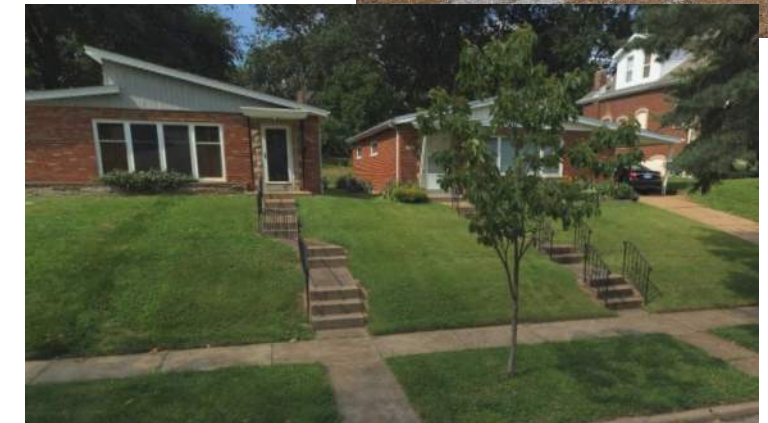
Looking north between #7423 (on the left) and #7419 (on the right). The space between houses may convey some of the runoff from the backyards, but the grading and available space is insufficient.

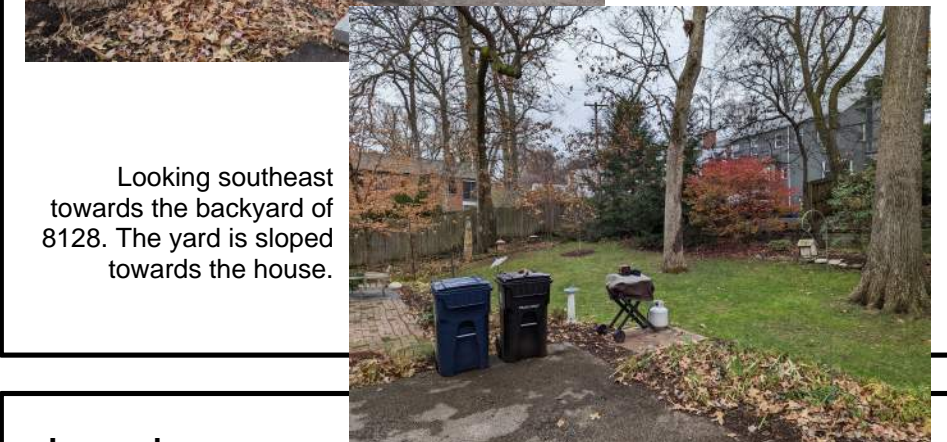
Looking west towards the backyard of #8132.

Looking southeast towards the backyard of 8128. The yard is sloped towards the house.

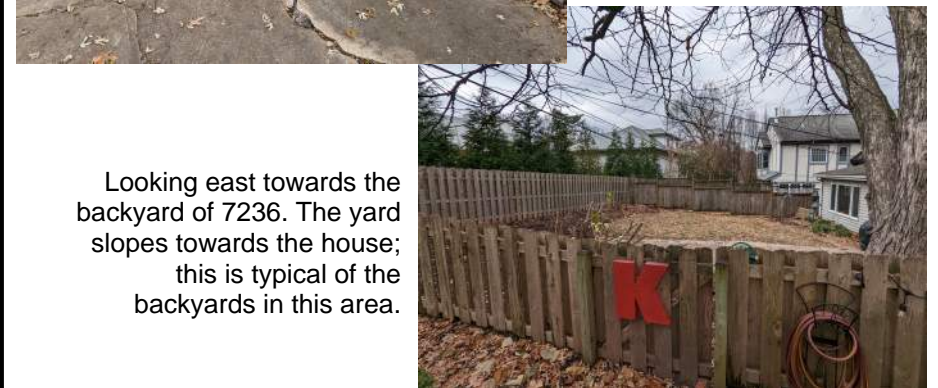
Looking north between #7236 (on the left) and #7232 (on the right). The tuck-under garage is at risk of flooding since the main flow path for water in the backyards is to flow down this driveway.

Looking east towards the backyard of 7236. The yard slopes towards the house; this is typical of the backyards in this area.
