# University City Hall Annex Building Facility Assessment + Feasibility Study

*Completed in Collaboration with Department of Public Works + Police Department*

September 9, 2019

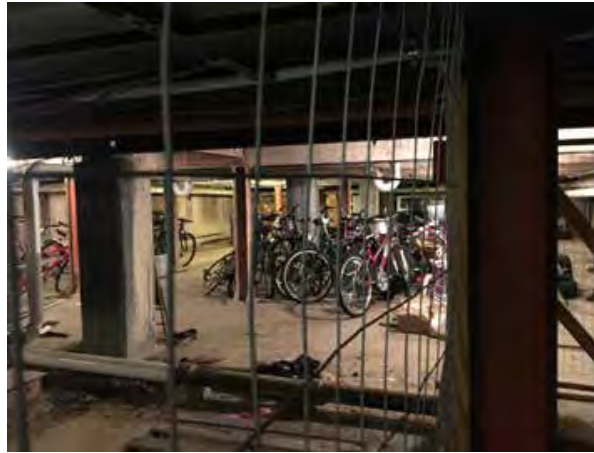
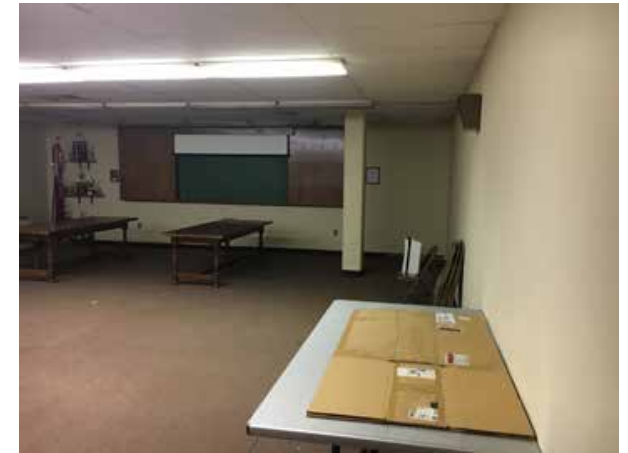
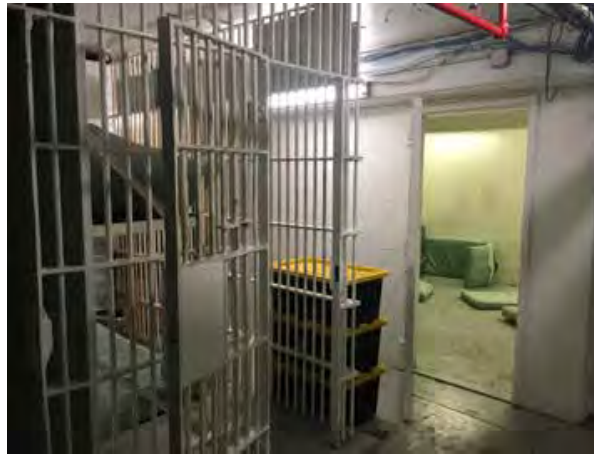
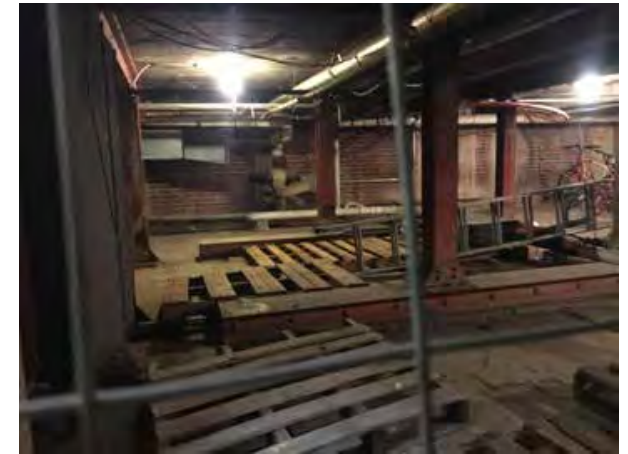
Approximately 4,000 square feet of the building are currently used for stolen bicycle storage. The lowered head clearance is resultant of the lowered floor elevation above as required for fire engine access at the first floor. Removing this modification would greatly increase the program flexibility in the basement. In addition, several window openings have been infilled which could be reopened to further improve the conditions within the space.

The inmate cells are unsafe as they have only one means of egress and do not have access to daylight. Relocation of these spaces should be considered.

The "EOC" has been described as a bunker like environment. In terms of safety, this is advantageous but is not a desirable work environment. This space should be relocated, potentially offsite, which may help decentralize some critical services and afford better working environs.

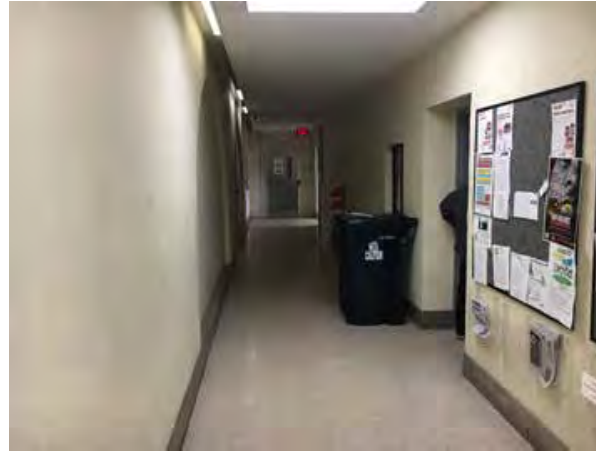
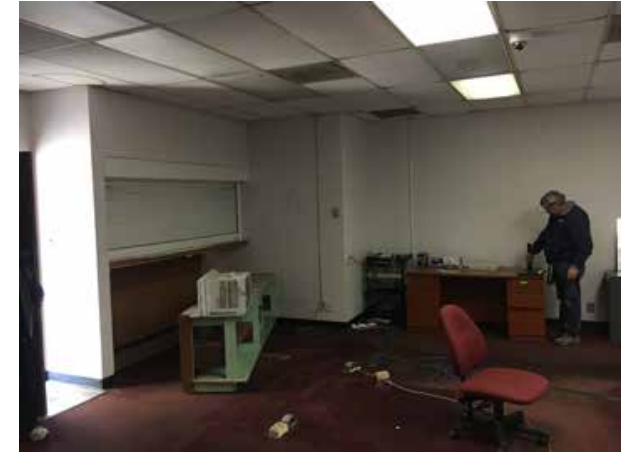
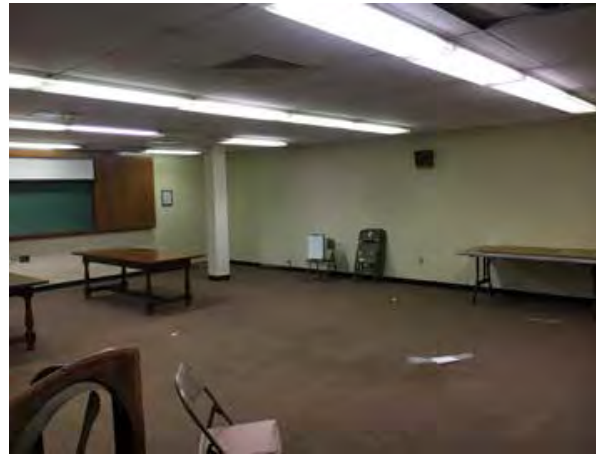
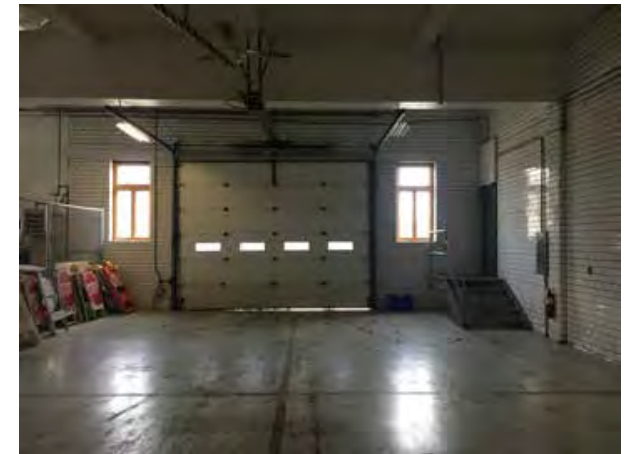
The eastern side of the building is primarily office space. The area has few to no limitations on space configurations and has generous ceiling heights.

The western side of the building has been significantly altered to accommodate the fire department once housed within the building. The floor has been lowered several feet in all but the southernmost bay. The area is currently completely inaccessible for those with disabilities. The elevator does not service this half level and two stairs connect this level to the primary first floor level. The window openings on this elevation have been altered significantly by removing the sills and widening at least one bay. The result is several different window and door openings that are not consistent with the historical rhythm of the building.

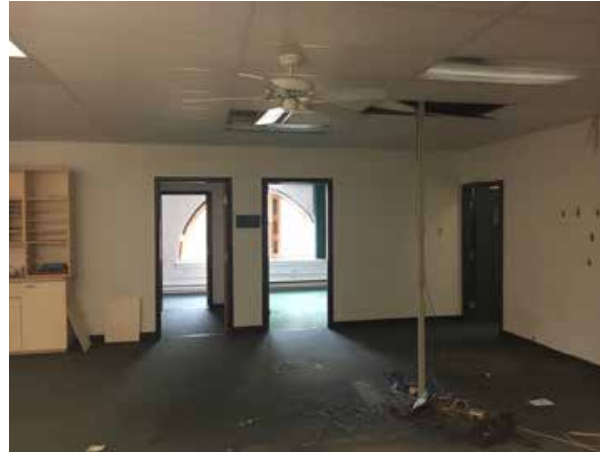
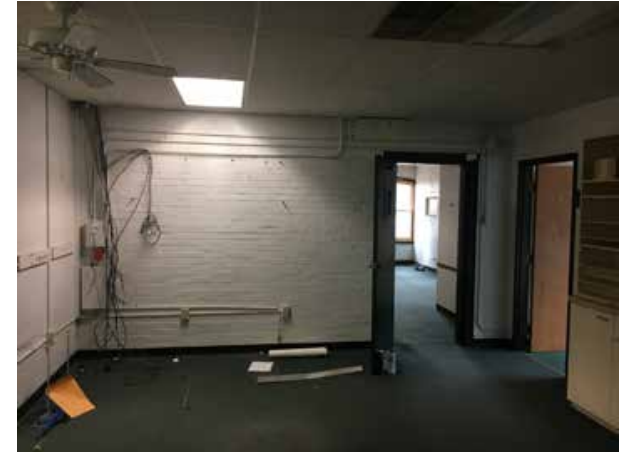
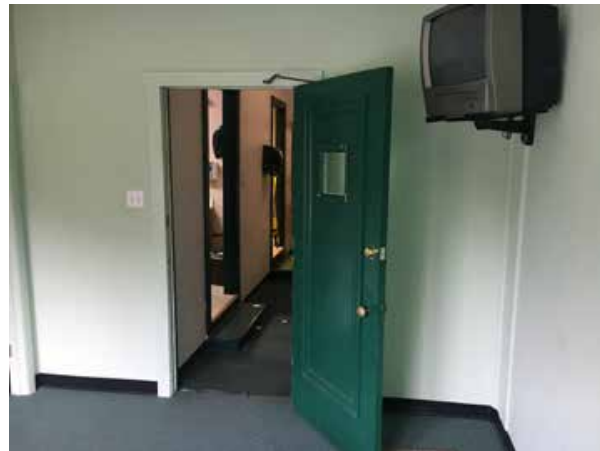
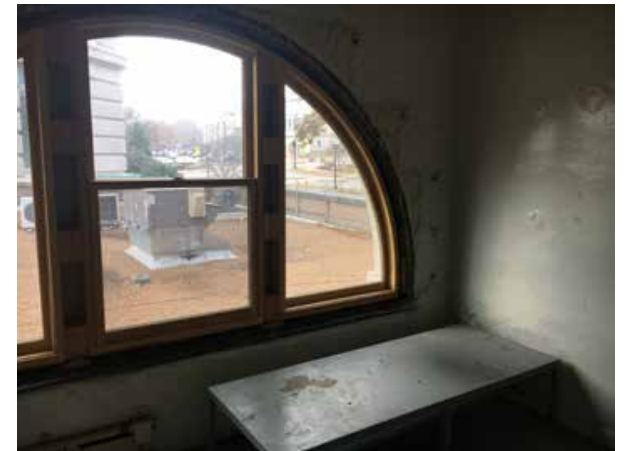
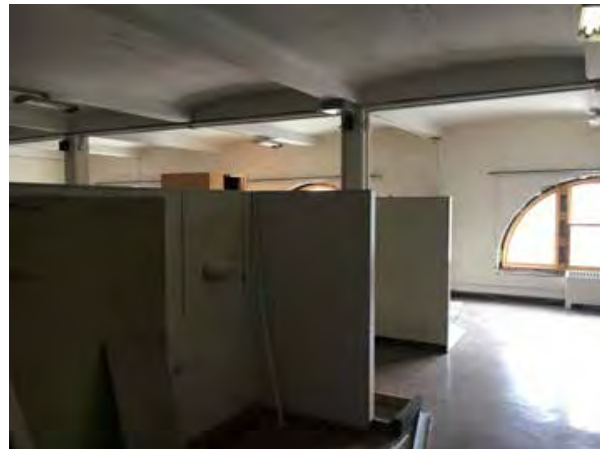
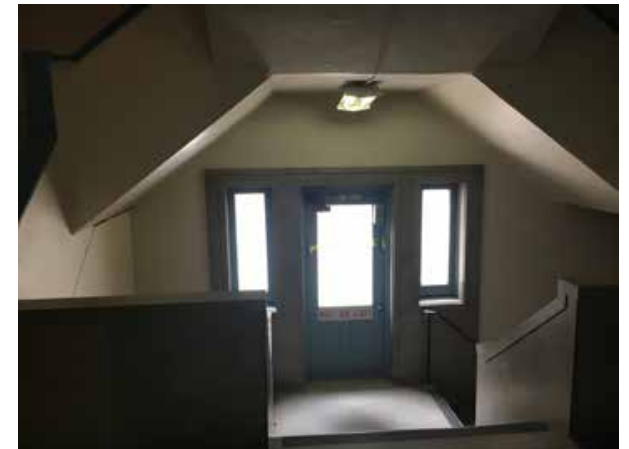
The ceilings are exposed board formed concrete barrel vaults. Similar to the windows, these elements can organize new space configuration. The floors may have original wood, but the extent of flooring is unknown due to the multiple layers of flooring.

Originally this level was a open floor plate with large amounts of daylight. New spaces should be organized to allow the occupant to recognize the historic volume and maintain historic elements.

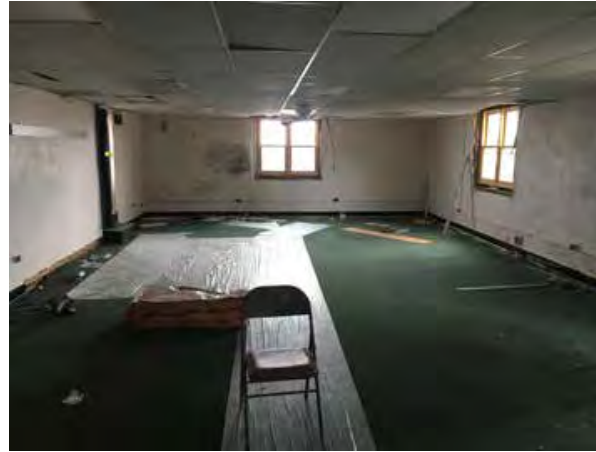
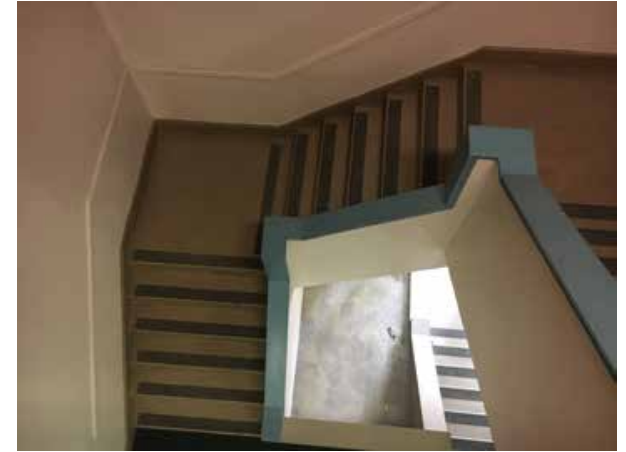
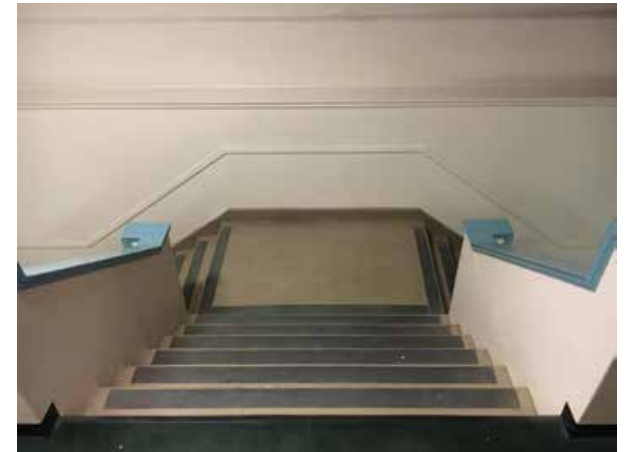
The third floor is smaller in area than the other three floors. It is one bay in width along the entire south end of the building. The stair hall bisects the floor plate which creates two equally sized rooms. Ceiling heights are much shorter on this floor. However, a set of north-facing unitized skylights add ceiling height and potential to flood the stair hall with natural light. Currently the skylights have been roofed over but look to be suitable to renovate and reuse. The windows are significantly smaller at this floor. Wood flooring was found under the existing carpeting and could potentially be salvaged and refinished.

There is access to the rooftop which could be investigated for an addition if space is needed. However, the addition should be offset from the building facade as to not negatively impact the historic sightlines of the existing building.

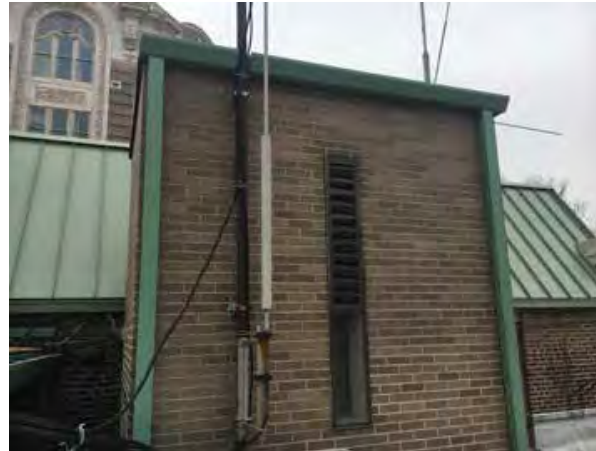
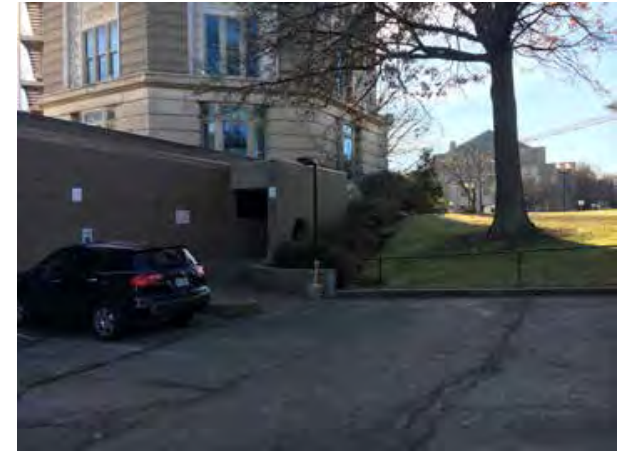
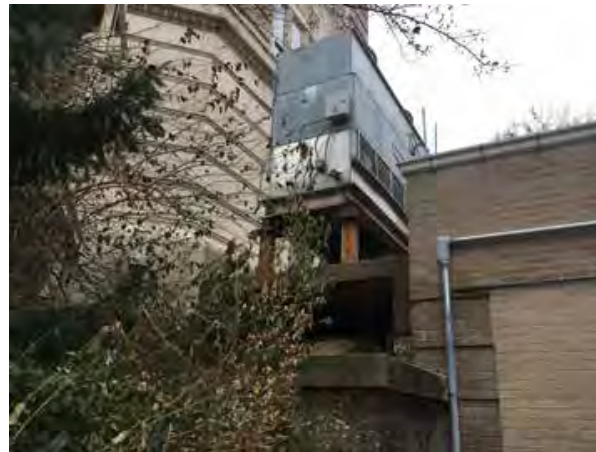
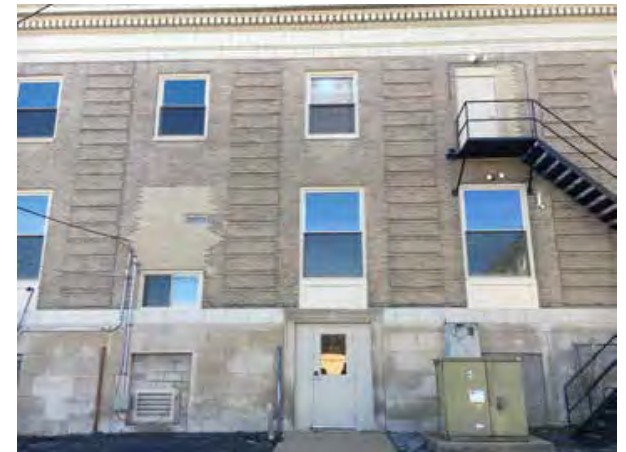
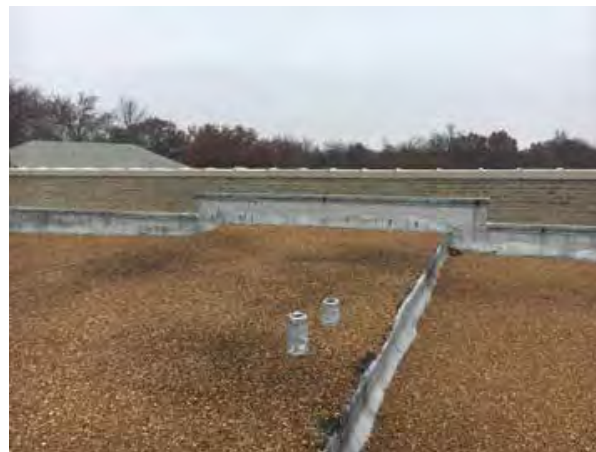
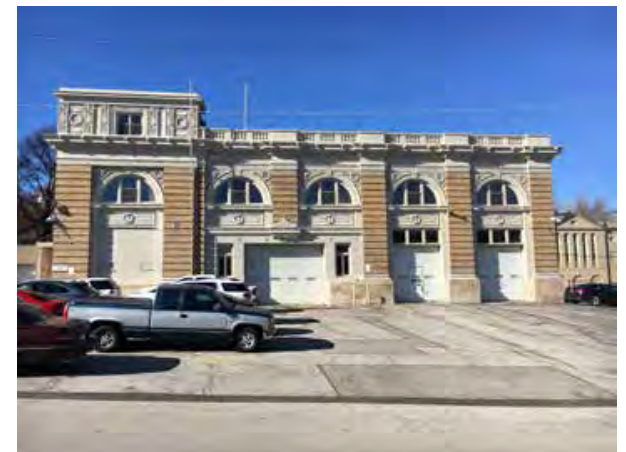
The exterior of the building is in good condition and has been renovated in the recent past. The only element that has not been renovated is the roofing system. It is near the end of its useful life and is showing signs of deterioration.

The building does suffer from lack of clear entry and lack of primary facade. The connector currently functions as the entrance but wayfinding is not intuitive and is not accessible. Back of house functions co-located with the existing front of building further confuses entry sequence and co-mingles disparate population groups.

The annex functions as the rear yard of the City Hall building which contributes visual clutter at an inappropriate location relative to the annex entry. A dedicated mechanical yard and enclosure should be explored. A celebrated entrance combined with reworking of the multiple modified openings along the east and north facades could greatly improve the user experience.

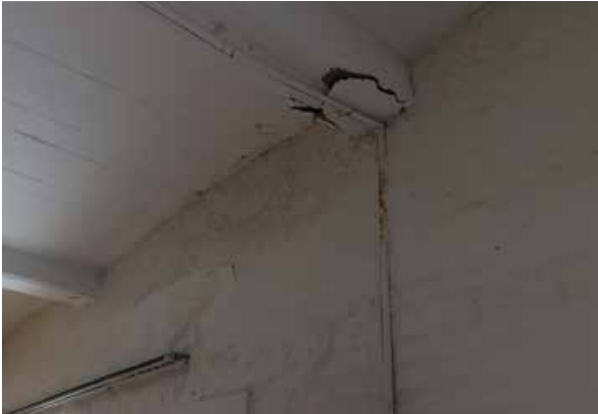
03.00 CONCRETE  
*Spalled Beam*

At the 2nd floor south wall there is one instance of a spalled concrete beam at its intersection with the exterior wall. This represents concern both architecturally and structurally. See structural assessment for additional information

Recommendation: Remove loose and unsound material. Document condition of reinforcing steel. See structural assessment for additional information.

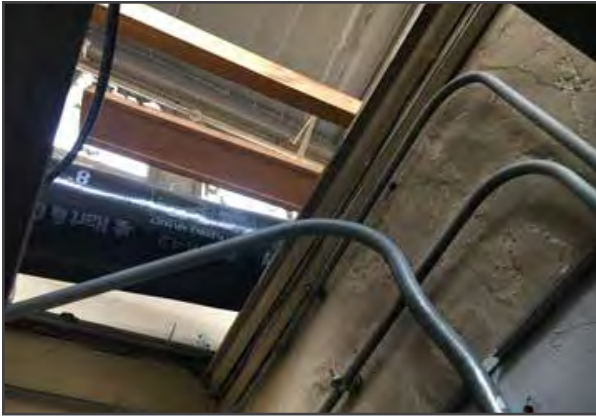
03.00 CONCRETE  
*Penthouse*

A concrete penthouse comprised of concrete columns, beams, and board formed roof deck is located at the central column bay running east-west for several bays. It is concealed above dropped ceilings in secured evidence storage rooms. Several additional bays have been infilled to eliminate the penthouse. The concrete structure looks to be appropriately roofed and painted with only minor indications of deterioration.

Recommendation: Limit use of dropped ceilings and organize systems to coordinate with penthouse. Consider restoring extents of penthouse for entire length of building. Emphasize the penthouse as a character defining feature and organizing element. See structural assessment for additional information.

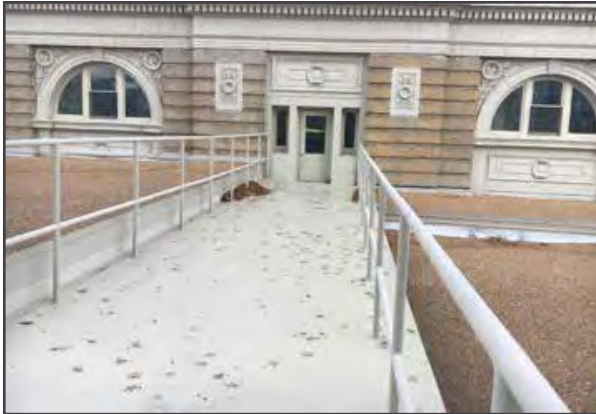
03.02 CAST IN PLACE CONCRETE SIDEWALKS  
& TERRACES  
*Rooftop walk*

Rooftop walk looks to be in good condition. No cracking or other signs of roof deflection. Walking surface coating is sanded but should be evaluated to ensure proper slip coefficient. Walking surface is not adequately lit.

Recommendation: Maintain surface coating and test for proper slip coefficient. Provide Min 3 footcandles per foot at walking surface.

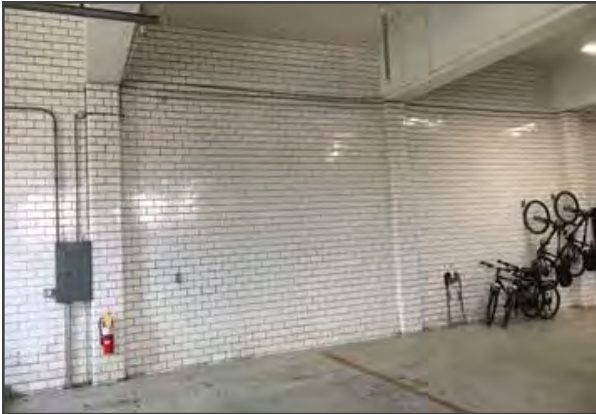
#### 04.01 INTERIOR MASONRY CLEANING

Glazed brick was likely added to the building when converted to the police/fire department. Brick condition is in good condition and while not original, may be beneficial to future space usage needs. Mortar is stained especially along the floor and high against the ceiling. Both are likely a result of idling emissions and/or washdown protocols.

Recommendation: Identify what extent brick may be exposed in new spaces. Remove, and re-point mortar and clean with the appropriate masonry cleaners with the gentlest means possible.

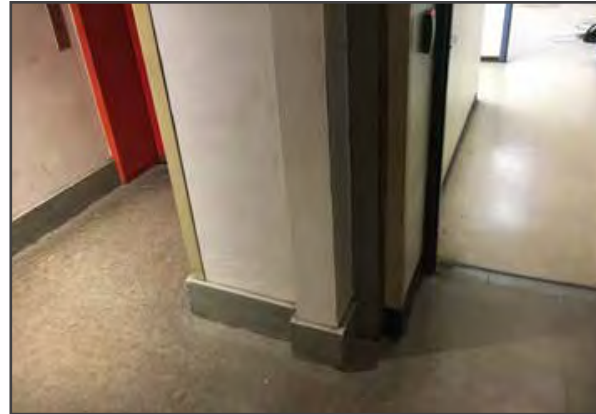
#### 04.02 INTERIOR STONE

Stair landing rooms have base trim that are natural or synthetic plaster based stone. They are a central character defining feature and preservation shall be prioritized. In general, elements are in good albeit soiled condition. Joint sealants/mortars should be evaluated for toxic and/or toxic materials.

Recommendation: Clean with gentlest means possible to remove atmospheric and biological staining.

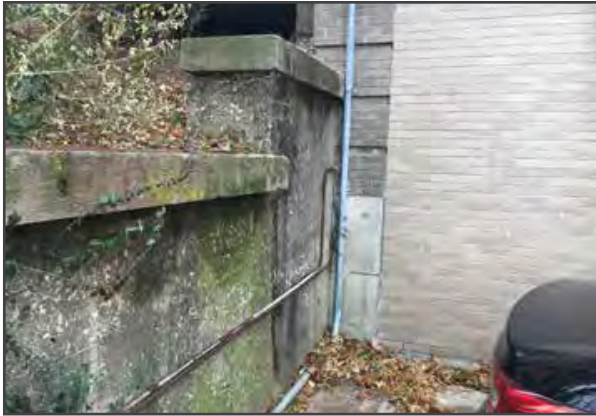
04.04 EXTERIOR MASONRY CLEANING

Site retaining walls concrete with extensive biological and atmospheric staining. The walls are unsightly and located adjacent to Annex Building entrances.

Recommendation: Apply biological and atmospheric cleaners.

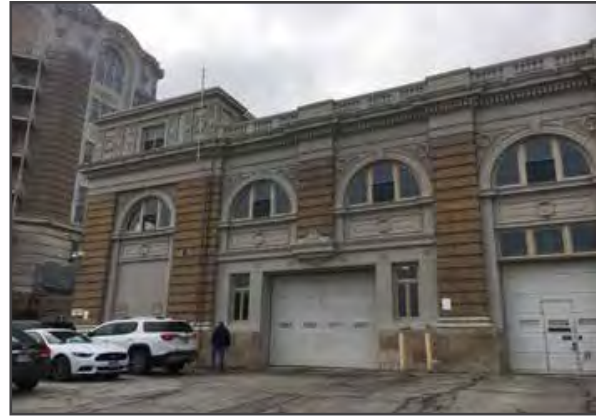
04.04 EXTERIOR MASONRY REPAIR

Existing brick is a unique buff color in contrast to the ubiquitous red brick in the St. Louis region. Brick of this color tends to be of poorer quality and is not locally sourced. However, the masonry envelope is in good condition with proper joint material and profiling. Brick is clean and devoid of staining on all elevations. No signs of step cracking or spalling which is evidence of larger issues.

Recommendation:  
None.

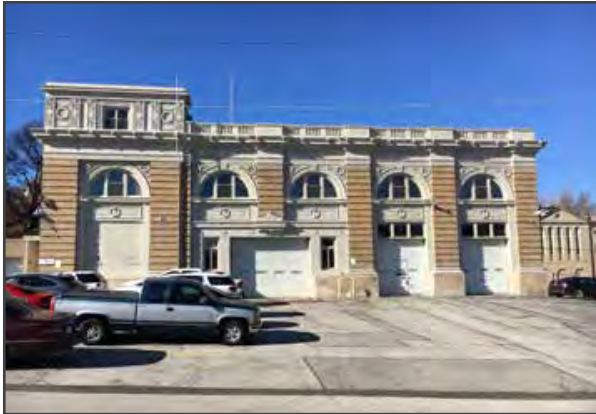
04.08 MASONRY INFILL  
*Modified Openings*

All five bays at ground level have been modified in height and or width to accommodate emergency vehicle access. Bays 2 and 3 have been modified to create a single opening that reads as historic but is in fact arbitrary and not historically accurate.

Recommendation: Evaluate future space needs to determine if openings are still needed in the current configuration. If needed, consider more appropriate overhead doors. If not needed, restore openings to original configurations as allowable by program needs.

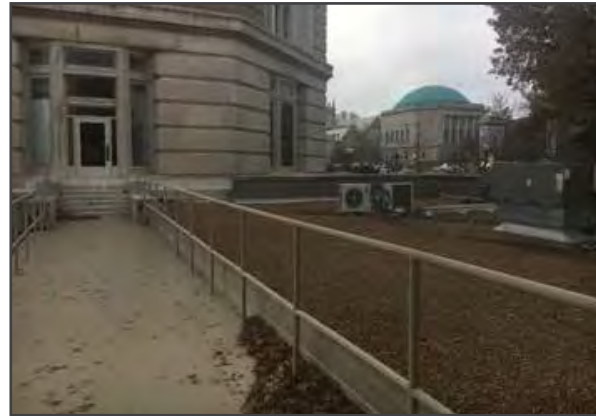
05.03 DECORATIVE METAL RAILINGS  
*Inconsistent styling*

Existing rooftop walk railings are utilitarian and not historically sensitive. While no pickets are required per code due to proximity to potential falls, their absence is a potential liability.

Recommendation: Remove and replace with more compatible railing style that limits access to rooftop.

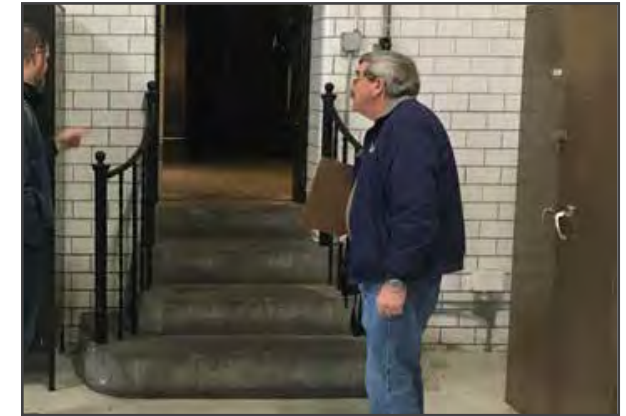
05.03 DECORATIVE METAL RAILINGS  
*Non-Code Compliant*

Faux traditional railings are non-code compliant. Handrails do not extend beyond top and bottom-most riser nosing.

Recommendation: Remove and replace railing to meet handrail code requirements.

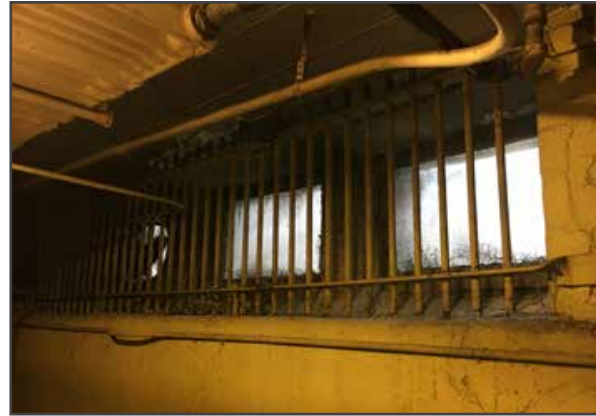
05.03 DECORATIVE METAL RAILINGS  
*Window Security Grille*

Window security grilles limit proper maintenance of windows. Cleanliness in interstitial space and of railings is compromised.

Recommendation: Remove grilles and locate high security threats away from windows.

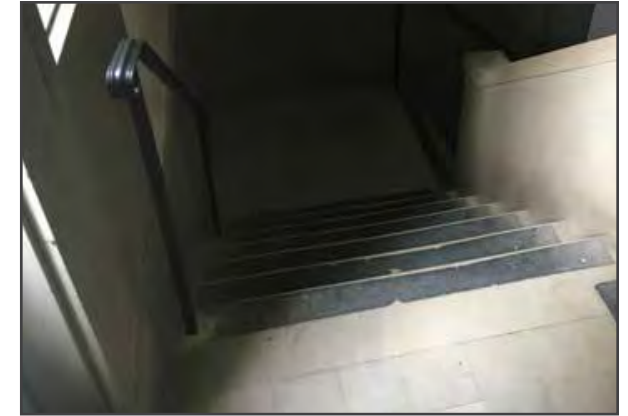
05.03 DECORATIVE METAL RAILINGS  
*Non-ADA Compliant*

Recommendation: Remove and replace railing to meet handrail code requirements.

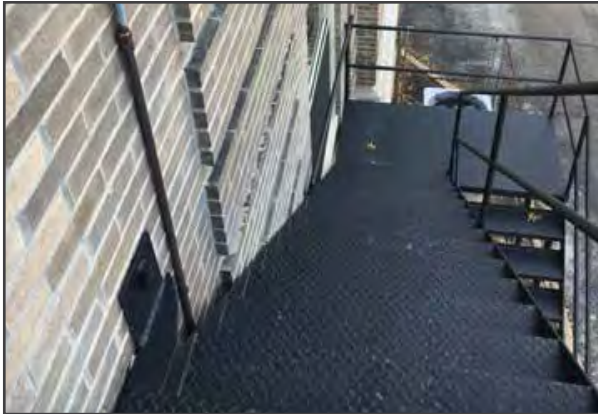
05.04 METAL STAIR FABRICATIONS

*Non-Code Compliant*

The second floor's second means of egress is an uncovered exterior stair. It is an unsecure location with high probability for slips and falls. Current railings are not code compliant and allow for someone to fall off the stairs between the rails. Painting requires consistent upkeep. Stair is an eyesore at the north elevation

Recommendation: Remove exterior stair and replace with an interior second means of egress.

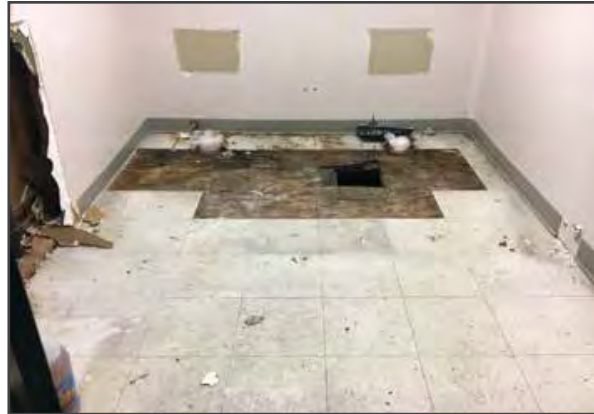
06.01 MAINTENANCE OF WOOD, PLASTICS & COMPOSITES

*Rotted Raised Floor*

Newer restrooms have been inserted at the 2nd floor. Raised flooring has been constructed which makes the restrooms inaccessible to disabled visitors/employees. In addition, plumbing fixtures had multiple leaks which resulted in significant wood rot and conditions conducive to mold growth.

Recommendation: Remove all restroom partitions and overbuilt floor materials down to historic fabric. Consider new locations and configure spaces for maximum inclusiveness.

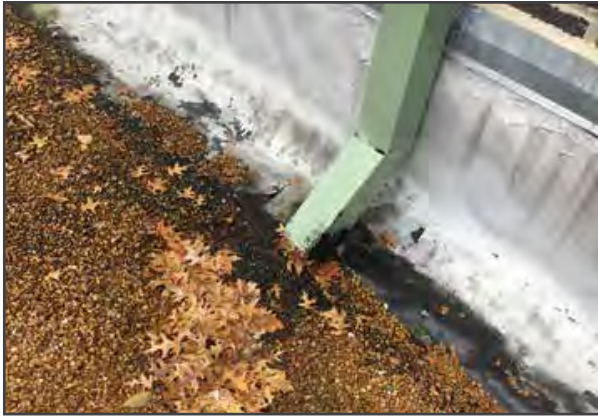
07.01 GUTTERS & DOWNSPOUTS

*Lack of Splashblock*

No splash blocks at downspouts. Scouring of roof ballast evident at some locations

Recommendation: Provide splashblocks at all downspout locations and reduce water travel distance to drain inlets.

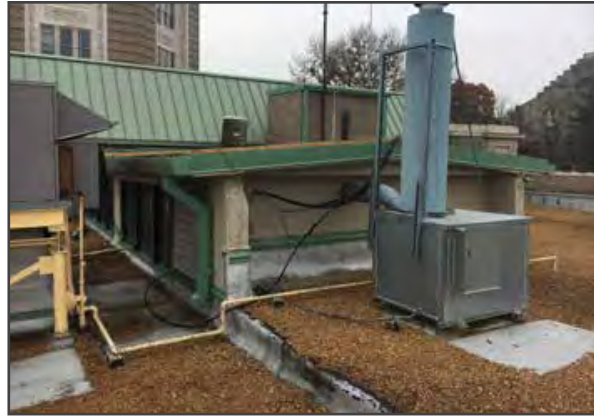
07.02 METAL FLASHINGS

*Typical Condition*

Pre-finished metal flashings were in good condition, securely attached and colorfast

Recommendation: Remove and replace as required when installing new roofing systems

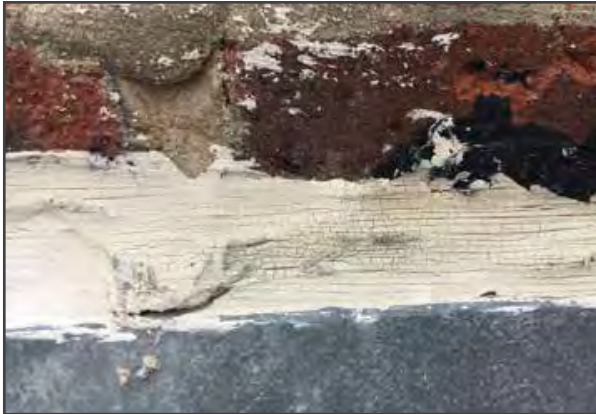
### 07.03 JOINT SEALANTS

*Adhesion Failure*

Most joint sealants were serviceable but show signs of repeated stress and UV degradation.

Recommendation: Replace areas where sealants have failed. Evaluate sealants on a periodic basis and remove and replace accordingly.

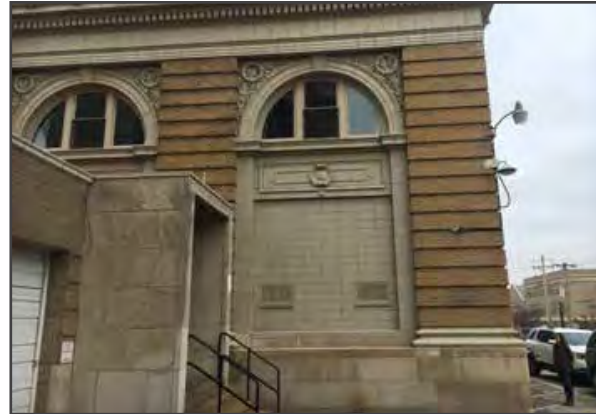
### 07.04 WATERPROOF COATINGS

*Typical Condition*

It is assumed the original glazed coating of the extensive terracotta work have been compromised beyond repair. A fluid applied coating now conceals all historic terracotta. In general, the coating was in good condition and the color selection looks to be an appropriate color for the building. Additional information is needed to evaluate the longterm suitability of the coating.

Recommendation: Evaluate coatings on a periodic basis and remove and replace accordingly.

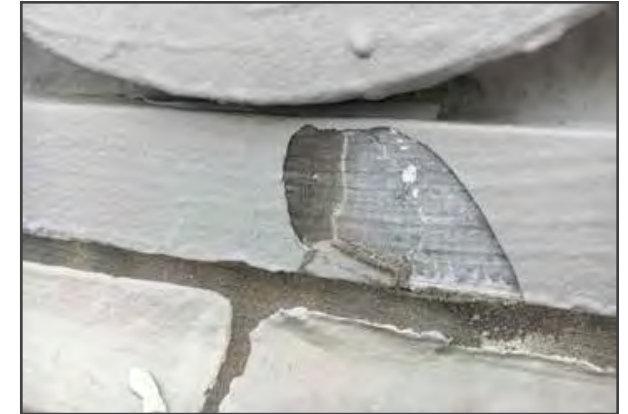
### 07.04 WATERPROOF COATINGS

*Adhesion Failure*

Some locations of the terracotta coating have been compromised. This allows for possible further deteriorations as moisture is allowed into the system and the breathability of the coating is likely non-porous

Recommendation: Remove unsound and loose materials to substrate. Reapply coating.

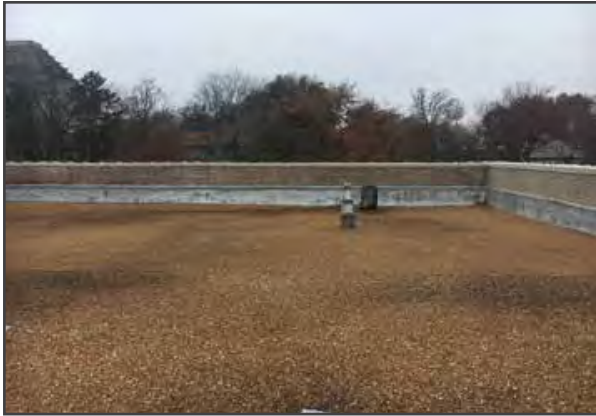
### 07.05 WATERPROOF MEMBRANES

*Ballasted Roof*

There are no roof walk mats to access rooftop equipment. Ballasted roofs have the propensity for punctures do to walking on the ballast. The roofing technology installed is antiquated and the system installed is near end of service. A new roof may accommodate increased thermal performance over the existing system

Recommendation: Consider new roofing systems with high albedo and or high thermal efficiency. Provide walking mats for rooftop access.

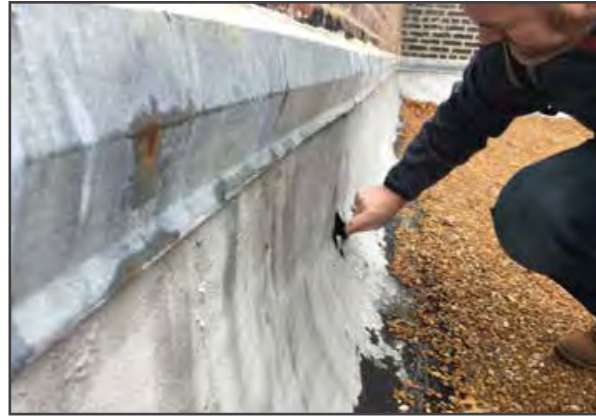
### 07.05 WATERPROOF MEMBRANES

*Fluid Applied Membrane Damage*

A liquid aluminum coating has been applied to the EPDM roofing substrate at the vertical parapet wall surfaces. This was likely applied in an effort to add longevity or remedy observed deterioration. Several locations were found to be compromised. In some areas the liquid coating had delaminated, in others, the substrate was not suitable for liquid application.

Recommendation: None. The liquid coating is integral to the roofing membrane and will be removed as part of a new roofing system installation.

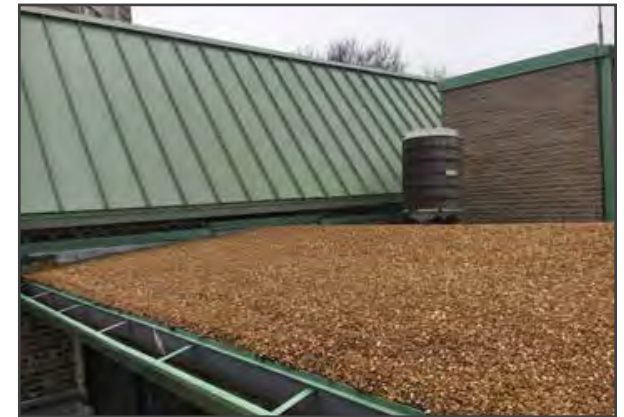
### 07.06 METAL ROOFING

*Typical Condition*

Metal standing seam roofing is installed over clerestory windows. Roofing is in good condition with no obvious signs of storm damage or leaks. However, roofing obscures metal skylights that are a character defining feature.

Recommendation: Remove metal roofing and restore skylights to original conditions.

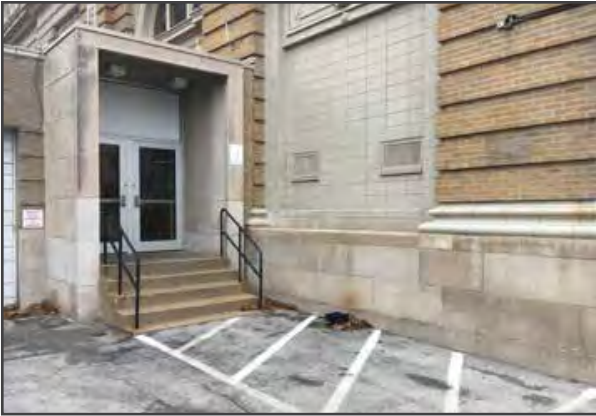
08.01 HOLLOW METAL DOORS & FRAMES

*Historically Inaccurate*

Exterior metal doors, frames. And blind transoms are in good condition. However, anodized aluminum finish is not historically compatible.

Recommendation: Remove and replace with door styles and colors that are more consistent with the color and style of the building.

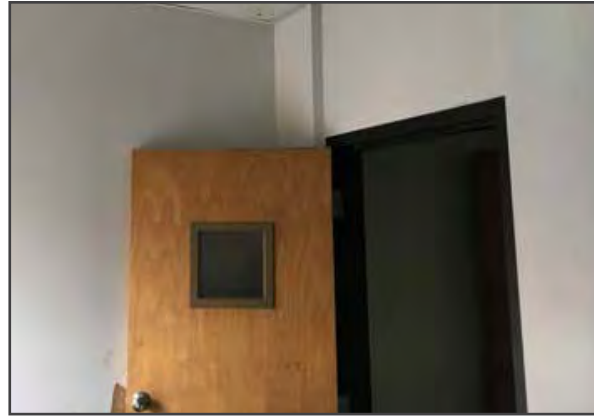
08.01 INTERIOR HOLLOW METAL DOORS & FRAMES

*Typical Condition*

Interior hollow metal frames are functional but utilitarian. Door leaves were inconsistent in both material, style, and finish.

Recommendation: Consider consistent door types and frame types. Reserve current frame and door styles for back of house and/or strictly utilitarian functions.

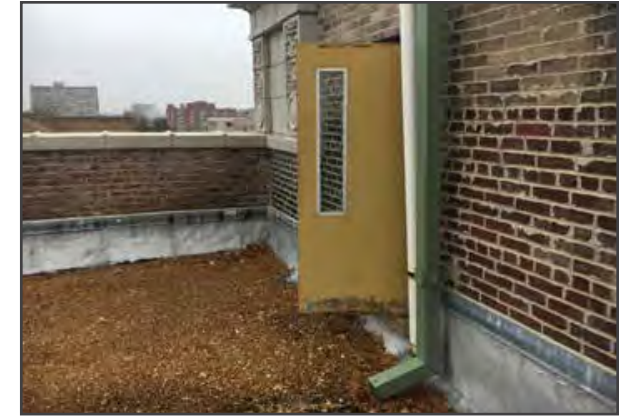
08.02 EXTERIOR HOLLOW METAL DOORS & FRAMES

*Typical Condition*

Exterior hollow metal doors and frames were in poor condition. Many doors did not close properly. Doors and frames had extensive rusting at heads and sills

Recommendation: Remove and replace doors and frames to ensure properly functionality and aesthetic consistency.

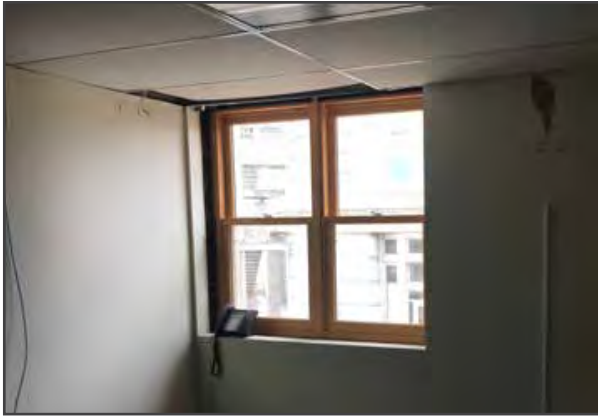
### 08.07 WOOD WINDOWS

*Typical Condition*

New wood replica windows installed at existing window openings. Infilled windows were not reopened to original configurations. Accuracy of sight lines and profiles undetermined. Energy efficiency undetermined at time of assessment.

Recommendation: Review original windows against new window sight lines and profiles. Review window performance numbers. Reopen all original window openings and remove infill materials.

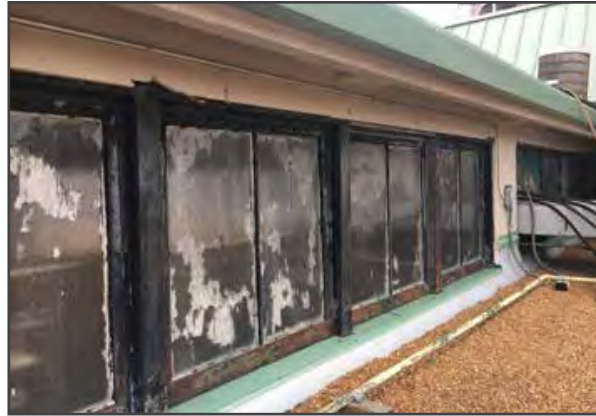
### 08.08 STEEL WINDOWS

*Rust*

Moderate rust is evident along with single pane glazing units at clerestory windows. These windows are a prominent character defining feature of the second floor space and should be prioritized for restoration and/or replacement back to their original configuration to the extent possible. Windows are in fair condition.

Recommendation: Preference restoration over replacement but consider overall energy performance.

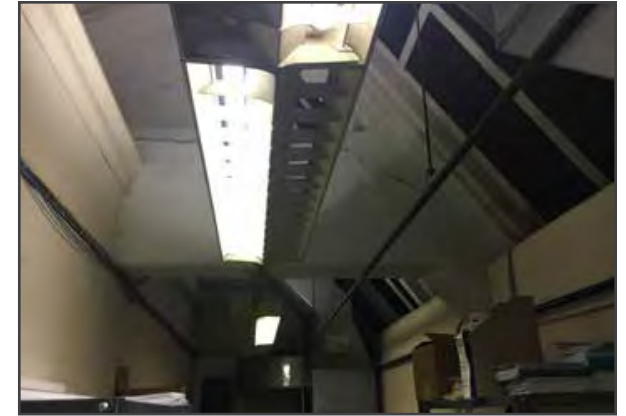
### 08.09 METAL-FRAMED SKYLIGHTS

Metal skylights are a key feature of the existing space that are no longer being used. Glazing units look to be painted opaque. Limited signs of water infiltration at failed sealants/gaskets.

Recommendation: Remove roofing materials. Review existing conditions. Preference restoration over replacement but consider overall energy performance.

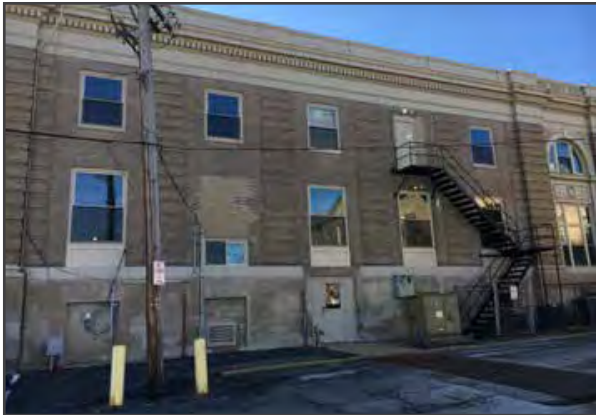
08.16 WALL VENTS  
*Inconsistent Size and Finish*

Wall vents create inconsistent openings and create a negative impact on multiple elevations.

Recommendation: Remove vents, consolidate, and/or locate vents at rooftop or other discreet location. Consider more aesthetically pleasing vent options where no other placement option is feasible.

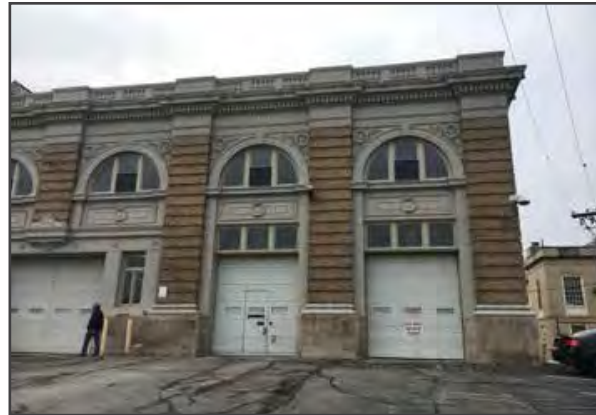
08.17 OVERHEAD DOOR  
*Historically Inaccurate*

Overhead doors are inconsistent with the period of significance. Doors should be considered for removal.

Recommendation: Restore openings to original configuration if possible. Where overhead doors are required, provide insulated, energy efficient options with details more compatible with historic building.

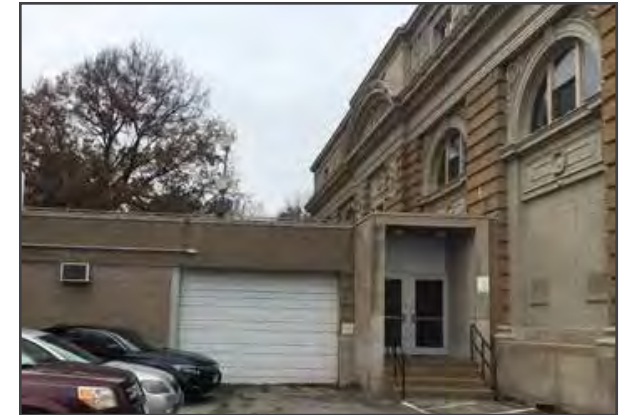
08.17 OVERHEAD DOOR  
*Historically Inaccurate*

Proximity of door to entrance is undesirable and confuses wayfinding. This overhead door in particular should be removed or the entrance location should be reconsidered.

Recommendation: Infill openings where overhead doors are no longer needed. Consider storefront systems that adequately differentiate themselves from historic elements. Where overhead doors are required, provide insulated, energy efficient options with details more consistent with historic building.

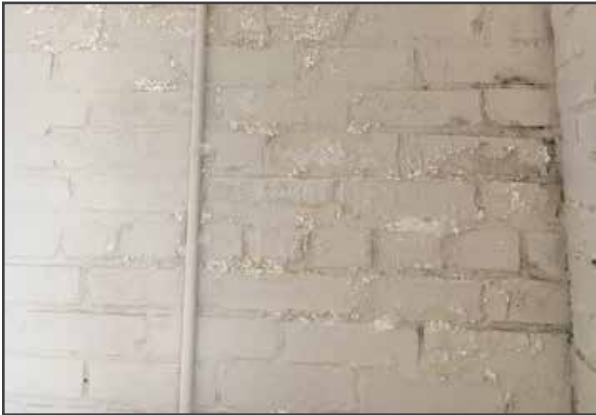
09.01 PAINT  
*Exterior Wall Efflorescence*

Paint efflorescence in and of itself is of little consequence especially since walls will be furred out in future work. However, it is indicative of moisture migration through the wall system. Furthermore, existing wall does not meet current R-Values

Recommendation: Review exterior wall conditions to determine if moisture is currently migrating through the wall. Review for structural cracks, open joints, and any sky facing ledges that may be allowing moisture into the wall. Furr out walls with appropriate materials as to not trap moisture within the wall assembly.

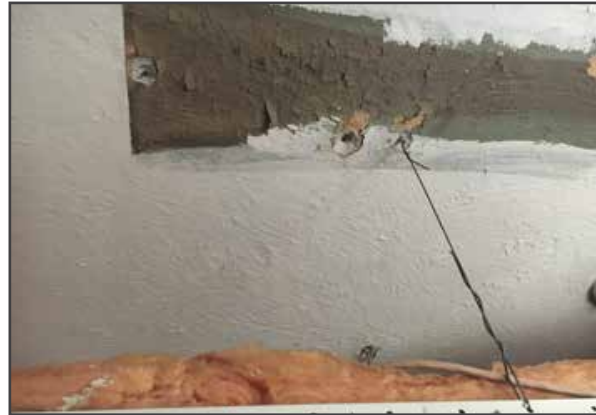
09.01 PAINT  
*Peeling Paint*

Peeling paint is not only unsightly but is likely lead based.

Recommendation: See environmental assessment for removal protocol. If no hazardous materials are present, remove paint down to substrate in locations where surface is exposed.

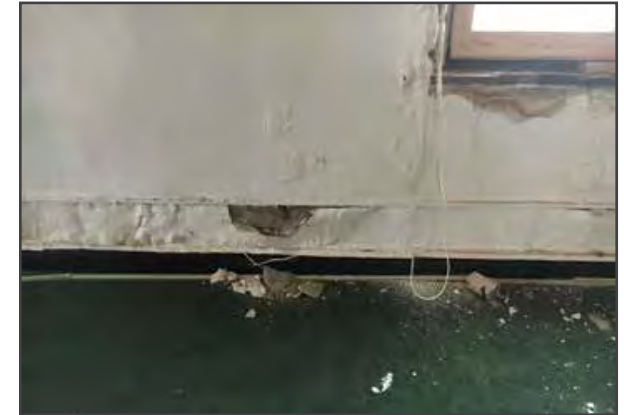
09.02 GYPSUM PLASTERING  
*Spalling*

Spalling is indicative of moisture migration through the wall system. Furthermore, existing wall does not meet current R-Values

Recommendation: Review exterior wall conditions to determine if moisture is currently migrating through the wall. Review for structural cracks, open joints, and any sky facing ledges that may be allowing moisture into the wall. Furr out walls with appropriate materials as to not trap moisture within the wall assembly.

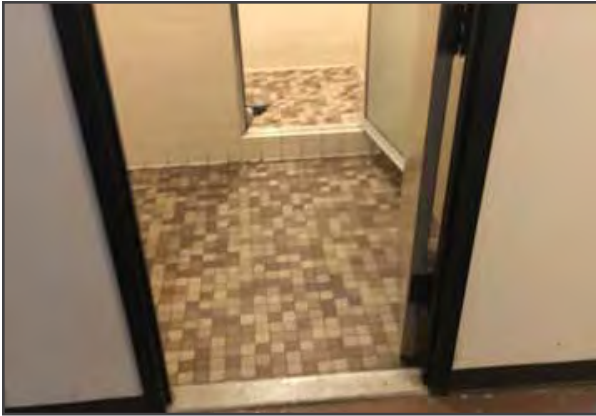
### 09.03 CERAMIC TILING

*Restroom Conditions*

Mosaic, small format tile was present on floors and 4" square tile was present on the walls of the restrooms. They are functional but have a high proportion of grout joints to solid surface which results in high maintenance requirements and fosters unsanitary restroom environments.

Recommendation: Consider large format tile in colors that demonstrate sanity conditions.

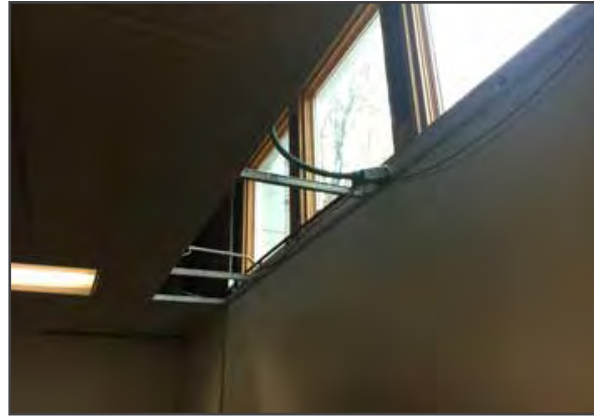
### 09.04 ACOUSTICAL TILE CEILINGS

*Dropped Ceilings*

Dropped ceilings significantly altered the quality of the spaces especially at the first floor. Most transom level windows were completely concealed above the ceiling plane.

Recommendation: Remove acoustical ceiling tile systems. Consider floating planes and/or ceiling soffits that allow spaces to have access to natural light to the greatest extent possible.

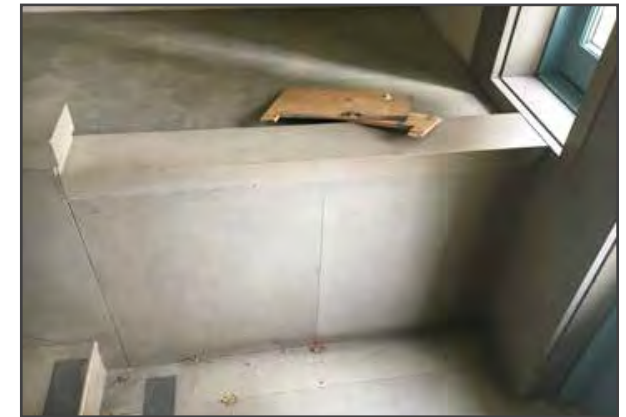
### 09.05 STONE FLOORING

*Worn Finish*

Stone flooring at the stair landings are in good condition. Some minor staining and loss of finish are evident

Recommendation: Remove stains using the gentlest means necessary and grind as needed to remove deeper scratches and gouges.

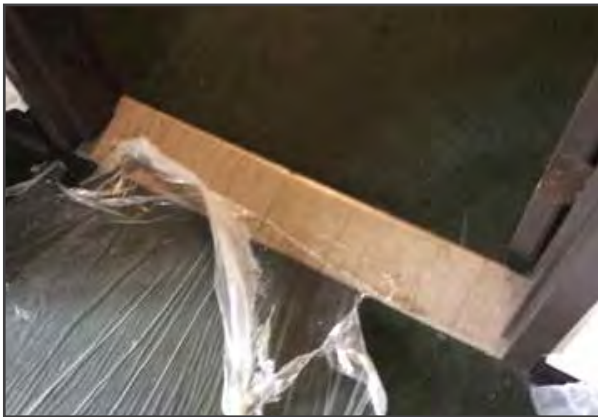
09.05 STONE FLOORING  
*Threshold(s)*

Stone thresholds were found in few locations. They are historic and should be preserved in any new flooring application

Recommendation: Maintain in place.

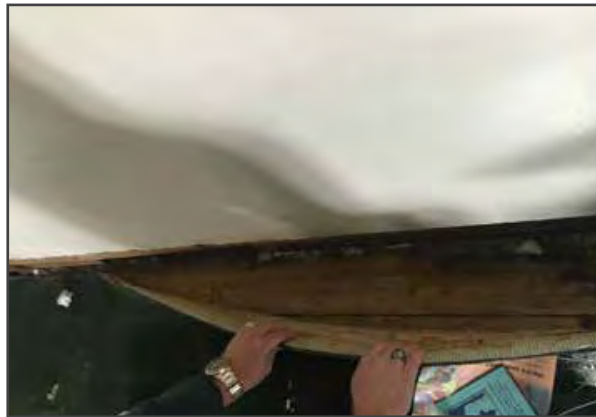
09.06 WOOD FLOORING  
*Concealment*

Original wood flooring was found in multiple locations below vct and carpet. Original flooring materials are important contributors to the quality of historic spaces.

Recommendation: Remove flooring materials concealing wood floors. Evaluate condition of wood flooring and identify areas where wood could be exposed in new spaces.

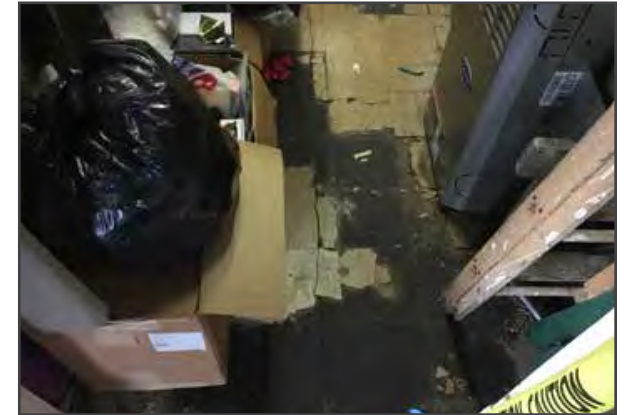
09.08 RESILIENT FLOORING  
*Multiple Plys*

Recommendation: Remove existing floor finished down to structural deck or historic flooring, whichever comes first.

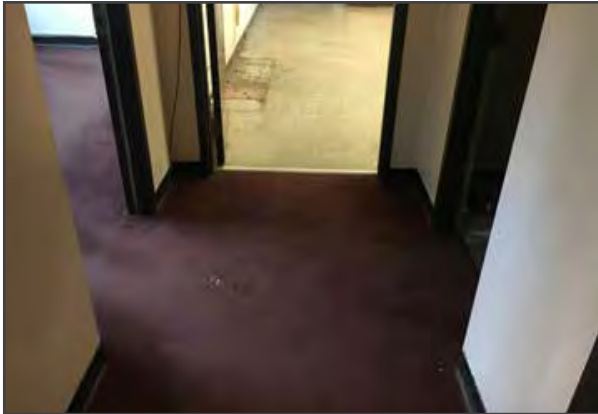
09.11 SHEET CARPETING  
*Stained/Crushed Pile*

Existing carpets are beyond their useful life. Widespread staining and crushed pile were observed in most spaces.

Recommendation: Remove all carpeting. Consider carpet tiles and/or more durable flooring materials that require less maintenance, have more longevity, and could be replaced in part as needed when damaged beyond repair.

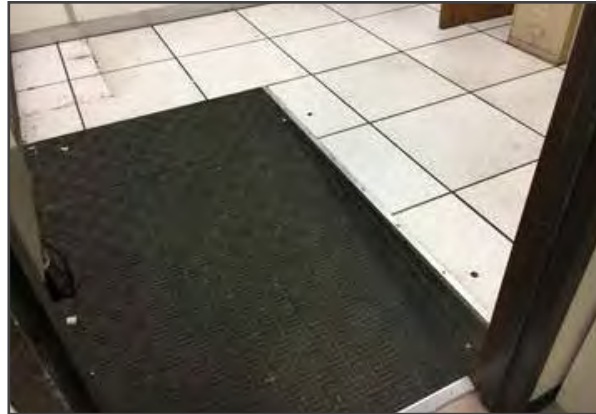
09.14 RAISED FLOOR  
*General Condition*

The raised floor system is highly specialized and likely is not suitable for reuse in the new program.

Recommendation: Remove flooring system.
