# University City Hall Annex Building Facility Assessment + Feasibility Study

*Completed in Collaboration with Department of Public Works + Police Department*

September 9, 2019

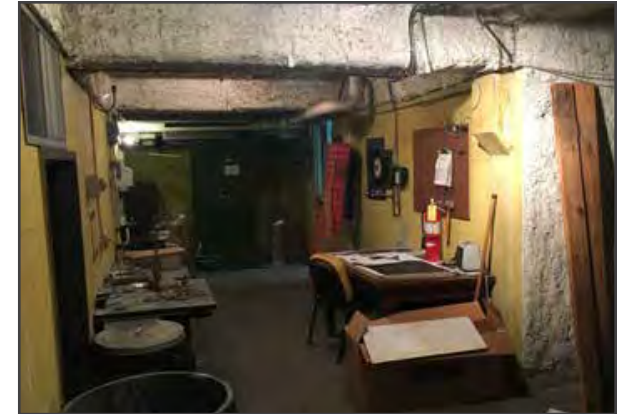
09.15 ACOUSTIC COATING  
*General Condition*

Acoustic coatings are present on many wall and ceiling surfaces. This sound mitigation material is antiquated and the firing range is not currently master planned for the same location. Lastly, the material is porous which presents two additional concerns in that cleanliness cannot be maintained and lead dust is captured which is a significant health risk. See environmental reports for additional hazardous material information.

Recommendation: Remove all acoustic coating in keeping with hazardous material removal protocol.

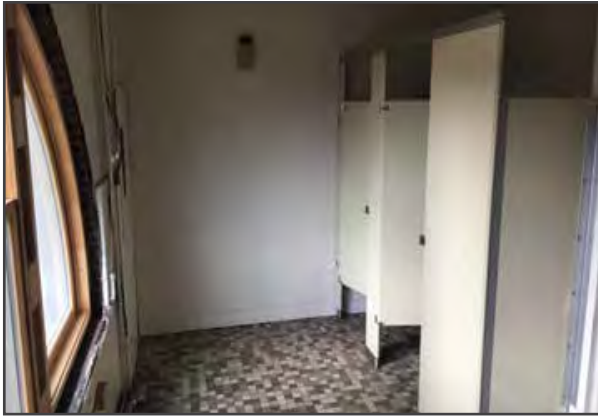
### 10.04 TOILET COMPARTMENTS

*Non-ADA compliant*

Current toilet compartments are in fair condition. New restroom layouts will not match existing in size or layout. In addition, current compartments are floor mounted and make housekeeping difficult and have shorter lifespan due to contact with wet surfaces.

Recommendation: Dispose of toilet compartments.

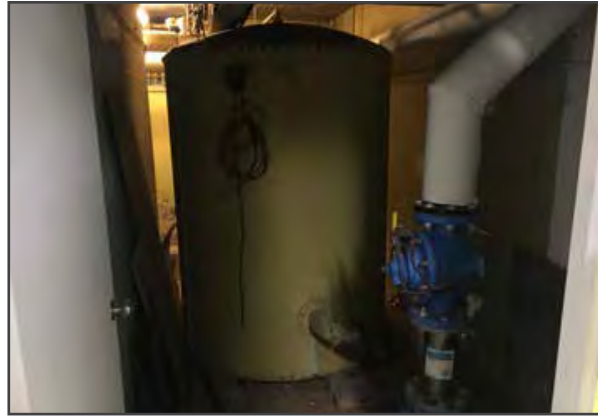
### 11.01 Water Reservoir

*General Condition*

A single hot water source is inefficient and not needed in future uses. See environmental report for any additional hazardous material information associated with tank piping or room finishes.

Recommendation: Remove tank and consider point source hot water for future needs.

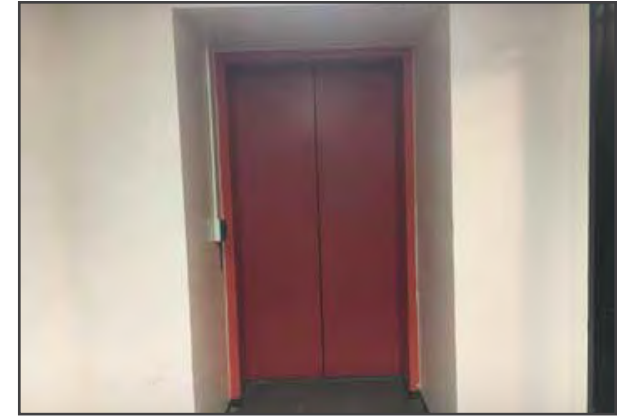
### 14.01 ELEVATOR

*General Condition*

Recommendation: Review future circulation paths and consider all users when establishing best location for vertical circulation. Consider locations which minimize impact to historic building materials as designated in attached preservation plans.

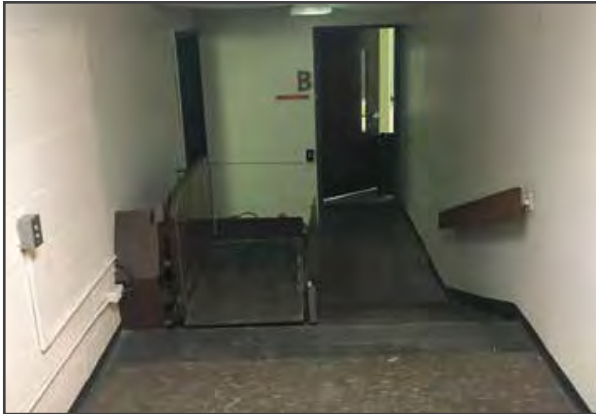
14.01 ELEVATOR  
*Lift General Condition*

Recommendation: Remove lift. Consider ramp and stair combinations that afford all users a similar experience, limits energy consumption, and reduces maintenance needs. Provide new lift(s) only where ramps are not feasible.

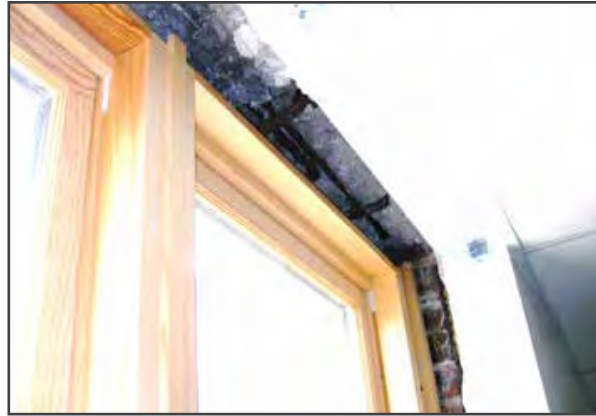
03.03 RUSTED REBAR AT WINDOW LINTELS  
*Freeze-Thaw Damage*

Lintels consist of reinforced concrete. Moisture damage has saturated the concrete in the past and has caused the reinforcing steel to rust and expand, resulting in spalled concrete. Exposed conditions exist on the third-floor south elevation on the west side. Other latent but not visible conditions could exist at other locations with flat window heads.

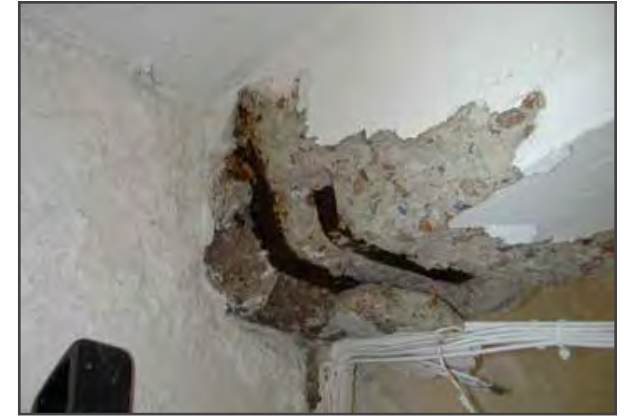
03.03 SPALLED CONCRETE AT ROOF BEAM  
*Overload Condition*

The roof construction consists of reinforced concrete slabs and beams. Moisture damage has saturated the concrete beams at beam pockets in the past and has caused the reinforcing steel to rust and expand, resulting in spalled concrete. Exposed conditions exist on the roof east elevation towards the center of the building as viewed from the second floor at two locations.

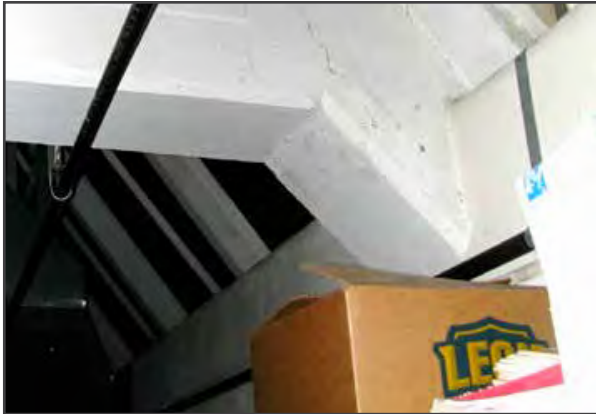
03.03 CRACKS IN MAIN ROOF BEAMS AT  
MONITOR  
*Cracking*

The monitor roof construction appears to consist of a system of reinforced concrete slabs and beams. The ends of the main concrete roof beams have cracks, that could be shear cracks. We recommend that the construction type and cause of cracks be investigated to determine the cause and degree of concern.

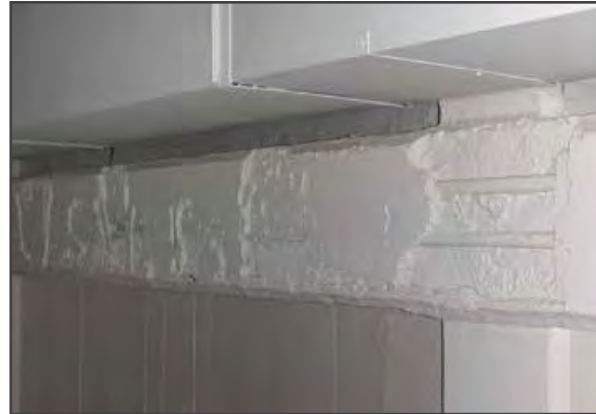
03.03 SPALLED CONCRETE COVER AT ROOF  
BEAM  
*Spalling*

The roof construction consists of reinforced concrete slabs and beams. At select interior roof beams (as viewed from the second floor), the concrete cover on the bottom of the beams has spalled, exposing reinforcing steel. This lack of concrete cover does not provide an adequate fire rating for the beams.

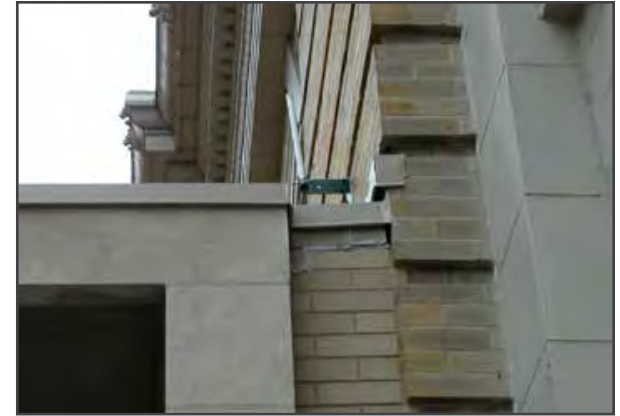
04.03 LOOSE BRICK AT GARAGE

Brick at the junction of the garage and main building at the roof line on the east elevation is dislodged and likely loose. It is likely that the masonry restoration contractor did not remove and reset the brick 2 to 3 years ago to avoid tampering with the roofing membrane. Open joints can allow water intrusion and resulting freeze-thaw damage to surrounding masonry.

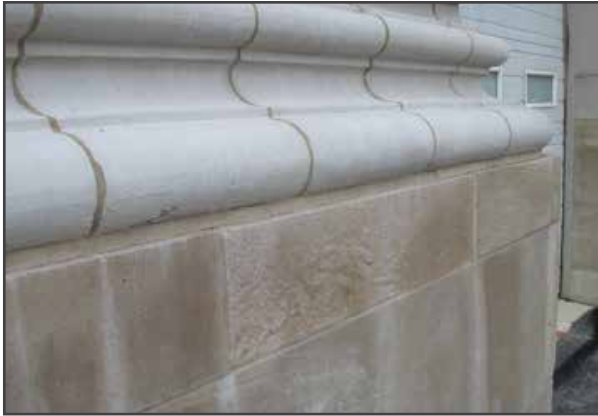
04.03 SPALLING PAINT ON TERRACOTTA

Terracotta was painted and sealed 2 to 3 years ago during the masonry restoration project. The paint is beginning to spall and peel on the water table on the east elevation. The condition shown occurs randomly around the building. The paint will continue to peel allowing moisture infiltration inside the terracotta eventually causing freeze-thaw damage.

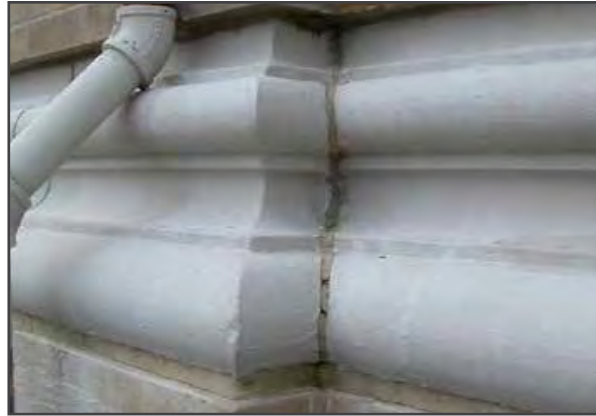
04.03 SPALLING RE-POINTING MORTAR

The masonry facade was re-pointed 2 to 3 years ago during the masonry restoration project. The re-pointing mortar is starting to spall on the water table on the east elevation. The condition shown occurs randomly around the building. The mortar will continue to spall allowing moisture infiltration inside the mortar joints eventually causing freeze-thaw damage.

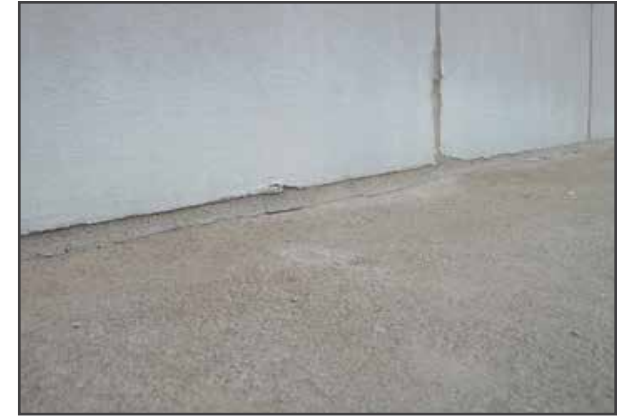
04.03 CRACKED RE-POINTING MORTAR & SPALLING PAINT AT TERRACOTTA

The masonry facade was re-pointed and terracotta painted and sealed 2 to 3 years ago during the masonry restoration project. The re-pointing mortar is starting to crack and paint starting to peel at localized locations on the water table on the east elevation. The condition shown occurs randomly around the building. The cracked mortar and peeling paint will continue to crack, spall and peel allowing moisture infiltration inside the mortar joints and into the terracotta eventually causing freeze-thaw damage.

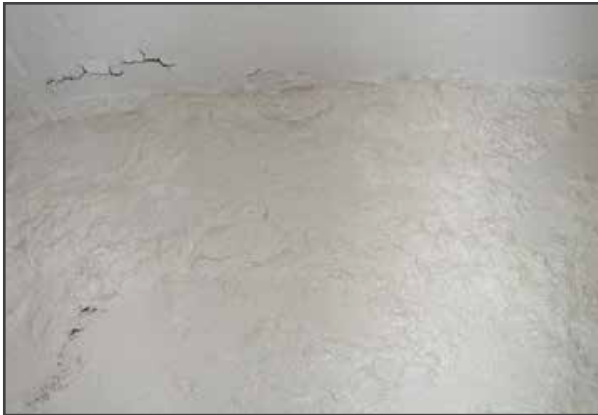
04.03 BUBBLED PAINT FROM MOISTURE INFILTRATION

Paint has “bubbled” randomly throughout the building on the inside of exterior walls. The masonry facade was re-pointed and terracotta painted and sealed 2 to 3 years ago during the masonry restoration project. Thus, the bubbled paint could be a result of moisture infiltration into the masonry wall prior to the facade restoration and may not be advancing. We would suggest removing the interior paint in bubbled areas to allow the moisture in the masonry to evaporate, then re-paint. Refer to environmental engineer assessment for hazardous material content discussion.

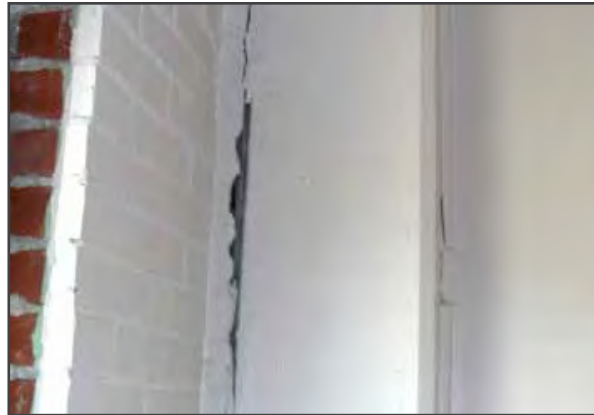
04.20 NORTH WALL SEPARATION AT COLUMN

The north exterior masonry wall was added to the structure when the northern portion of the building was demolished from fire damage. The wall sits outside the concrete frame at this elevation. The wall has separated from the concrete frame at certain locations, primarily on the middle of the elevation. This is likely from expansion/contraction from temperature changes and possibly moisture infiltration. It is not known whether the masonry facade was anchored to the concrete frame when constructed. We suggest that an investigation be performed on any facade anchorage, and the wall be anchored to the concrete frame if it does not exist, or if it is found to be inadequate.

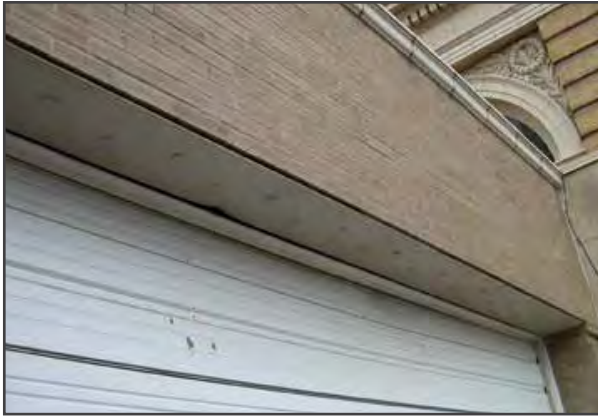
05.12 STEEL LINTEL AT GARAGE DOOR

There is no caulking above the garage door lintel on the east elevation. Water can accumulate in the gap between the masonry and steel lintel, eventually causing rust and deterioration to the steel lintel.

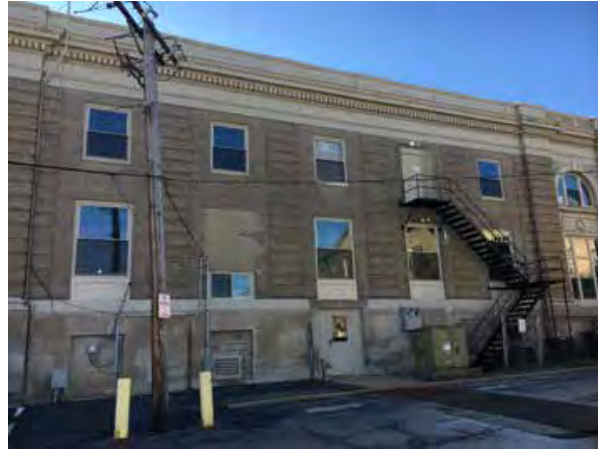
05.52 STEEL FIRE ESCAPE RAILING

The railing at the steel fire escape on the north elevation does not appear to meet building code requirements. Other structural members such as plate stringers and posts appear to be undersized based on current code requirements. Also, the egress route is not covered. We suggest that an architectural and structural review be undertaken to determine the adequacy of the fire escape, and that it be upgraded or replaced as required.

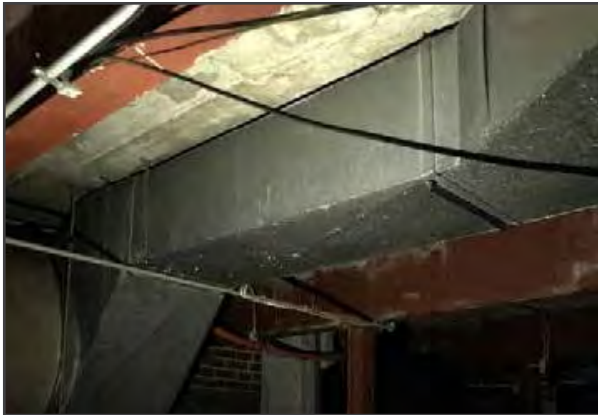
### 23.01 POWER VENTILATORS

Exhaust systems appear to not have proper protection from outside air infiltrating into the building. The exhaust fan located in the old Fire house basement that is causing the ductwork to fill with unconditioned air. The temperature difference between the unconditioned air and the conditioned interior space is causing condensate to form and leak into the conditioned space.

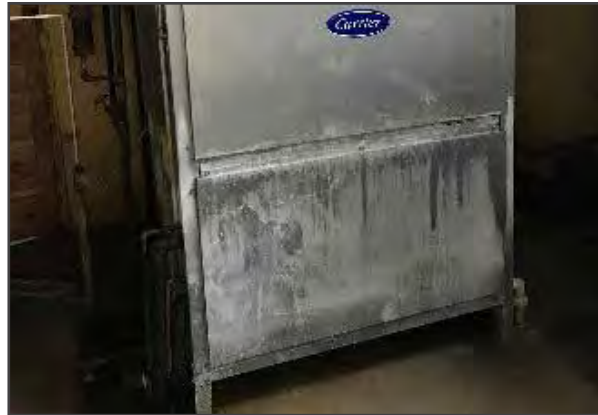
### 23.03 VENTILATION RATES

There are only two units within the building that appear to be bringing in ventilation air to the building. There is a rooftop unit serving the second floor of the firehouse and an air handling unit serving the first floor police station. The building is not meeting current codes for ventilation rates.

This equipment was manufactured around 2006 and the average life expectancy of this equipment is 15-20 years.

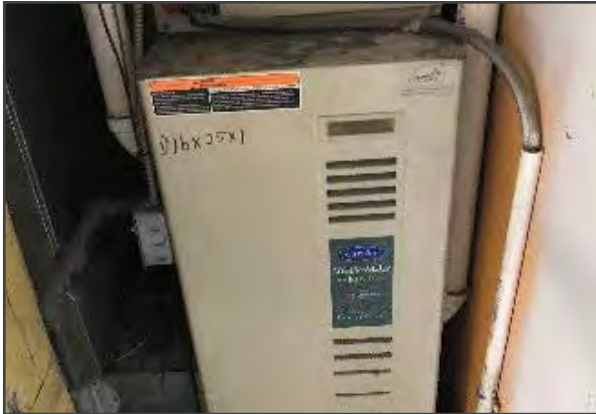
#### 23.04 RESIDENTIAL SPLIT SYSTEMS

The remainder of the building is served with residential split systems with DX cooling and natural Gas heating. These systems are not equipped to overcome any humidity issues with a space.

The date of manufacture for the residential splits is unknown. The average life expectancy of this equipment is 10-15 years.

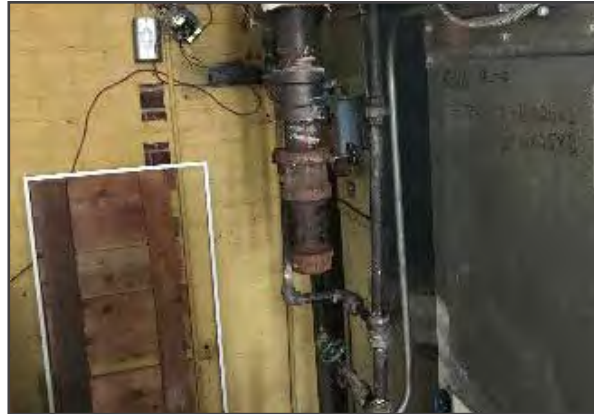
#### 23.05 MECHANICAL PIPING

Existing mechanical piping appears to be leaking near the air handler on the first floor.

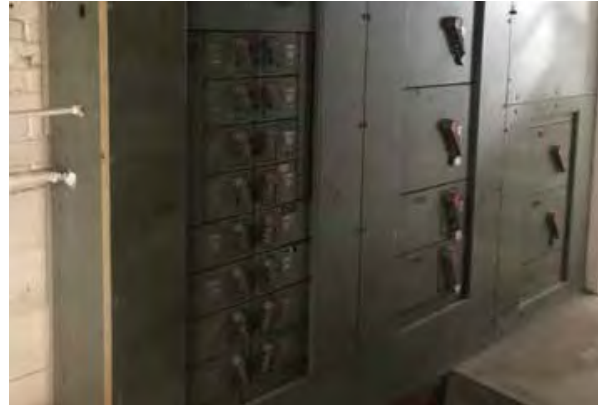
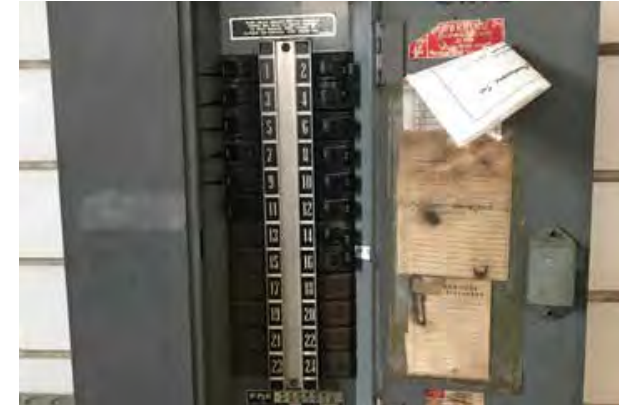
The main electrical switchboard is located in a basement hallway against the north exterior wall. It is a Federal Pacific QMQB switchboard, 1600 amps, 120/208,3-phase, 4-wire. The switchboard is likely adequately sized to service the building for any major renovation project, but it is not re-usable for two reasons. Firstly, the switchboard has exceeded what is considered to be its useful life of 20-25 years, and it could experience catastrophic failure at any time. Secondly, replacement parts are no longer manufactured for this switchboard. Any renovation project would undoubtedly require a different configuration of switches. For these reasons, a new service entrance switchboard would be required as part of any upgrades to the facility. Additionally, we would recommend choosing a different location for the building's main distribution switchgear. The current location makes for difficult distribution of electrical feeders to different areas of the building.

Existing panelboards in the facility are also outdated and have exceeded their useful life, with new parts no longer manufactured. Multiple manufacturers of panelboards were observed including Frank Adams and Federal Pacific. Certain subpanels were observed to be single-phase, 3-wire. Others were observed to be inadequately sized for the areas they serve.

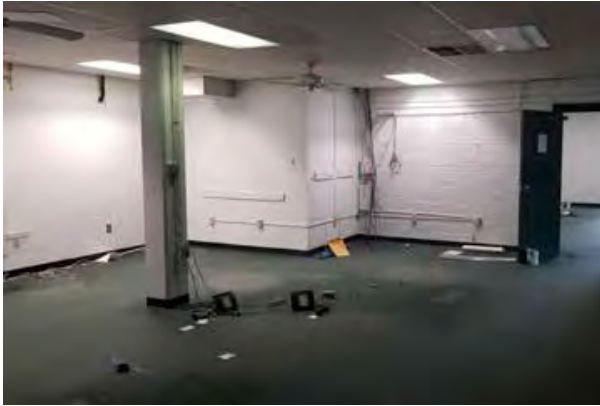
26.04 LIGHTING

In general, existing interior lighting consists of fluorescent lights with local light switches. The lighting is outdated, inefficient and prone to failure. The existing lighting would not be reused in any improvements to the facility.

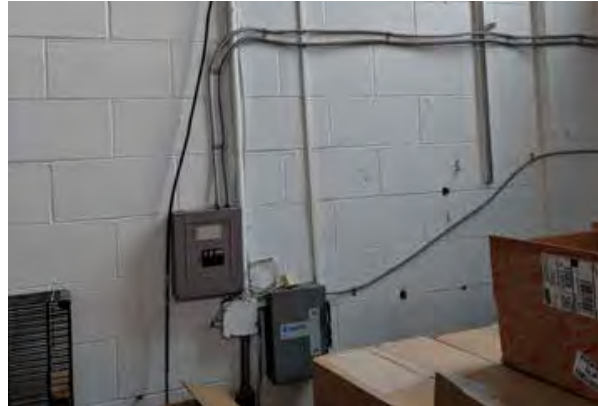
26.05 BRANCH POWER

No exposed wiring was observed. In general, exposed branch circuits were installed in conduit or in MC cable. From casual field investigation, it was unclear whether the existing branch circuits are properly grounded.

Existing receptacles are present throughout the facility. It is unlikely that any of the existing receptacles would be reused, as any improvement project would likely include a complete reconfiguration of the building's electrical system.

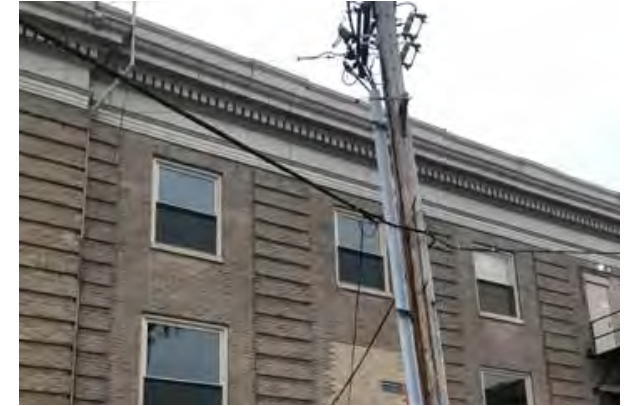
27.01 TELECOMMUNICATIONS

Telecommunications enters the Annex from overhead lines on the North side of the building, and it is routed through the basement crawlspace to other areas. Communications to (or from) the Annex are also routed under the pavement to the north.

Phone service is present in certain areas of the Annex building. Phones are connected and active in formerly occupied areas.

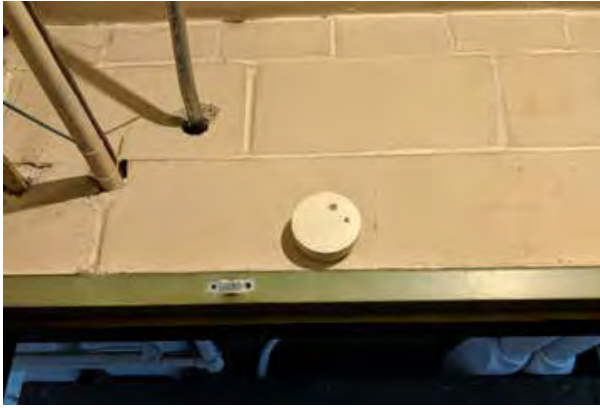
28.01 ELECTRONIC SAFETY & SECURITY  
*Fire Alarms*

A fire alarm system was not observed. Battery operated smoke detectors were present in certain areas. Any improvements to the facility would require the installation of a new fire alarm system. Ideally, the fire alarm system would be connected and/or integrated with the fire alarm systems of the connected structures and the University Police building to the north.

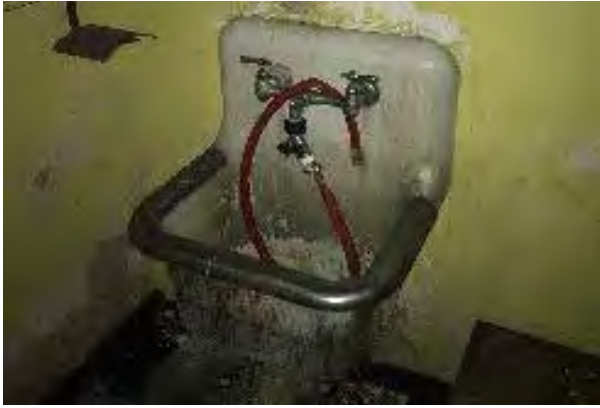
## 22.01 PLUMBING FIXTURES

Several existing fixtures have been removed from the building. It is unclear as to why they were removed, however several spots indicate water damage near the area. Many fixtures have sat with stagnant water and are starting to show signs of damage. Many fixtures will require replacement.

The current plumbing fixtures do not meet current ADA guidelines for required clearances and protection. Current fixtures in public restrooms have mostly manual operations and are higher flow fixtures that use more water and are less efficient.

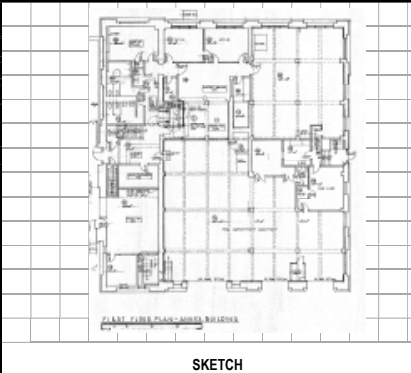
SKETCH

COMMENTS:  
Interior is a reinforced concrete gravity frame structure with reinforced concrete barrel arch slabs. Exterior walls are URM bearing walls on three sides. The north URM wall is not an infill wall, and is outside the gravity frame, thus it is not a shear wall and creates torsion in the lateral system.  
The parapet h>2.5, therefore requires bracing.  
The ground floor has been modified over time. The floor in the fire truck garage area was lowered and consists of a one-way reinforced concrete slab supported by steel beams/columns. Other areas were replaced with what appears to be one-way reinforced concrete slabs and beams with some new concrete columns and footings. Some smaller areas of the ground floor are original construction.

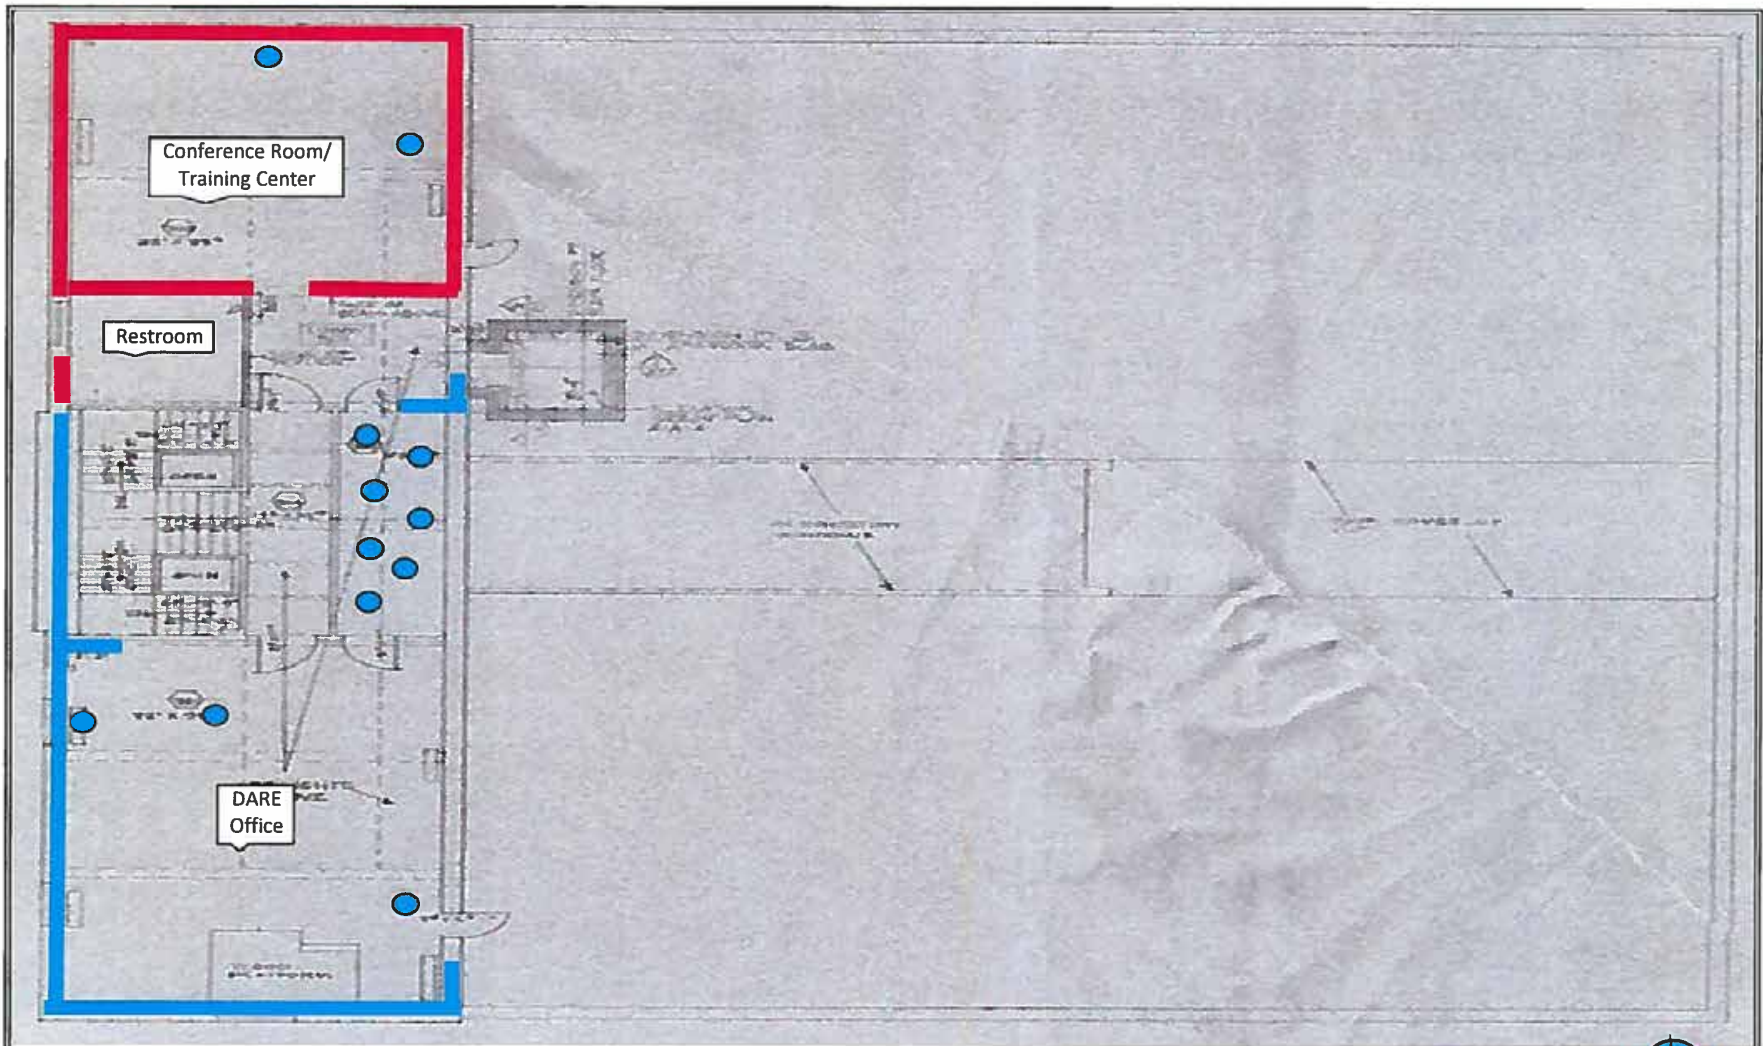
Water Damage/Efflorescence on Wall

Water Staining On Ceiling

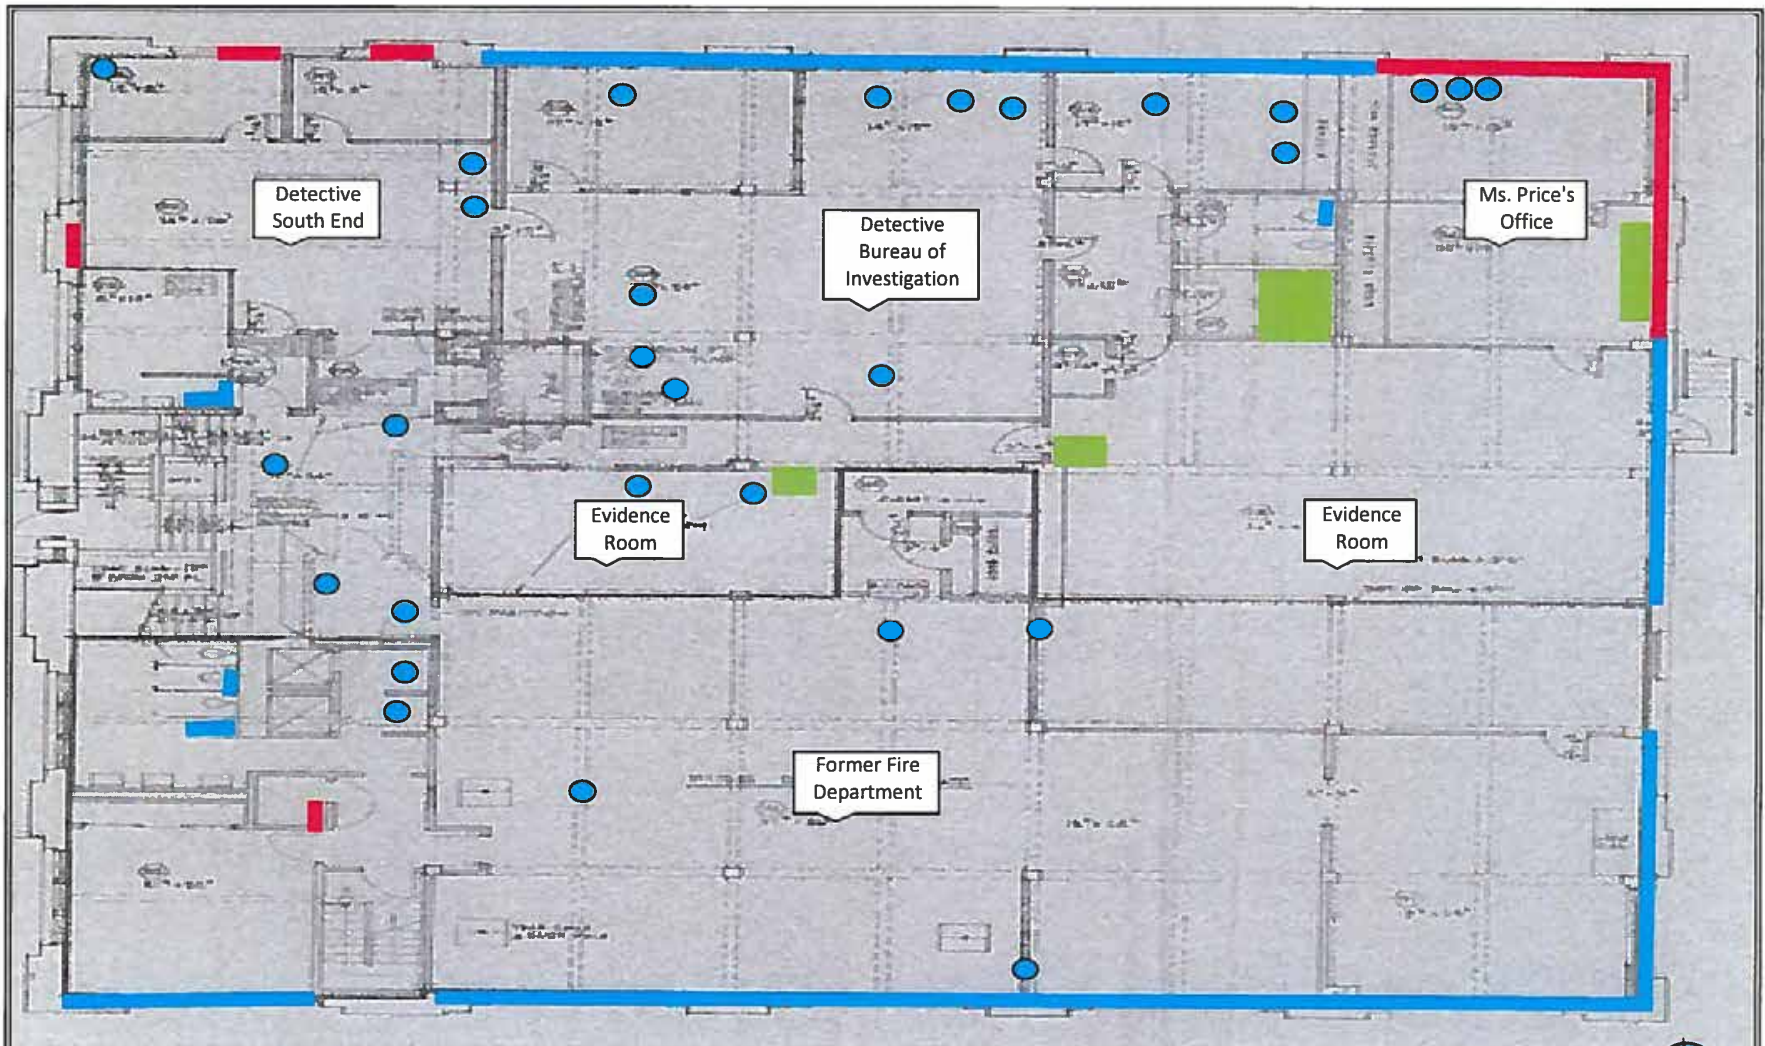
PSI Project No.:	0029-2564-1
2nd Floor - Site Map	
Date:	Drawn By:
March 31, 2016	KCR

■ Water Damage and/or Water Staining on Floor  
— Water Damage/Efflorescence on Wall      ● Water Staining On Ceiling      — Suspect Visible Mold on Wall
