**CITY HALL ANNEX - FACILITY ASSESSMENT REPORT**

PREPARED FOR UNIVERSITY CITY  
PREPARED BY TRIVERS  
2019.08.07

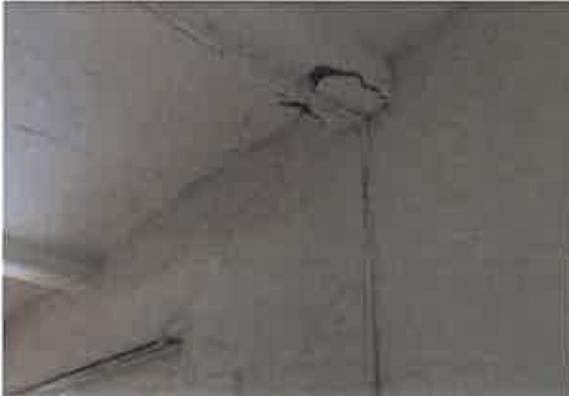
**03.00 CONCRETE**  
*Spalled Beam*

At the 2nd floor south wall there is one instance of a spalled concrete beam at its intersection with the exterior wall. This represents concern both architecturally and structurally. See structural assessment for additional information

Recommendation: Remove loose and unsound material. Document condition of reinforcing steel. See structural assessment for additional information.

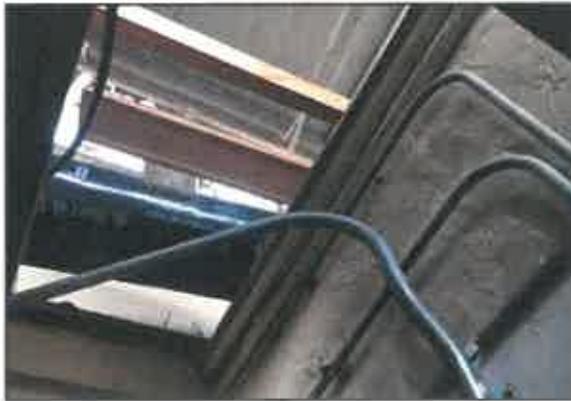
**03.00 CONCRETE**  
*Penthouse*

A concrete penthouse comprised of concrete columns, beams, and board formed roof deck is located at the central column bay running east-west for several bays. It is concealed above dropped ceilings in secured evidence storage rooms. Several additional bays have been infilled to eliminate the penthouse. The concrete structure looks to be appropriately roofed and painted with only minor indications of deterioration.

Recommendation: Limit use of dropped ceilings and organize systems to coordinate with penthouse. Consider restoring extents of penthouse for entire length of building. Emphasize the penthouse as a character defining feature and organizing element. See structural assessment for additional information.

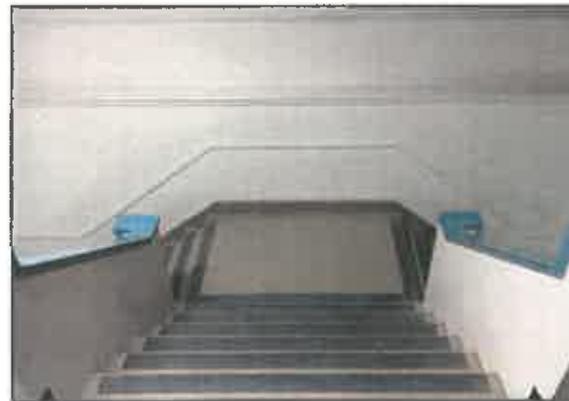
**03.00 CONCRETE**  
*Cast-in-place stairs*

Recommendation: Clean and prep for new floor finishes. Modify existing guardrails to meet code required height and add handrails. Consider new stair for primary vertical circulation and limit public use to the extent possible.

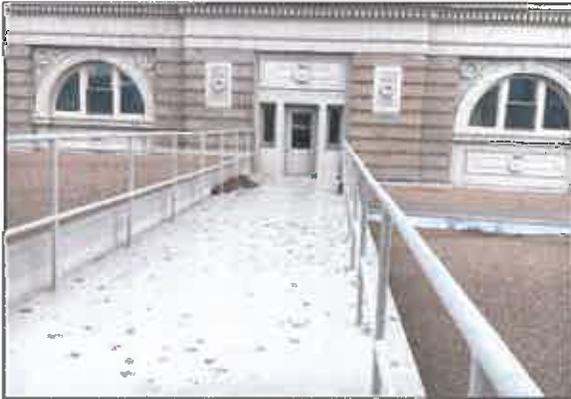
**03.02 CAST IN PLACE CONCRETE SIDEWALKS & TERRACES**  
*Rooftop walk*

Rooftop walk looks to be in good condition. No cracking or other signs of roof deflection. Walking surface coating is sanded but should be evaluated to ensure proper slip coefficient. Walking surface is not adequately lit.

Recommendation: Maintain surface coating and test for proper slip coefficient. Provide Min 3 footcandles per foot at walking surface.

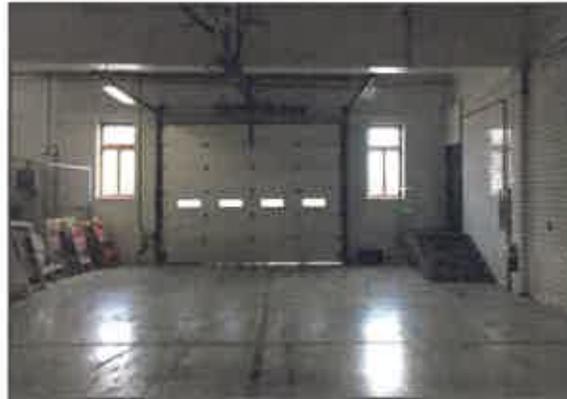
**03.02 CAST IN PLACE CONCRETE**  
*Hi-bay slab*

Recommendation: Test concrete for toxic and/or hazardous materials. Consider unique open floor and increased head height areas for multifunction, sally-port, or other program elements not suitable for other locations in the building. Evaluate potential replace floor at original elevation.

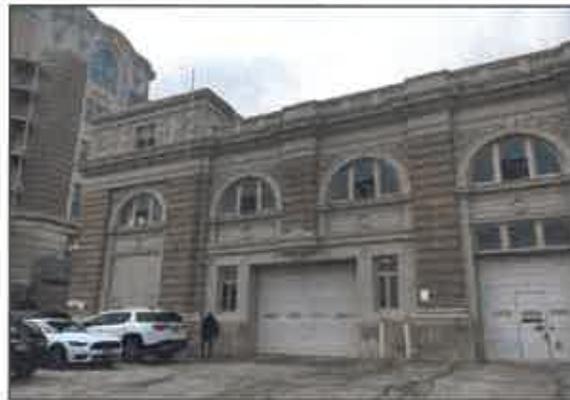
**04.04 EXTERIOR MASONRY REPAIR**  
*Typical Masonry Condition*

Existing brick is a unique buff color in contrast to the ubiquitous red brick in the St. Louis region. Brick of this color tends to be of poorer quality and is not locally sourced. However, the masonry envelope is in good condition with proper joint material and profiling. Brick is clean and devoid of staining on all elevations. No signs of step cracking or spalling which is evidence of larger issues.

Recommendation:  
None.

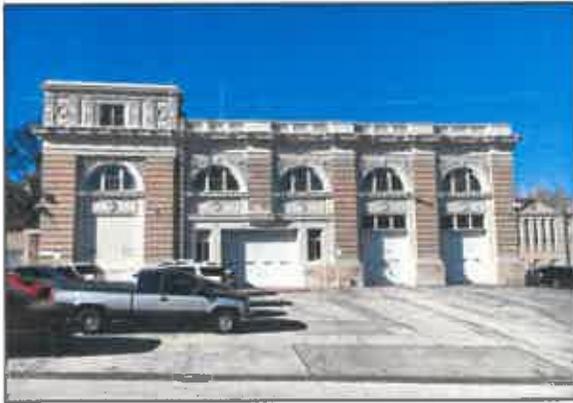
**04.08 MASONRY INFILL**  
*Modified Openings*

All five bays at ground level have been modified in height and or width to accommodate emergency vehicle access. Bays 2 and 3 have been modified to create a single opening that reads as historic but is in fact arbitrary and not historically accurate.

Recommendation: Evaluate future space needs to determine if openings are still needed in the current configuration. If needed, consider more appropriate overhead doors. If not needed, restore openings to original configurations as allowable by program needs.

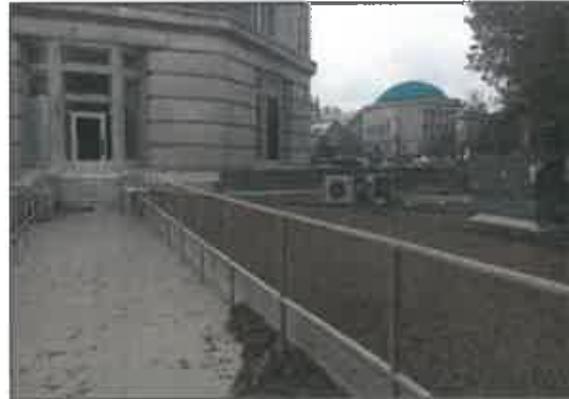
**05.03 DECORATIVE METAL RAILINGS**  
*Inconsistent styling*

Existing rooftop walk railings are utilitarian and not historically sensitive. While no pickets are required per code due to proximity to potential falls, their absence is a potential liability.

Recommendation: Remove and replace with more compatible railing style that limits access to rooftop.

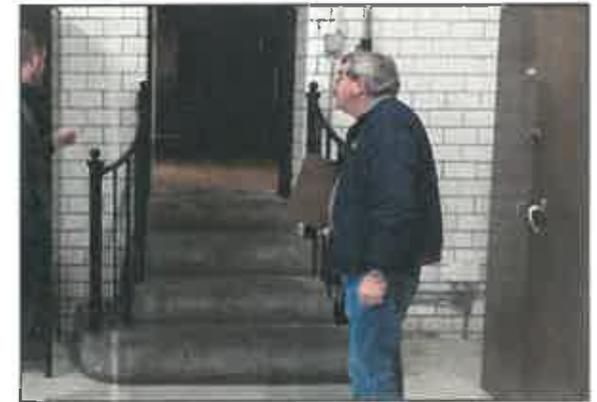
**05.03 DECORATIVE METAL RAILINGS**  
*Non-Code Compliant*

Faux traditional railings are non-code compliant. Handrails do not extend beyond top and bottom-most riser nosing.

Recommendation: Remove and replace railing to meet handrail code requirements.

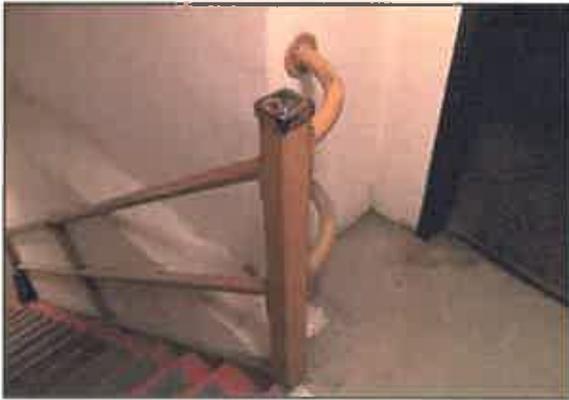
05.03 DECORATIVE METAL RAILINGS  
*Non-ADA Compliant*

Utilitarian railings are non-code compliant. Handrails do not extend beyond top and bottom most riser nosing. Paint loss along length of railing.

Recommendation: Remove and replace railing to meet handrail code requirements.

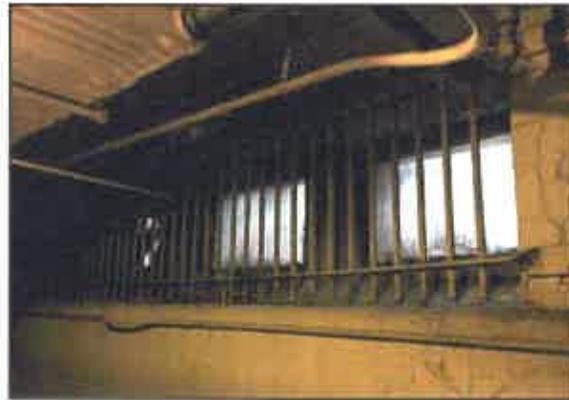
05.03 DECORATIVE METAL RAILINGS  
*Window Security Grille*

Window security grilles limit proper maintenance of windows. Cleanliness in interstitial space and of railings is compromised.

Recommendation: Remove grilles and locate high security threats away from windows.

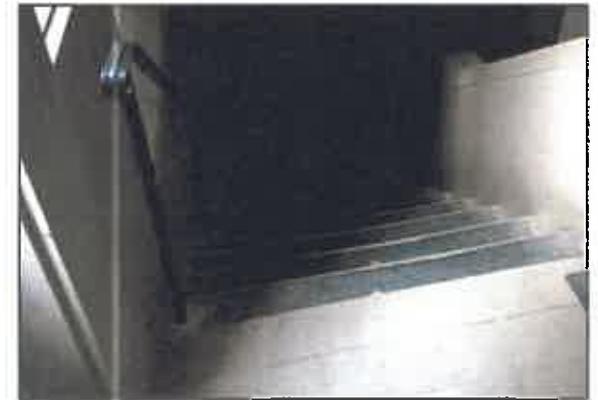
05.03 DECORATIVE METAL RAILINGS  
*Non-ADA Compliant*

Recommendation: Remove and replace railing to meet handrail code requirements.

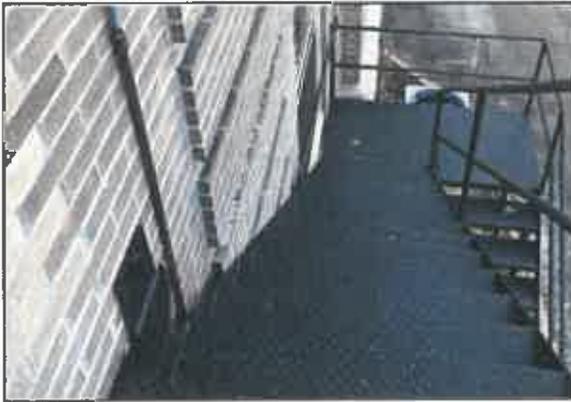
**05.04 METAL STAIR FABRICATIONS**

*Non-Code Compliant*

Recommendation: Remove exterior stair and replace with an interior second means of egress.

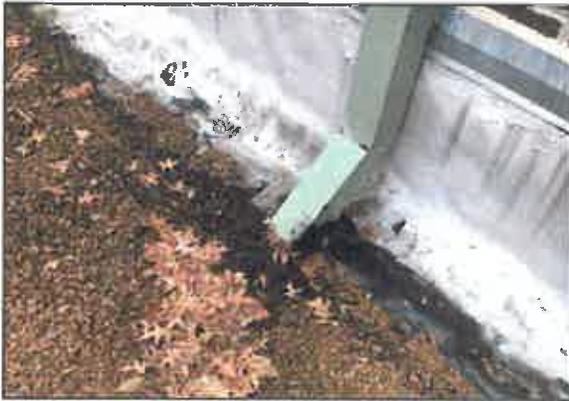
**07.01 GUTTERS & DOWNSPOUTS**  
*Lack of Splashblock*

Recommendation: Provide splashblocks at all downspout locations and reduce water travel distance to drain inlets.

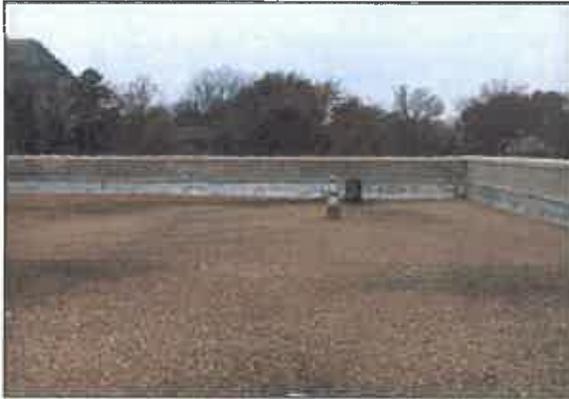
**07.05 WATERPROOF MEMBRANES**  
*Ballasted Roof*

There are no roof walk mats to access rooftop equipment. Ballasted roofs have the propensity for punctures do to walking on the ballast. The roofing technology installed is antiquated and the system installed is near end of service. A new roof may accommodate increased thermal performance over the existing system

Recommendation: Consider new roofing systems with high albedo and or high thermal efficiency. Provide walking mats for rooftop access.

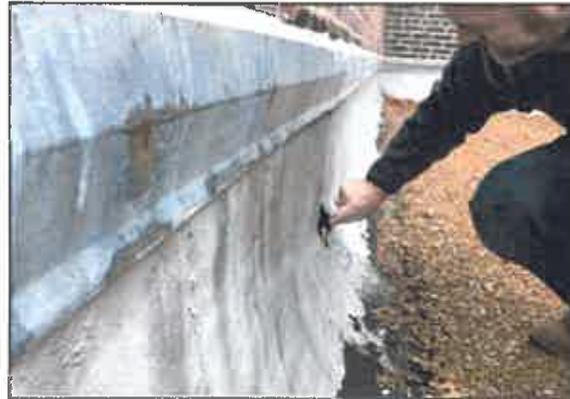
**07.05 WATERPROOF MEMBRANES**  
*Fluid Applied Membrane Damage*

A liquid aluminum coating has been applied to the EPDM roofing substrate at the vertical parapet wall surfaces. This was likely applied in an effort to add longevity or remedy observed deterioration. Several locations were found to be compromised. In some areas the liquid coating had delaminated, in others, the substrate was not suitable for liquid application.

Recommendation: None. The liquid coating is integral to the roofing membrane and will be removed as part of a new roofing system installation.

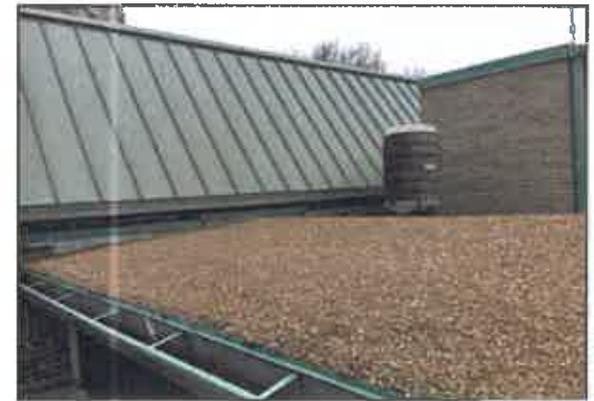
**07.06 METAL ROOFING**  
*Typical Condition*

Metal standing seam roofing is installed over clerestory windows. Roofing is in good condition with no obvious signs of storm damage or leaks. However, roofing obscures metal skylights that are a character defining feature.

Recommendation: Remove metal roofing and restore skylights to original conditions.

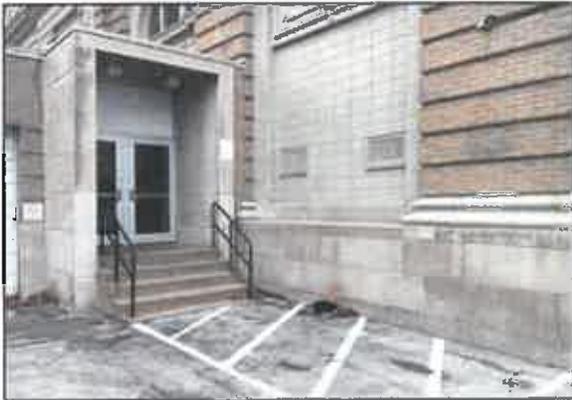
**08.01 HOLLOW METAL DOORS & FRAMES**  
*Historically Inaccurate*

Exterior metal doors, frames. And blind transoms are in good condition. However, anodized aluminum finish is not historically compatible.

Recommendation: Remove and replace with door styles and colors that are more consistent with the color and style of the building.

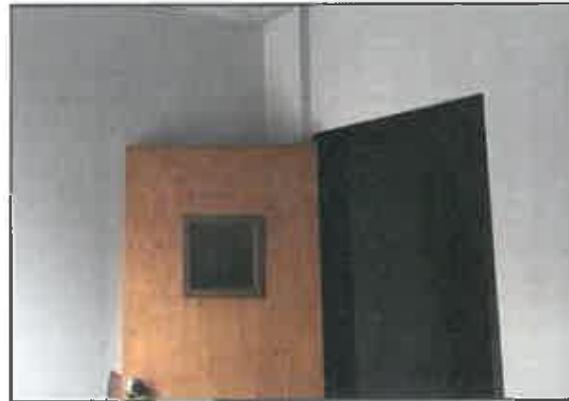
**08.01 INTERIOR HOLLOW METAL DOORS & FRAMES**  
*Typical Condition*

Interior hollow metal frames are functional but utilitarian. Door leaves were inconsistent in both material, style, and finish.

Recommendation: Consider consistent door types and frame types. Reserve current frame and door styles for back of house and/or strictly utilitarian functions.

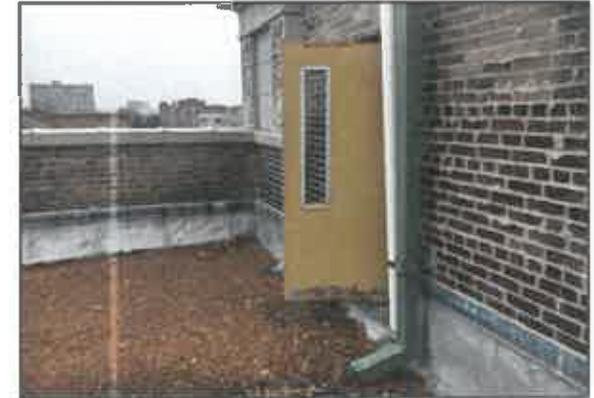
**08.02 EXTERIOR HOLLOW METAL DOORS & FRAMES**  
*Typical Condition*

Exterior hollow metal doors and frames were in poor condition. Many doors did not close properly. Doors and frames had extensive rusting at heads and sills

Recommendation: Remove and replace doors and frames to ensure properly functionality and aesthetic consistency.

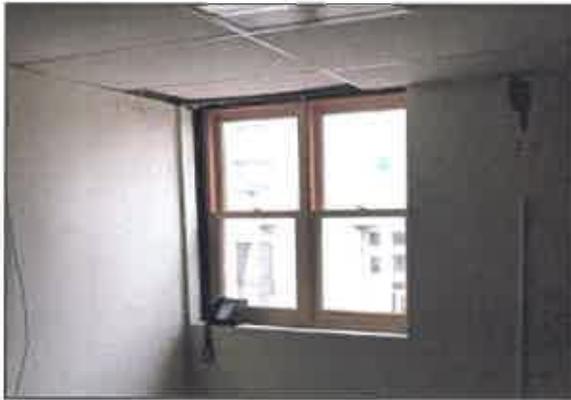
**08.07 WOOD WINDOWS**  
*Typical Condition*

New wood replica windows installed at existing window openings. Infilled windows were not reopened to original configurations. Accuracy of sight lines and profiles undetermined. Energy efficiency undetermined at time of assessment.

Recommendation: Review original windows against new window sight lines and profiles. Review window performance numbers. Reopen all original window openings and remove infill materials.

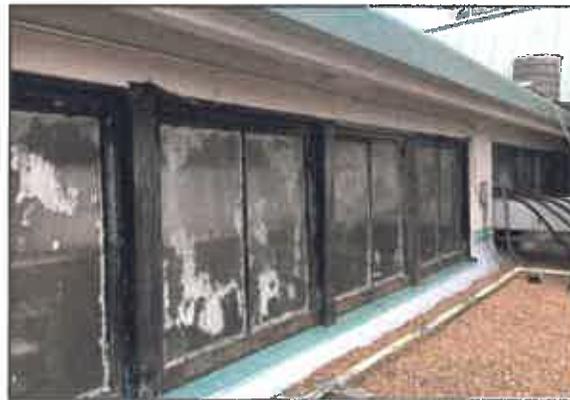
**08.08 STEEL WINDOWS**  
*Rust*

Moderate rust is evident along with single pane glazing units at clerestory windows. These windows are a prominent character defining feature of the second floor space and should be prioritized for restoration and/or replacement back to their original configuration to the extent possible. Windows are in fair condition.

Recommendation: Preference restoration over replacement but consider overall energy performance.

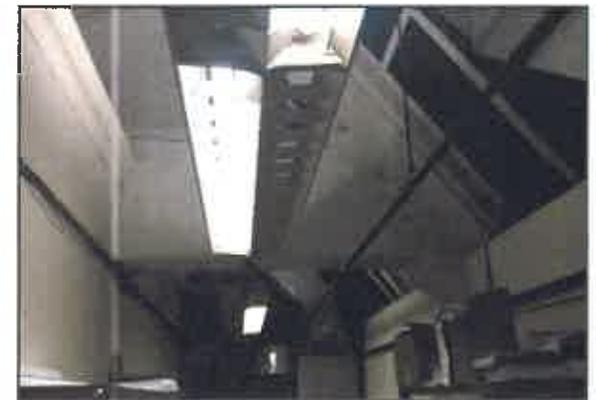
**08.09 METAL-FRAMED SKYLIGHTS**

Metal skylights are a key feature of the existing space that are no longer being used. Glazing units look to be painted opaque. Limited signs of water infiltration at failed sealants/gaskets.

Recommendation: Remove roofing materials. Review existing conditions. Preference restoration over replacement but consider overall energy performance.

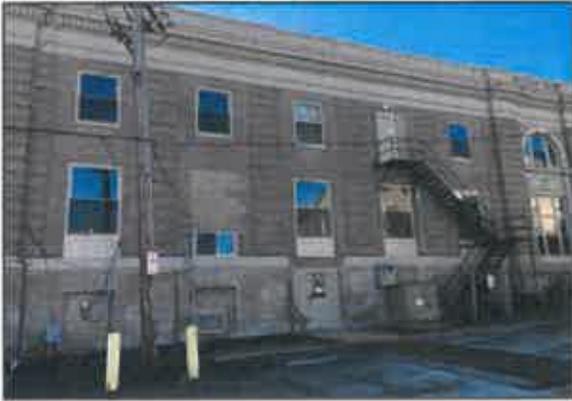
**08.16 WALL VENTS**  
*Inconsistent Size and Finish*

Wall vents create inconsistent openings and create a negative impact on multiple elevations.

**Recommendation:** Remove vents, consolidate, and/or locate vents at rooftop or other discreet location. Consider more aesthetically pleasing vent options where no other placement option is feasible.

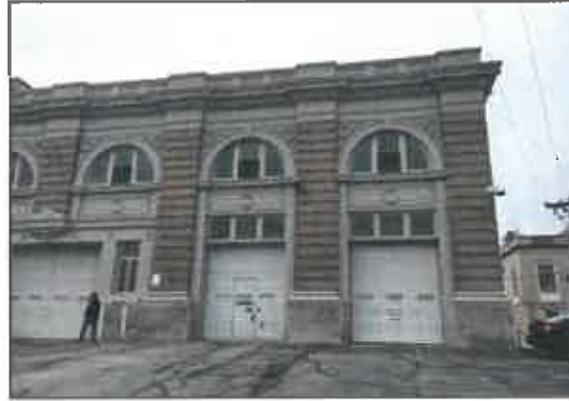
**08.17 OVERHEAD DOOR**  
*Historically Inaccurate*

**Recommendation:** Restore openings to original configuration if possible. Where overhead doors are required, provide insulated, energy efficient options with details more compatible with historic building.

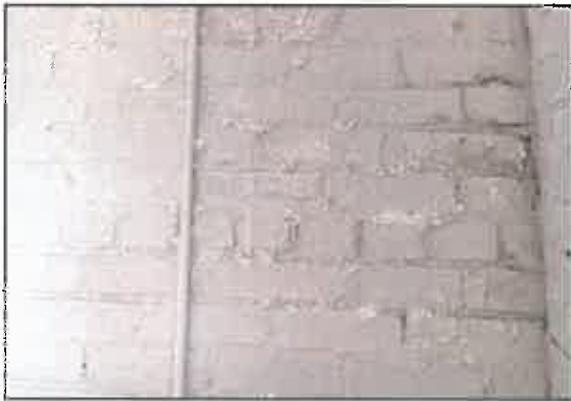
**09.01 PAINT**  
*Exterior Wall Efflorescence*

Paint efflorescence in and of itself is of little consequence especially since walls will be furred out in future work. However, it is indicative of moisture migration through the wall system. Furthermore, existing wall does not meet current R-Values

Recommendation: Review exterior wall conditions to determine if moisture is currently migrating through the wall. Review for structural cracks, open joints, and any sky facing ledges that may be allowing moisture into the wall. Furr out walls with appropriate materials as to not trap moisture within the wall assembly.

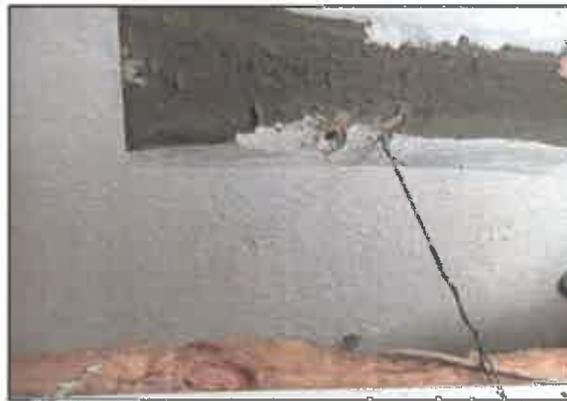
**09.01 PAINT**  
*Peeling Paint*

Peeling paint is not only unsightly but is likely lead based.

Recommendation: See environmental assessment for removal protocol. If no hazardous materials are present, remove paint down to substrate in locations where surface is exposed.

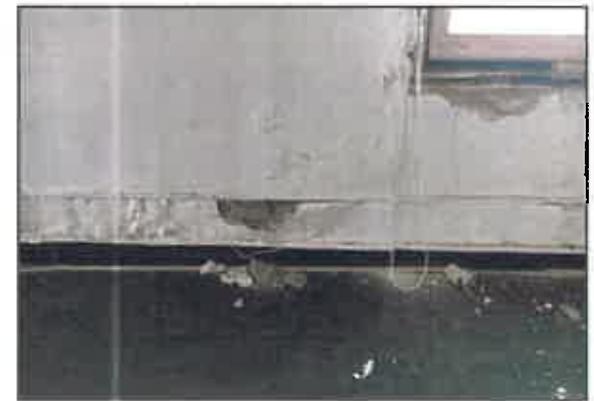
**09.02 GYPSUM PLASTERING**  
*Spalling*

Spalling is indicative of moisture migration through the wall system. Furthermore, existing wall does not meet current R-Values

Recommendation: Review exterior wall conditions to determine if moisture is currently migrating through the wall. Review for structural cracks, open joints, and any sky facing ledges that may be allowing moisture into the wall. Furr out walls with appropriate materials as to not trap moisture within the wall assembly.

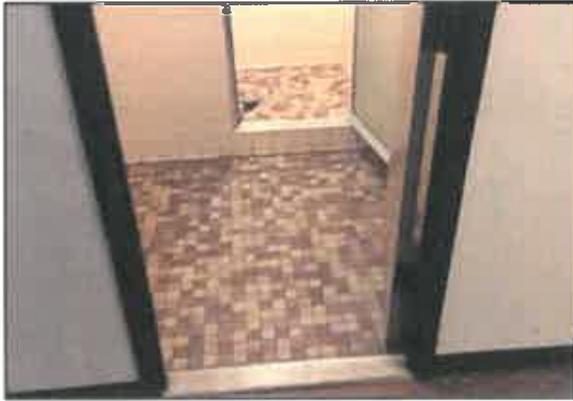
**09.03 CERAMIC TILING**  
*Restroom Conditions*

Mosaic, small format tile was present on floors and 4" square tile was present on the walls of the restrooms. They are functional but have a high proportion of grout joints to solid surface which results in high maintenance requirements and fosters unsanitary restroom environments.

Recommendation: Consider large format tile in colors that demonstrate sanitary conditions.

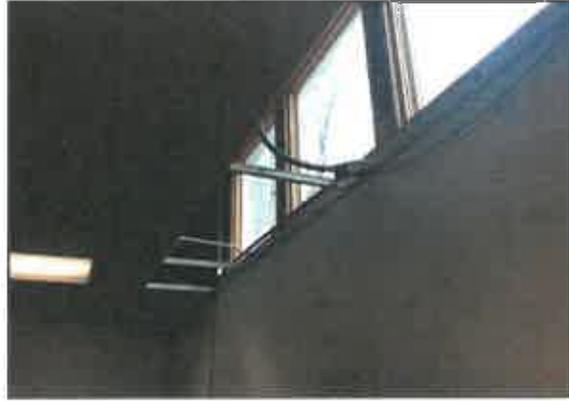
**09.04 ACOUSTICAL TILE CEILINGS**  
*Dropped Ceilings*

Dropped ceilings significantly altered the quality of the spaces especially at the first floor. Most transom level windows were completely concealed above the ceiling plane.

Recommendation: Remove acoustical ceiling tile systems. Consider floating planes and/or ceiling soffits that allow spaces to have access to natural light to the greatest extent possible.

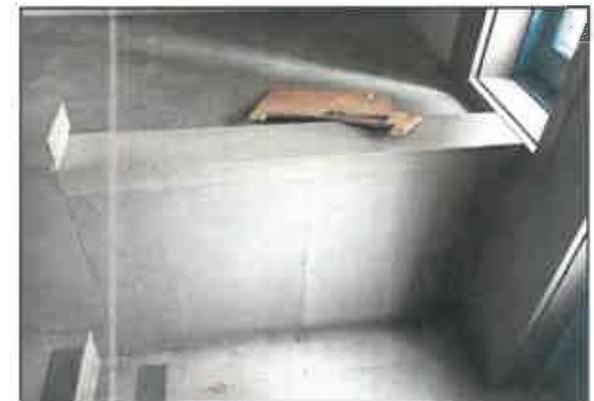
**09.05 STONE FLOORING**  
*Worn Finish*

Stone flooring at the stair landings are in good condition. Some minor staining and loss of finish are evident

Recommendation: Remove stains using the gentlest means necessary and grind as needed to remove deeper scratches and gouges.

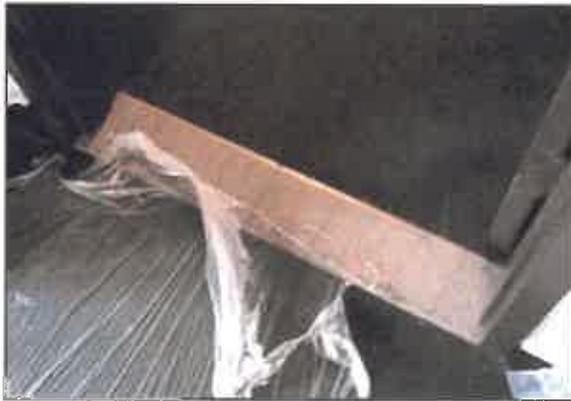
**09.05 STONE FLOORING**  
*Threshold(s)*

Stone thresholds were found in few locations. They are historic and should be preserved in any new flooring application

Recommendation: Maintain in place.

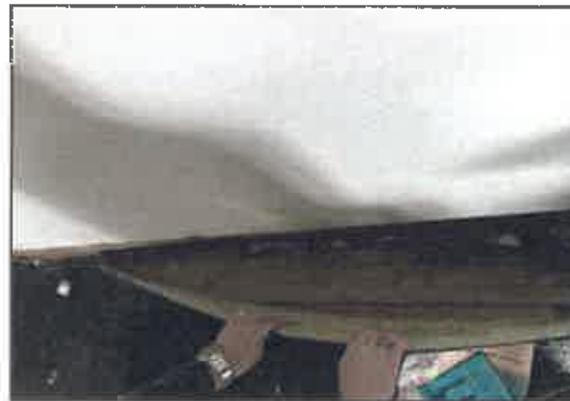
**09.06 WOOD FLOORING**  
*Concealment*

Original wood flooring was found in multiple locations below vct and carpet. Original flooring materials are important contributors to the quality of historic spaces.

Recommendation: Remove flooring materials concealing wood floors. Evaluate condition of wood flooring and identify areas where wood could be exposed in new spaces.

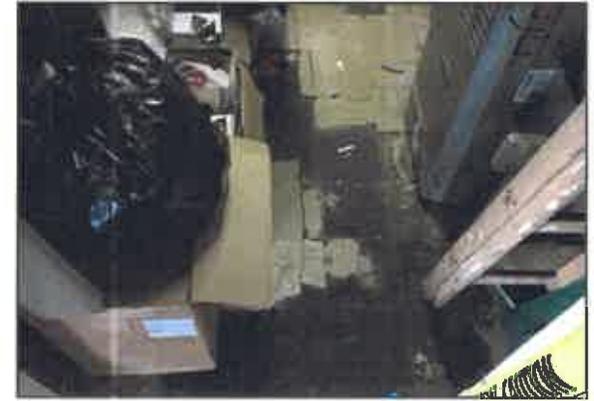
**09.08 RESILIENT FLOORING**  
*Multiple Plys*

Recommendation: Remove existing floor finished down to structural deck or historic flooring, whichever comes first.

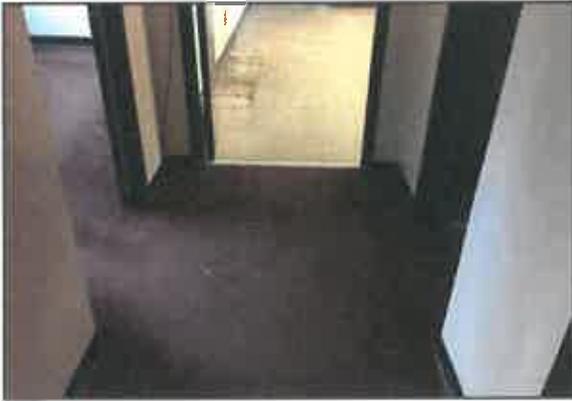
**09.11 SHEET CARPETING**  
*Stained/Crushed Pile*

Existing carpets are beyond their useful life. Widespread staining and crushed pile were observed in most spaces.

**Recommendation:** Remove all carpeting. Consider carpet tiles and/or more durable flooring materials that require less maintenance, have more longevity, and could be replaced in part as needed when damaged beyond repair.

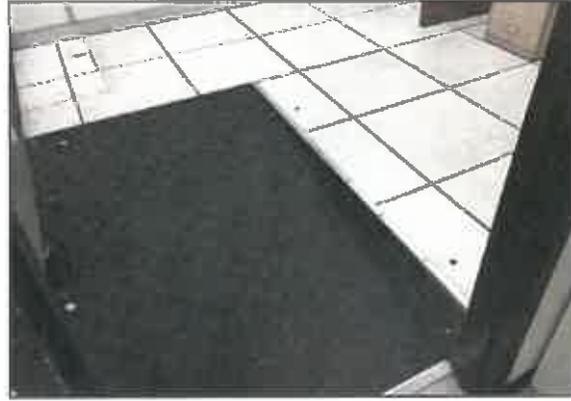
**09.14 RAISED FLOOR**  
*General Condition*

The raised floor system is highly specialized and likely is not suitable for reuse in the new program.

**Recommendation:** Remove flooring system.

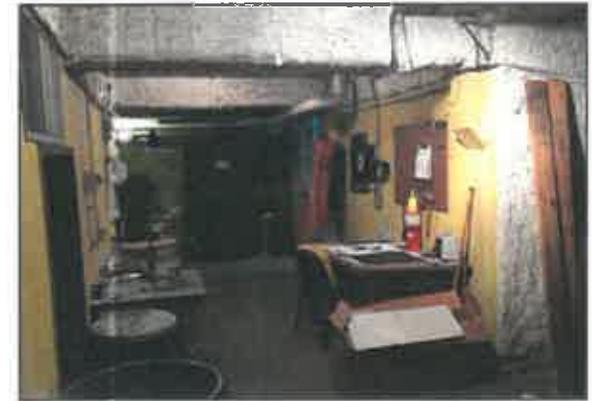
**09.15 ACOUSTIC COATING**  
*General Condition*

Acoustic coatings are present on many wall and ceiling surfaces. This sound mitigation material is antiquated and the firing range is not currently master planned for the same location. Lastly, the material is porous which presents two additional concerns in that cleanliness cannot be maintained and lead dust is captured which is a significant health risk. See environmental reports for additional hazardous material information.

**Recommendation:** Remove all acoustic coating in keeping with hazardous material removal protocol.

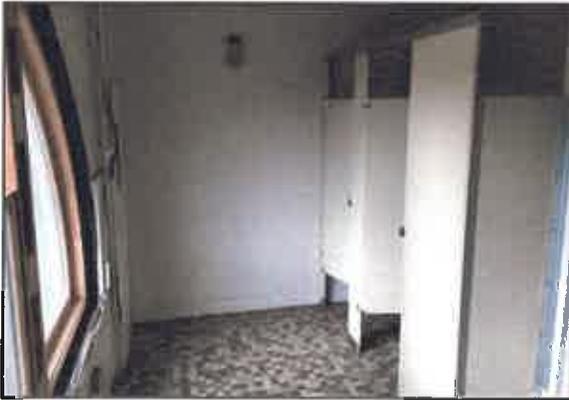
**10.04 TOILET COMPARTMENTS**  
*Non-ADA compliant*

Current toilet compartments are in fair condition. New restroom layouts will not match existing in size or layout. In addition, current compartments are floor mounted and make housekeeping difficult and have shorter lifespan due to contact with wet surfaces.

Recommendation: Dispose of toilet compartments.

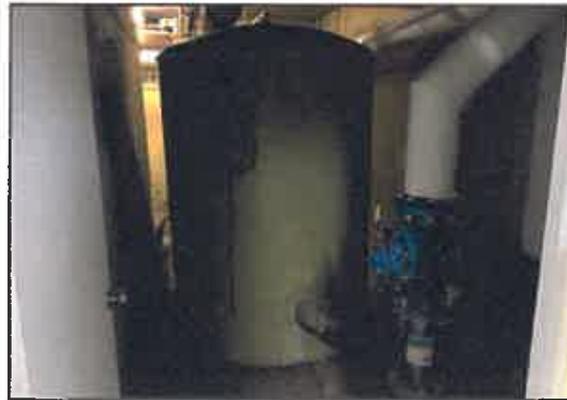
**11.01 Water Reservoir**  
*General Condition*

A single hot water source is inefficient and not needed in future uses. See environmental report for any additional hazardous material information associated with tank piping or room finishes.

Recommendation: Remove tank and consider point source hot water for future needs.

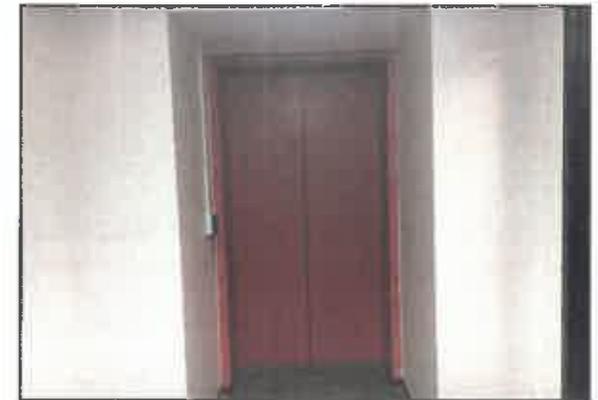
**14.01 ELEVATOR**  
*General Condition*

Recommendation: Review future circulation paths and consider all users when establishing best location for vertical circulation. Consider locations which minimize impact to historic building materials as designated in attached preservation plans.

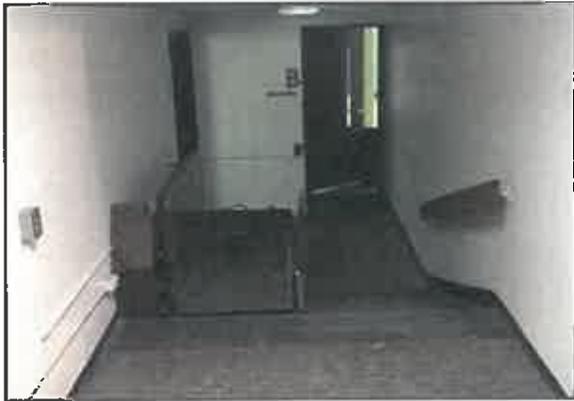
**14.01 ELEVATOR**  
*Lift General Condition*

Lift requires power and maintenance and limits space for circulation. While still functional, modern lifts have additional safety components that better ensure safe operation

Recommendation: Remove lift. Consider ramp and stair combinations that afford all users a similar experience, limits energy consumption, and reduces maintenance needs. Provide new lift(s) only where ramps are not feasible.

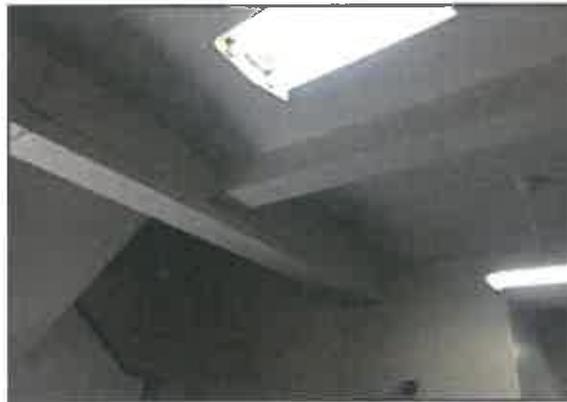
**26.01 INTERIOR LIGHTING**  
*General Condition*

Recommendation: Dispose lighting in accordance with hazardous material protocol. Consider light fixtures are compatible with the architecture of the building and are "smart" (photo sensors, occupancy sensors, etc.)

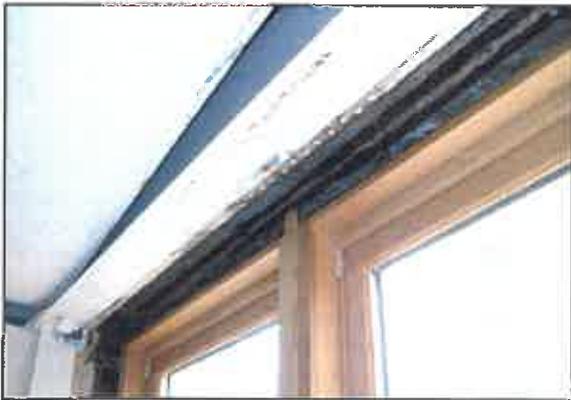
**03.03 RUSTED REBAR AT WINDOW LINTELS**  
*Natural Seams*

Lintels consist of reinforced concrete. Moisture damage has saturated the concrete in the past and has caused the reinforcing steel to rust and expand, resulting in spalled concrete. Exposed conditions exist on the third-floor south elevation on the west side. Other latent but not visible conditions could exist at other locations with flat window heads.

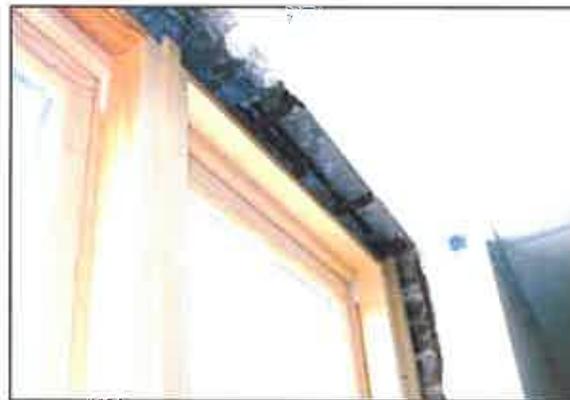
**03.03 RUSTED REBAR AT WINDOW LINTELS**  
*Freeze-Thaw Damage*

Lintels consist of reinforced concrete. Moisture damage has saturated the concrete in the past and has caused the reinforcing steel to rust and expand, resulting in spalled concrete. Exposed conditions exist on the third-floor south elevation on the west side. Other latent but not visible conditions could exist at other locations with flat window heads.

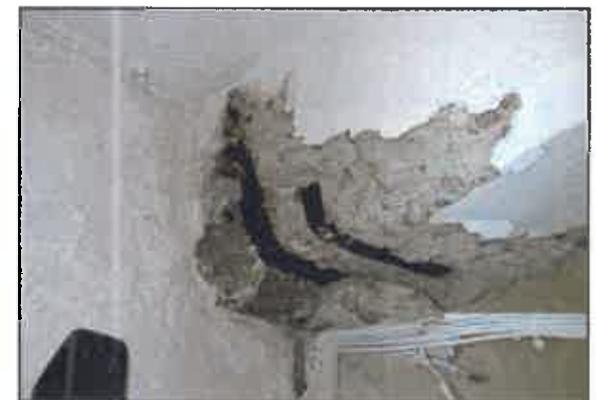
**03.03 SPALLED CONCRETE AT ROOF BEAM**  
*Overload Condition*

The roof construction consists of reinforced concrete slabs and beams. Moisture damage has saturated the concrete beams at beam pockets in the past and has caused the reinforcing steel to rust and expand, resulting in spalled concrete. Exposed conditions exist on the roof east elevation towards the center of the building as viewed from the second floor at two locations.

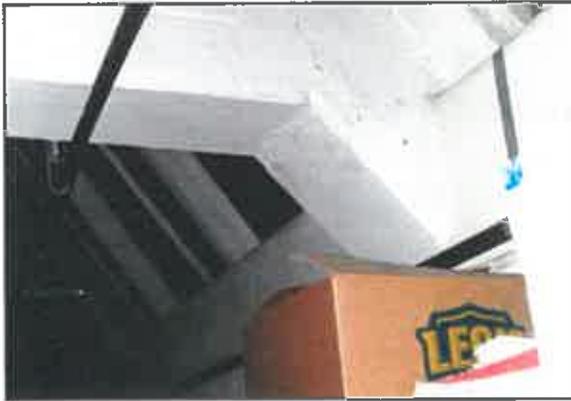
**03.03 CRACKS IN MAIN ROOF BEAMS AT MONITOR**  
Cracking

The monitor roof construction appears to consist of a system of reinforced concrete slabs and beams. The ends of the main concrete roof beams have cracks, that could be shear cracks. We recommend that the construction type and cause of cracks be investigated to determine the cause and degree of concern.

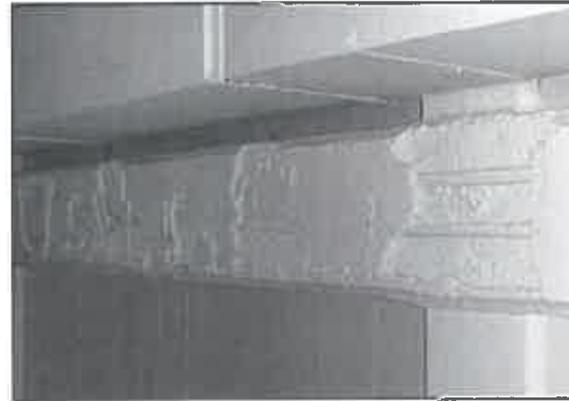
**03.03 SPALLED CONCRETE COVER AT ROOF BEAM**  
Spalling

The roof construction consists of reinforced concrete slabs and beams. At select interior roof beams (as viewed from the second floor), the concrete cover on the bottom of the beams has spalled, exposing reinforcing steel. This lack of concrete cover does not provide an adequate fire rating for the beams.

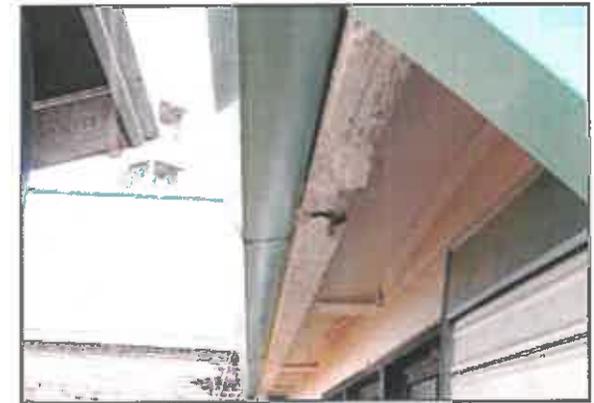
**03.03 SPALLED CONCRETE COVER AT MONITOR ROOF**  
Spalling

The monitor roof construction consists of reinforced concrete. Concrete has spalled at the gutter line exposing the reinforcing steel bars to the elements. Long term exposure will cause deterioration to the reinforcing steel.

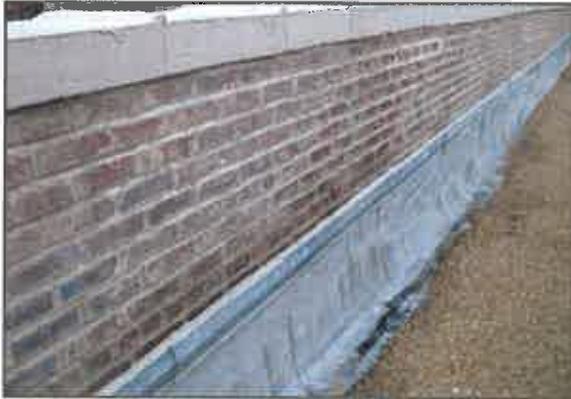
04.03 POINTING AT PARAPET

The masonry facade was re-pointed 2 to 3 years ago. In general, the masonry pointing is in very good condition, as the back side of the parapets show. The condition of the exterior masonry facade for the entire building is very good.

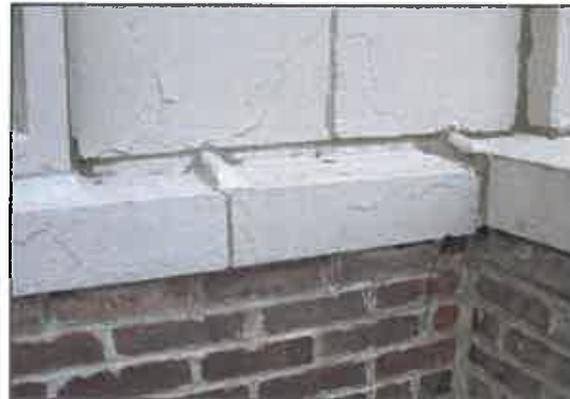
04.03 POINTING AT THIRD FLOOR CORNICE

The masonry facade was re-pointed 2 to 3 years ago. In general, the masonry pointing is in very good condition, as the north side of the third-floor cornice shows. The terracotta on the building appears to have also been painted and sealed. The condition of the exterior masonry facade for the entire building is very good.

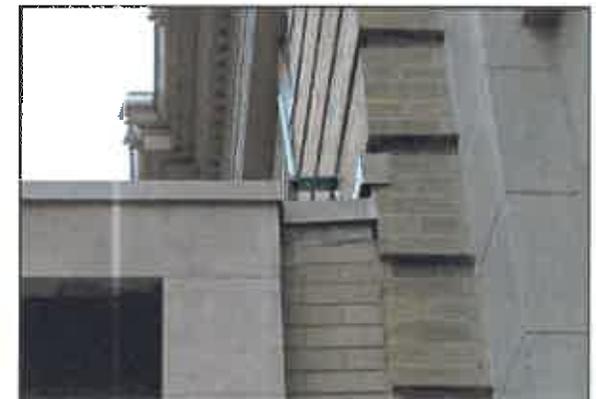
04.03 LOOSE BRICK AT GARAGE  
*Overload Condition*

Brick at the junction of the garage and main building at the roof line on the east elevation is dislodged and likely loose. It is likely that the masonry restoration contractor did not remove and reset the brick 2 to 3 years ago to avoid tampering with the roofing membrane. Open joints can allow water intrusion and resulting freeze-thaw damage to surrounding masonry.

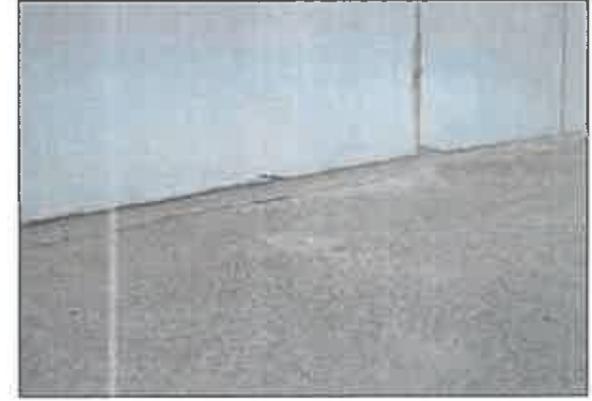
**04.03 CRACKED RE-POINTING MORTAR & SPALLING PAINT AT TERRACOTTA**  
*Spalling*

The masonry facade was re-pointed and terracotta painted and sealed 2 to 3 years ago during the masonry restoration project. The re-pointing mortar is starting to crack and paint starting to peel at localized locations on the water table on the east elevation. The condition shown occurs randomly around the building. The cracked mortar and peeling paint will continue to crack, spall and peel allowing moisture infiltration inside the mortar joints and into the terracotta eventually causing freeze-thaw damage.

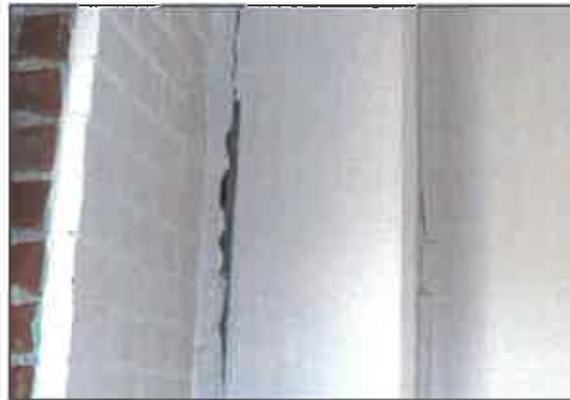
04.20 NORTH WALL SEPARATION AT COLUMN

The north exterior masonry wall was added to the structure when the northern portion of the building was demolished from fire damage. The wall sits outside the concrete frame at this elevation. The wall has separated from the concrete frame at certain locations, primarily on the middle of the elevation. This is likely from expansion/contraction from temperature changes and possibly moisture infiltration. It is not known whether the masonry facade was anchored to the concrete frame when constructed. We suggest that an investigation be performed on any facade anchorage, and the wall be anchored to the concrete frame if it does not exist, or if it is found to be inadequate.

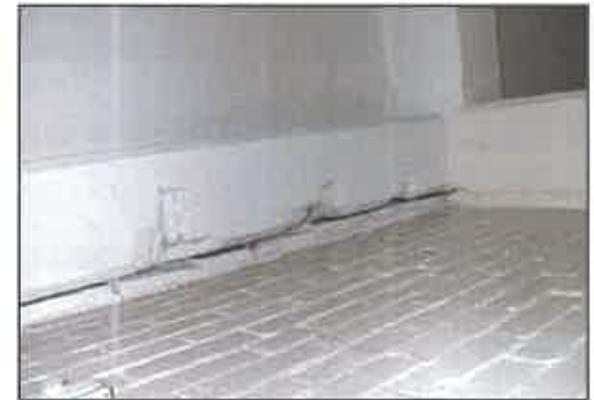
04.20 NORTH WALL GAP AT FLOOR BEAM

The north exterior masonry wall was added to the structure when the northern portion of the building was demolished from fire damage. The wall sits outside the concrete frame at this elevation. The wall has separated from the concrete frame at certain locations, primarily on the middle of the elevation. This is likely from expansion contraction from temperature changes and possibly moisture infiltration. It is not known whether the masonry facade was anchored to the concrete frame when constructed. We suggest that an investigation be performed on any facade anchorage, and the wall be anchored to the concrete frame if it does not exist, or if it is found to be inadequate.

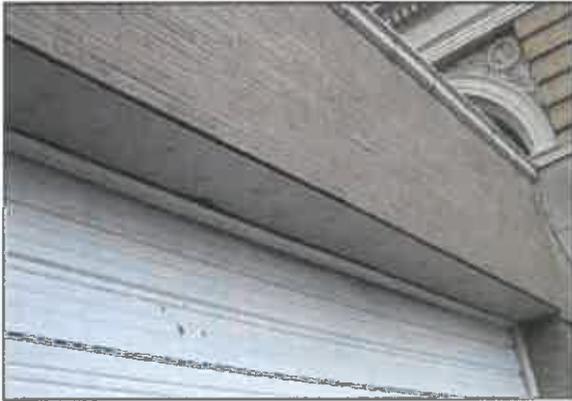
05.12 STEEL LINTEL AT GARAGE DOOR

There is no caulking above the garage door lintel on the east elevation. Water can accumulate in the gap between the masonry and steel lintel, eventually causing rust and deterioration to the steel lintel.

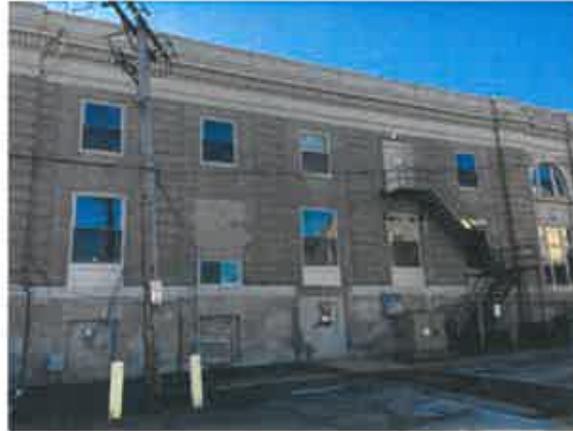
05.52 STEEL FIRE ESCAPE RAILING

The railing at the steel fire escape on the north elevation does not appear to meet building code requirements. Other structural members such as plate stringers and posts appear to be undersized based on current code requirements. Also, the egress route is not covered. We suggest that an architectural and structural review be undertaken to determine the adequacy of the fire escape, and that it be upgraded or replaced as required.

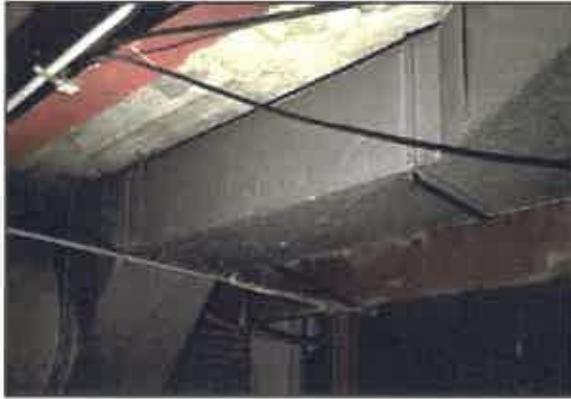
**23.01 POWER VENTILATORS**  
*Insufficient*

Exhaust systems appear to not have proper protection from outside air infiltrating into the building. The exhaust fan located in the old Fire house basement that is causing the ductwork to fill with unconditioned air. The temperature difference between the unconditioned air and the conditioned interior space is causing condensate to form and leak into the conditioned space.

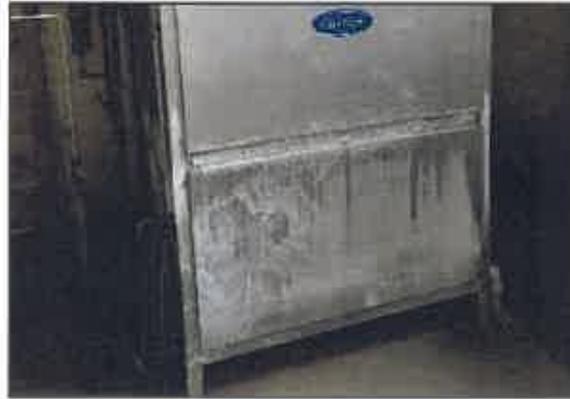
**23.03 VENTILATION RATES**  
*Age and Inefficient*

There are only two units within the building that appear to be bringing in ventilation air to the building. There is a rooftop unit serving the second floor of the firehouse and an air handling unit serving the first floor police station. The building is not meeting current codes for ventilation rates.

This equipment was manufactured around 2006 and the average life expectancy of this equipment is 15-20 years.

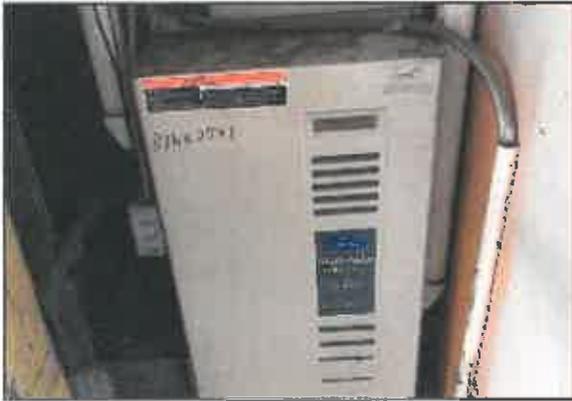
#### 23.04 RESIDENTIAL SPLIT SYSTEMS

The remainder of the building is served with residential split systems with DX cooling and natural Gas heating. These systems are not equipped to overcome any humidity issues with a space.

The date of manufacture for the residential splits is unknown. The average life expectancy of this equipment is 10-15 years.

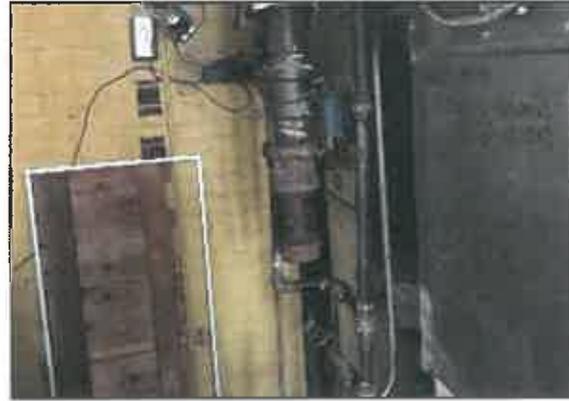
#### 23.05 MECHANICAL PIPING

Existing mechanical piping appears to be leaking near the air handler on the first floor.

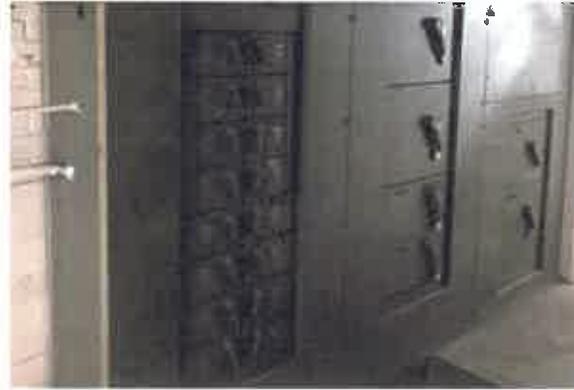
26.02 MAIN SWITCHBOARD  
*Inoperable*

The main electrical switchboard is located in a basement hallway against the north exterior wall. It is a Federal Pacific QMQB switchboard, 1600 amps, 120/208, 3-phase, 4-wire. The switchboard is likely adequately sized to service the building for any major renovation project, but it is not reusable for two reasons. Firstly, the switchboard has exceeded what is considered to be its useful life of 20-25 years, and it could experience catastrophic failure at any time. Secondly, replacement parts are no longer manufactured for this switchboard. Any renovation project would undoubtedly require a different configuration of switches. For these reasons, a new service entrance switchboard would be required as part of any upgrades to the facility. Additionally, we would recommend choosing a different location for the building's main distribution switchgear. The current location makes for difficult distribution of electrical feeders to different areas of the building.

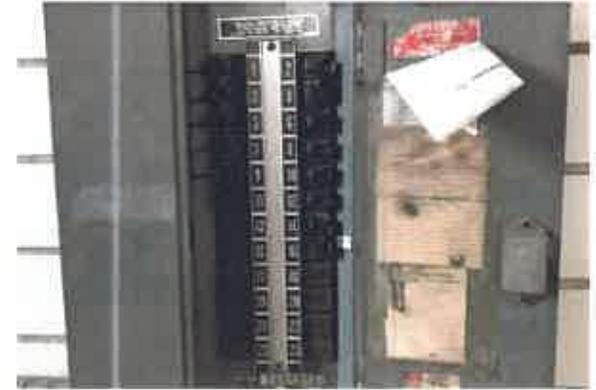
26.03 SUB PANELS  
*Inoperable*

Existing panelboards in the facility are also outdated and have exceeded their useful life, with new parts no longer manufactured. Multiple manufacturers of panelboards were observed including Frank Adams and Federal Pacific. Certain subpanels were observed to be single-phase, 3-wire. Others were observed to be inadequately sized for the areas they serve.

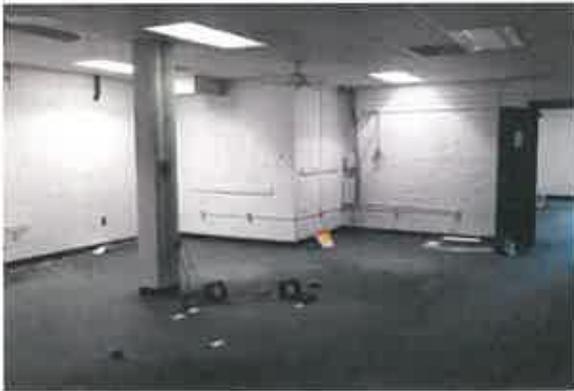
26.04 LIGHTING

In general, existing interior lighting consists of fluorescent lights with local light switches. The lighting is outdated, inefficient and prone to failure. The existing lighting would not be reused in any improvements to the facility.

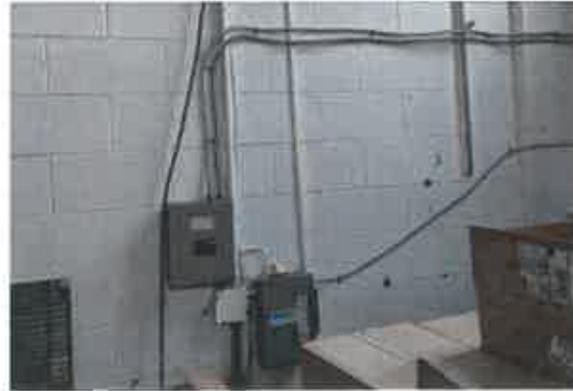
26.05 BRANCH POWER

No exposed wiring was observed. In general, exposed branch circuits were installed in conduit or in MC cable. From casual field investigation, it was unclear whether the existing branch circuits are properly grounded.

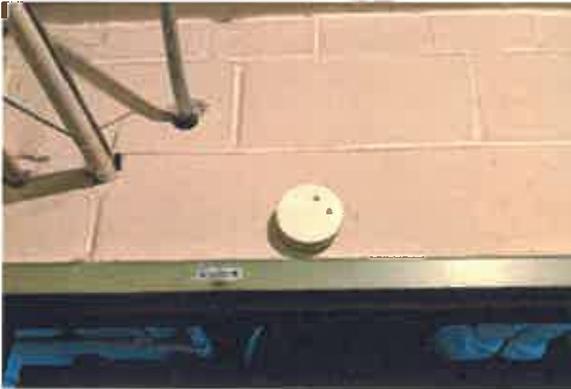
**28.01 ELECTRONIC SAFETY & SECURITY**  
*Fire Alarms*

A fire alarm system was not observed. Battery operated smoke detectors were present in certain areas. Any improvements to the facility would require the installation of a new fire alarm system. Ideally, the fire alarm system would be connected and/or integrated with the fire alarm systems of the connected structures and the University Police building to the north.

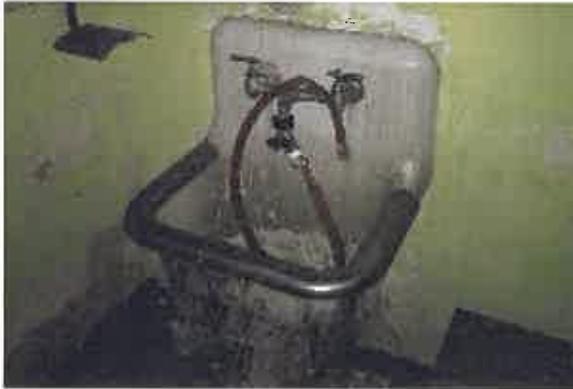
**22.01 PLUMBING FIXTURES**  
*Fire Alarms*

Several existing fixtures have been removed from the building. It is unclear as to why they were removed, however several spots indicate water damage near the area. Many fixtures have sat with stagnant water and are starting to show signs of damage. Many fixtures will require replacement.

The current plumbing fixtures do not meet current ADA guidelines for required clearances and protection. Current fixtures in public restrooms have mostly manual operations and are higher flow fixtures that use more water and are less efficient.
