**CITY HALL ANNEX - FACILITY ASSESSMENT REPORT**

PREPARED FOR UNIVERSITY CITY  
PREPARED BY TRIVERS  
2019.08.07

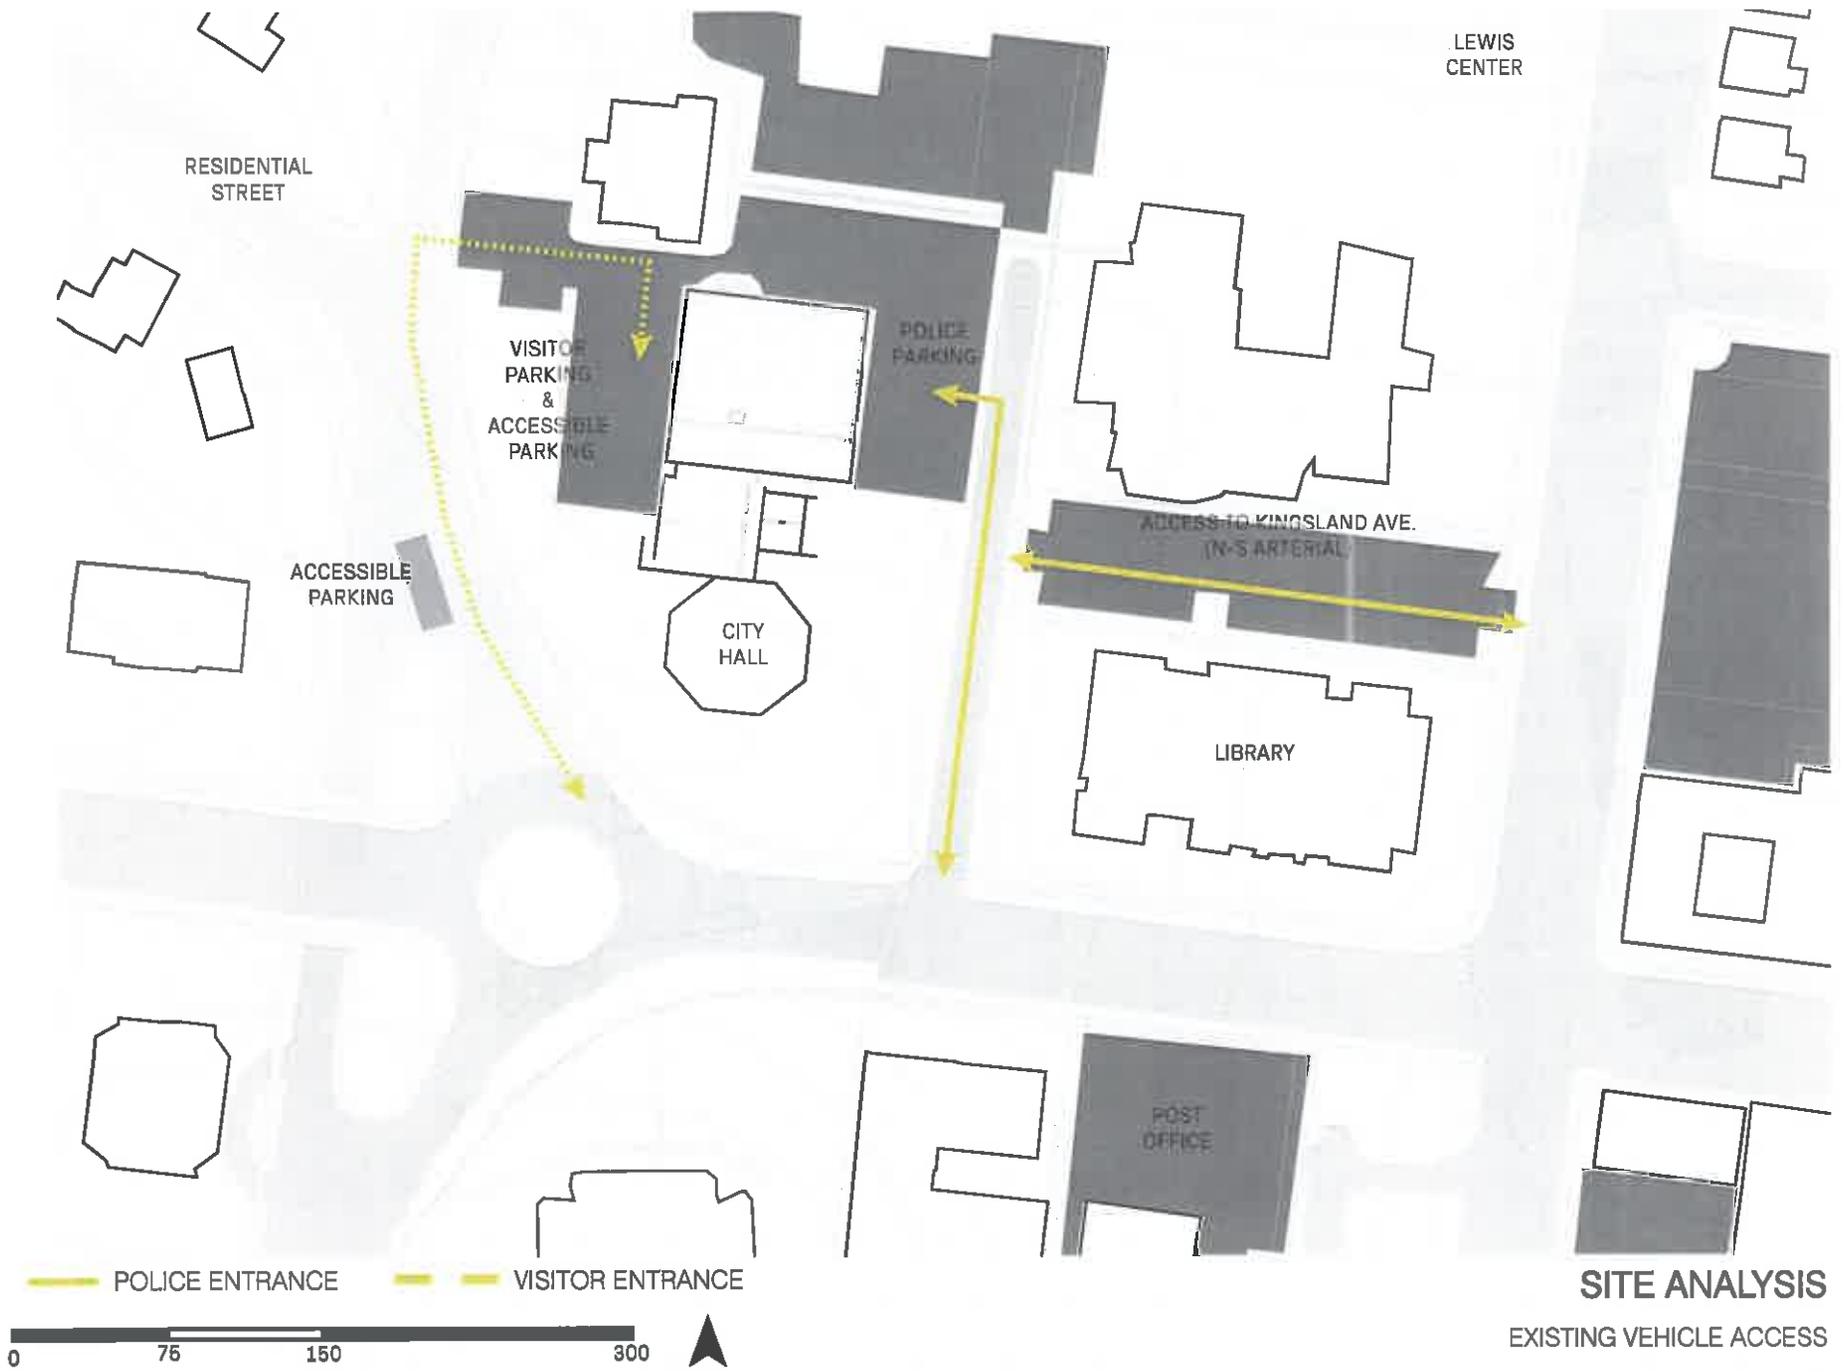
SUMMARY OF EXISTING CONDITIONS

1. High traffic volume on residential street.
2. Hidden and remote accessible entrance.
3. Dead end street limits police mobility.
4. Back of house program elements occur at primary elevation.
5. Library parking lot functions as short cut between Kingsland Ave and Sgt Mike King Dr.

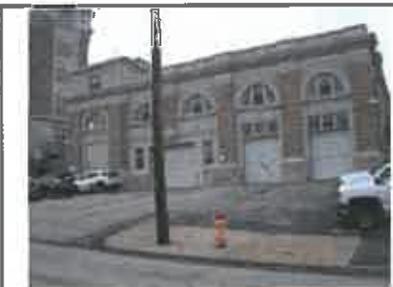
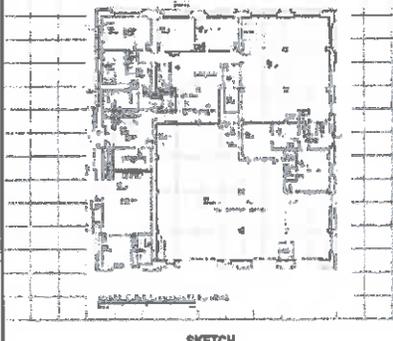
**Rapid Visual Screening of Buildings for Potential Seismic Hazards**  
**FEMA 154 Data Collection Form**

**COMMENTS:**  
 Interior is a reinforced concrete gravity frame structure with reinforced concrete barrel arch slabs. Exterior walls are URM bearing walls on three sides. The north URM wall is not an in-fill wall, and is outside the gravity frame, thus it is not a shear wall and creates torsion in the lateral system. The parapet h>2.5, therefore requires bracing.  
 The ground floor has been modified over time. The floor in the truck garage area was lowered and consists of a one-way reinforced concrete slab supported by steel beams/columns. Other areas were replaced with what appears to be the one-way reinforced concrete slabs and beams with some new concrete columns and footings. Some smaller areas of the ground floor are original construction.
