AGENDA
COMMISSION ON STORM WATER ISSUES MEETING
HEMAN PARK COMMUNITY CENTER
975 PENNSYLVANIA
Tuesday, March 7, 2023,
6:30 PM

Draft: MINUTES OF THE STORMWATER COMMISSION
February 7, 2023

TO: Darren Girdler, Director of Public Works
 Mirela Celaj, CFM, Assistant Director of Public Works
 FROM: Stormwater Master Plan Team (HR Green and Reitz & Jens)
 SUBJECT: University City Stormwater Master Plan
Public versus Private – Recommended Definition Scope of work Task 2.2
 DATE: February 28, 2023

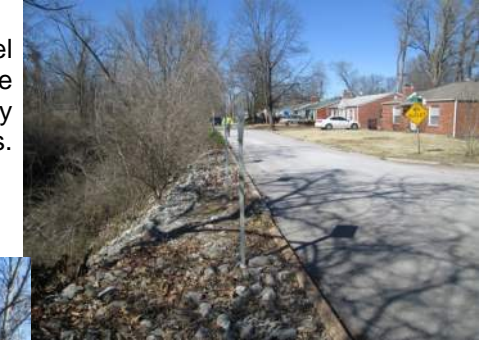
Over-steepened channel banks threaten Mona Drive which provides the only access to 6 houses.

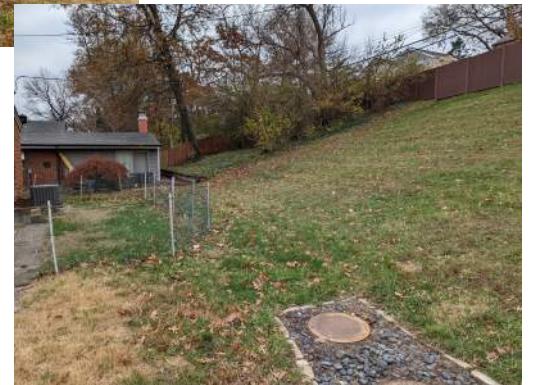
Looking east towards the backyards of two homes; 7832 Balson Ave is the house with the fence and 7828 Balson Ave is the house with the retaining wall.

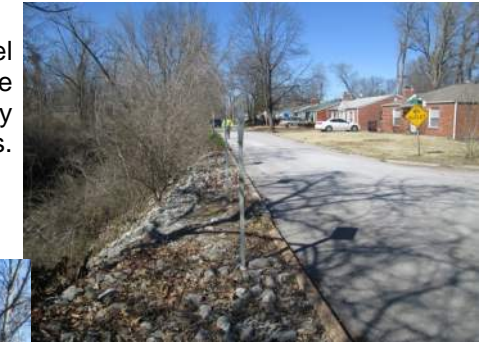
Over-steepened channel banks threaten Mona Drive which provides the only access to 6 houses.

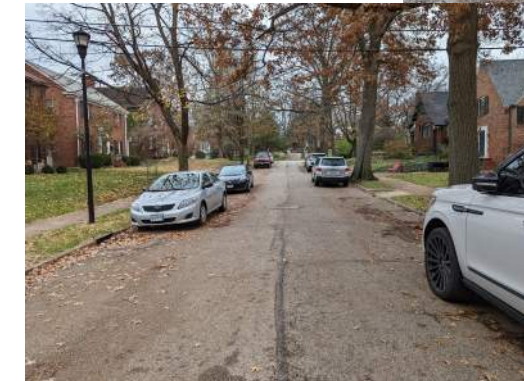
Looking south towards the inlets in front of #414 and 415. Both of these inlets are grated with a side intake.
