AGENDA
COMMISSION ON STORM WATER ISSUES
SPECIAL MEETING
HEMAN PARK COMMUNITY CENTER
975 PENNSYLVANIA
Tuesday, April 18, 2023,
3:00 PM

TO: City of University City
FROM: Stormwater Management Plan Team
SUBJECT: University City Stormwater Master Plan – *Prioritization Method* Scope of work Task 2.1
DATE: August 25, 2022

TO: Darren Girdler, Director of Public Works
 Mirela Celaj, CFM, Assistant Director of Public Works
 FROM: Stormwater Master Plan Team (HR Green and Reitz & Jens)
 SUBJECT: University City Stormwater Master Plan
Public versus Private – Recommended Definition Scope of work Task 2.2
 DATE: February 28, 2023

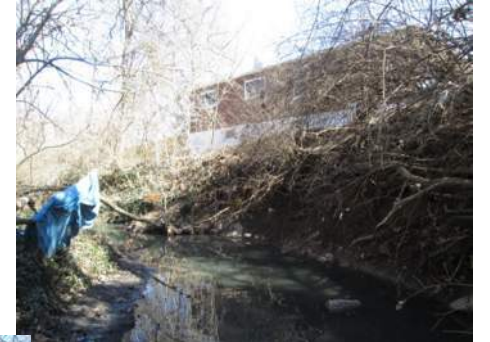
The 13-foot high eroding bank at 7591 Amherst is 20 feet from the home (measured from the toe of bank), and has not advanced significantly since 2006, but is considered severe by MSD's bank erosion rating (V/H=1.46). The July 26, 2022 flood was above the basement floor of 7591 Amherst and collapsed their fence.

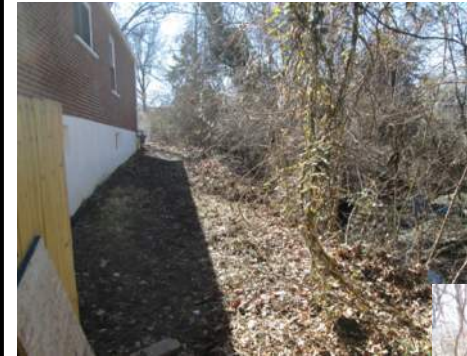
The 13-foot high eroding bank at 7591 Amherst is 9 feet from the home (measured from the top of bank).

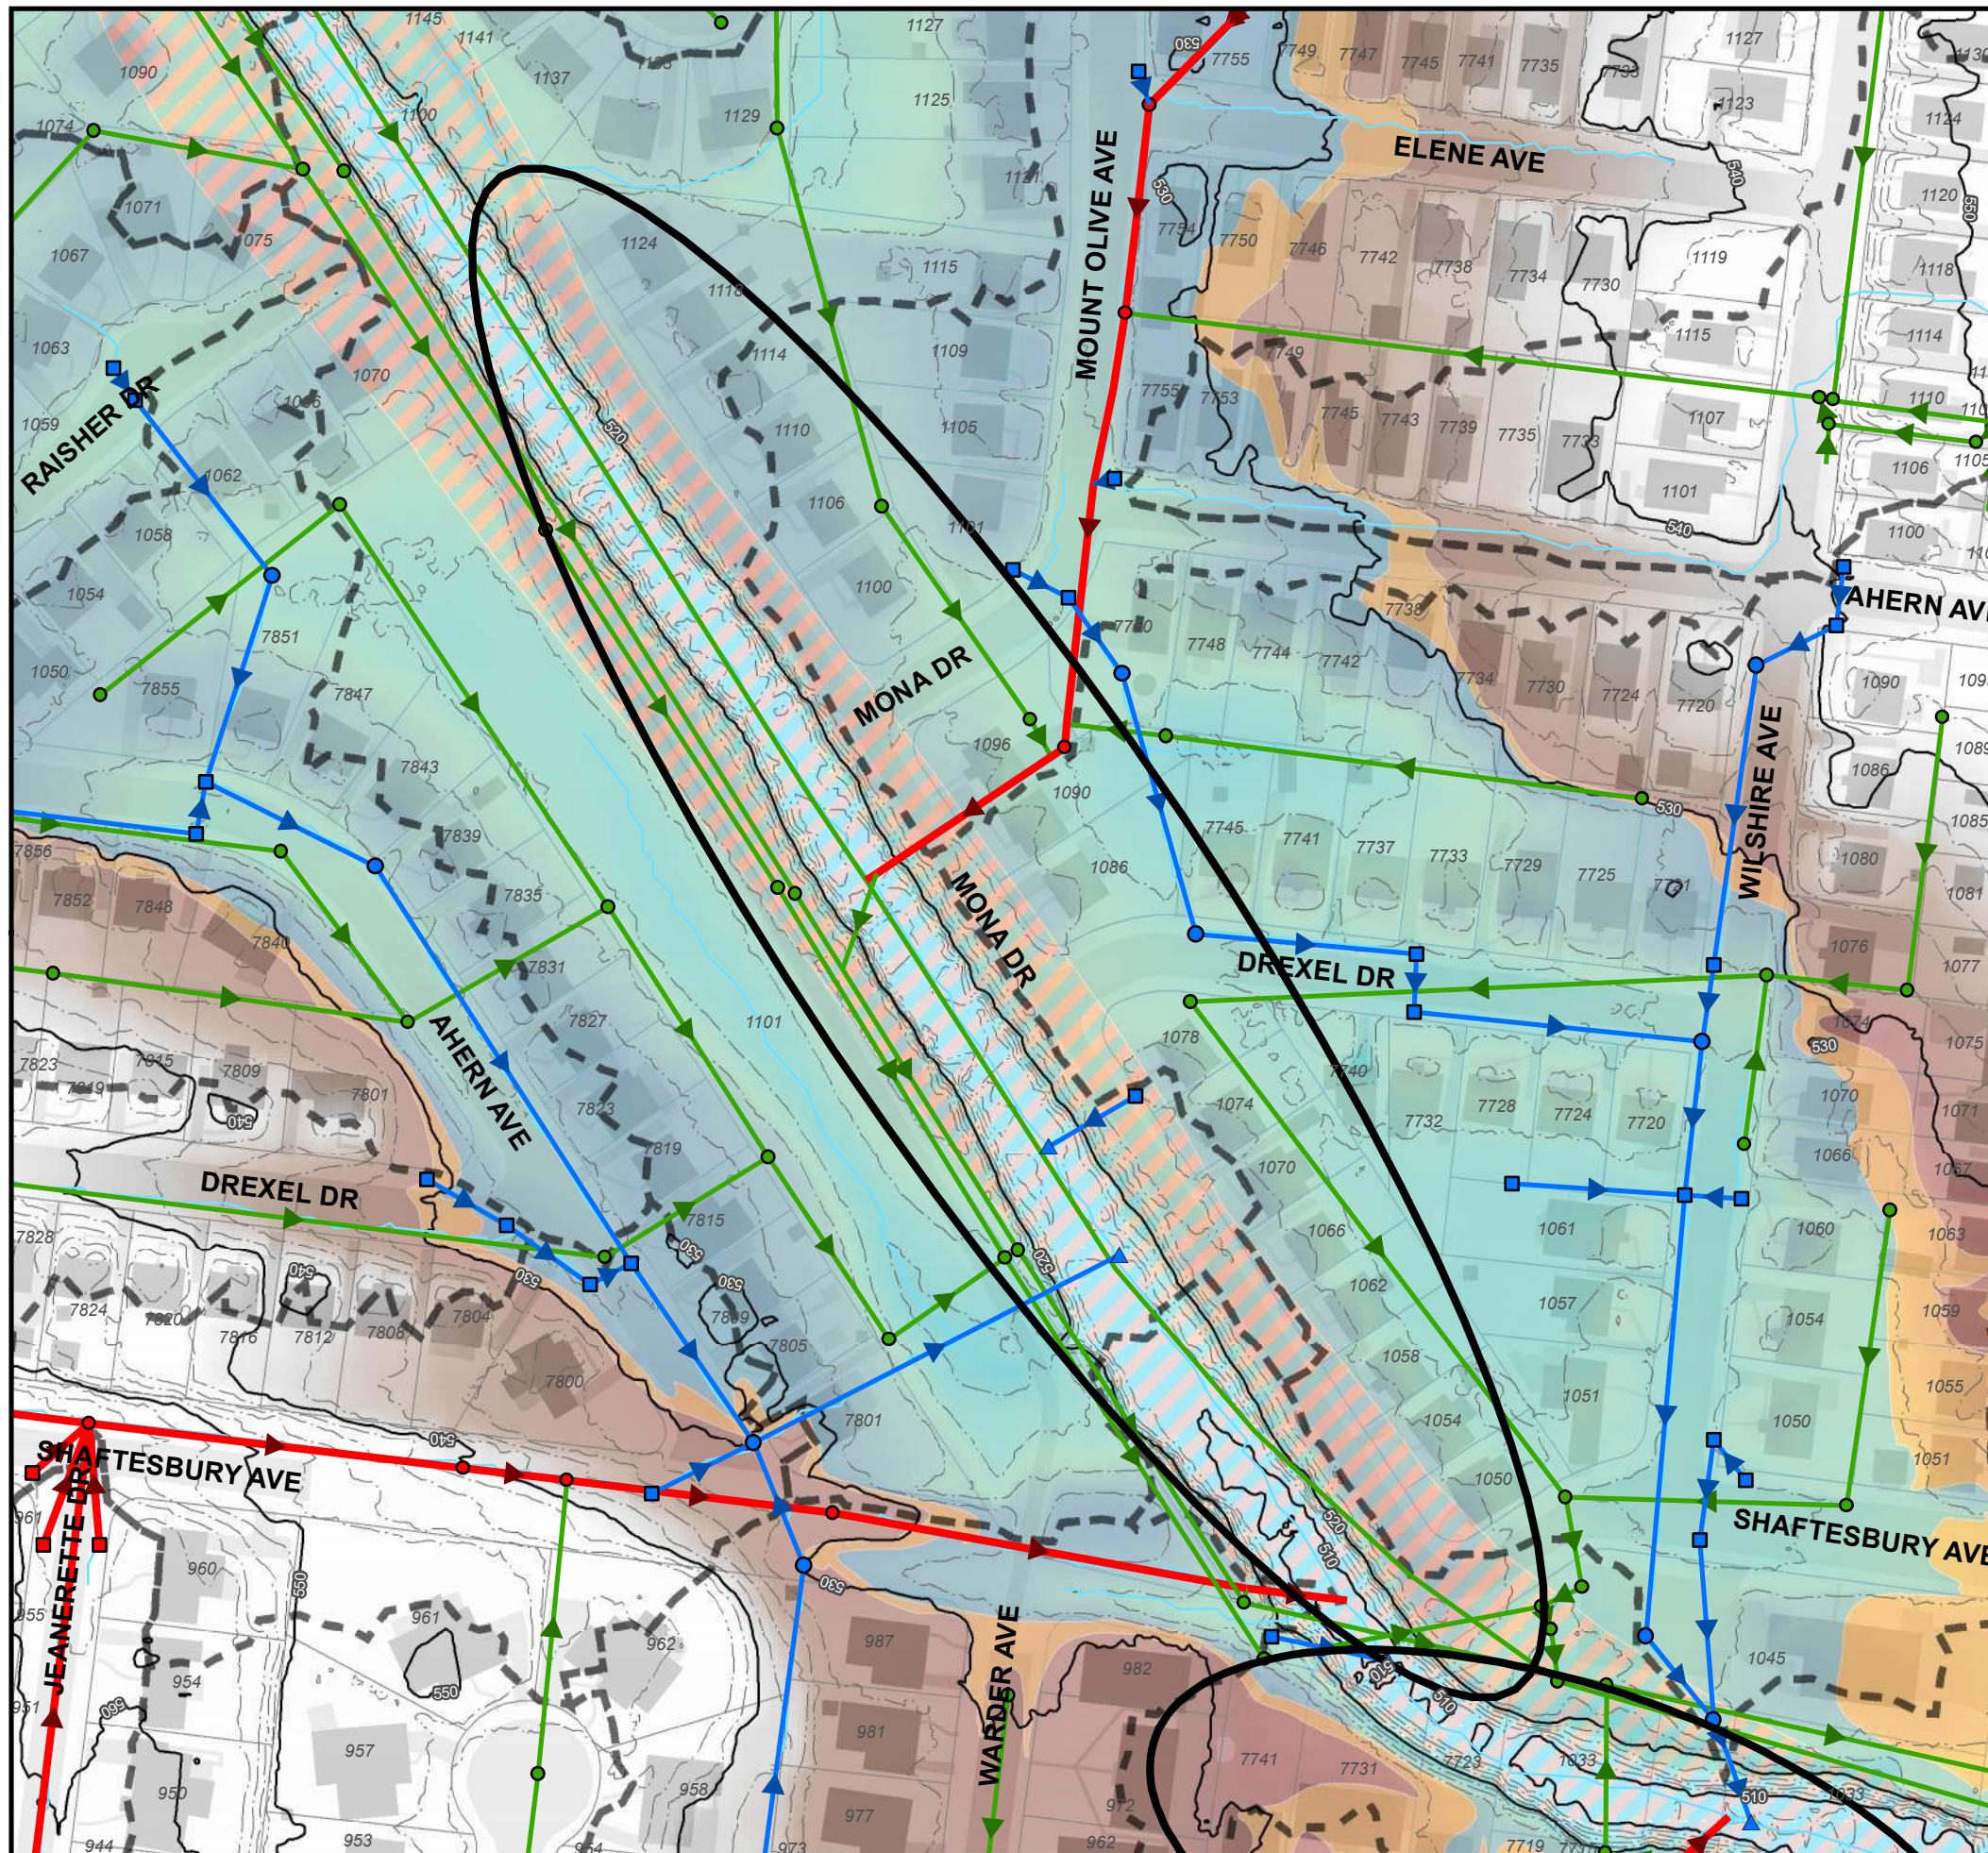
**Tributary to River Des Peres
Between Amherst Ave and
Blackberry Ave**

An un-named tributary to the River des Peres flows from a closed storm sewer outfall at Amherst and North & South. A 500-foot reach of the creekbank is over-steepened and actively eroding. MSD and the City initially identified this bank erosion in 1988, and MSD confirmed the issue and developed a conceptual solution and cost estimate in 2007.

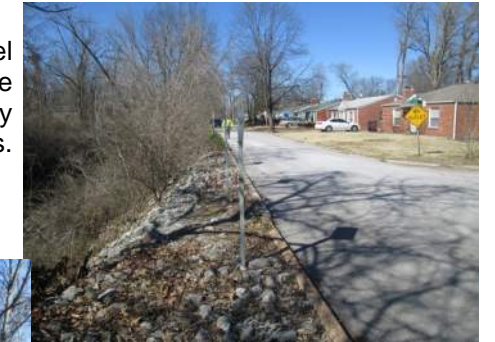
Over-steepened channel banks threaten Mona Drive which provides the only access to 6 houses.

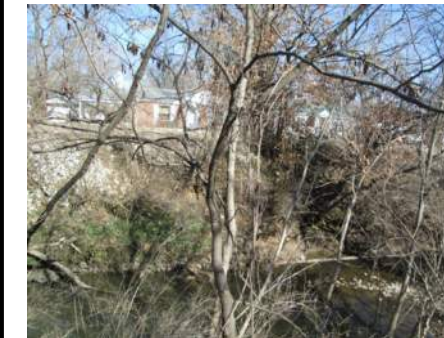
Over-steepened channel banks, and the remains of riprap placed by MSD that has since eroded and slid off the bank.

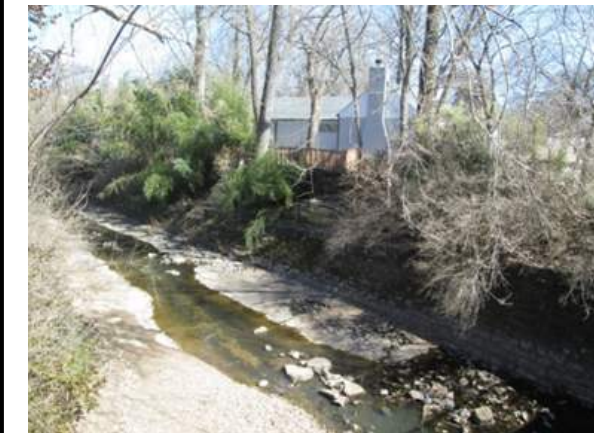
Problem Description:
 A 16-foot high bank with a combination of public and private walls is compromised and a house located only 7 feet from the top of wall is at risk. The wood tie wall is compromised, but the lower 6-feet of the bank of the Rider des Peres at this location is a WPA hand-placed stone wall, which appears stable.

Wood tie wall and WPA block wall. 7425 Shaftesbury Ave is the house behind the wall in the photo.

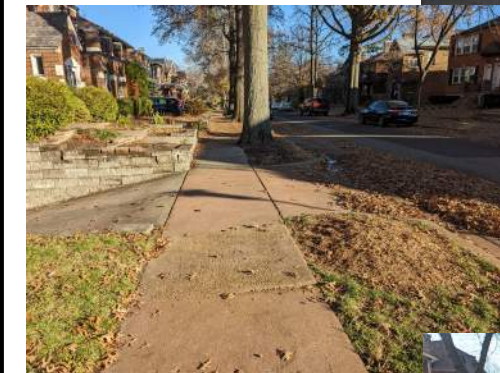
Several basement garages along Amherst Avenue flood from street drainage. Combined sewers with street inlets exist on the street. Amherst Ave is very flat, which reduces inlet capacity.

Grated drains were observed near each garage door. It is likely that each of these are connected into the nearby combined sewer. Therefore, it is possible the flooding is due to backup from the combined sewer main.

The driveway at 7037 Amherst Ave.

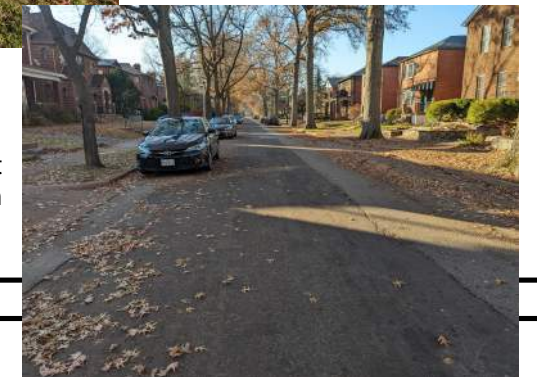
Looking east along Amherst Ave towards the inlets between 7033/7029 Amherst Ave.

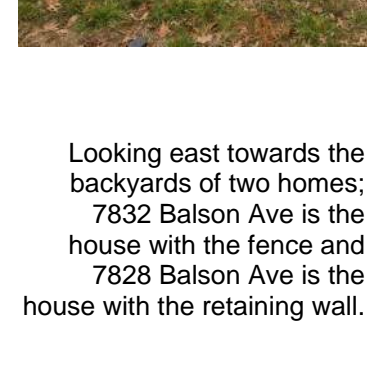
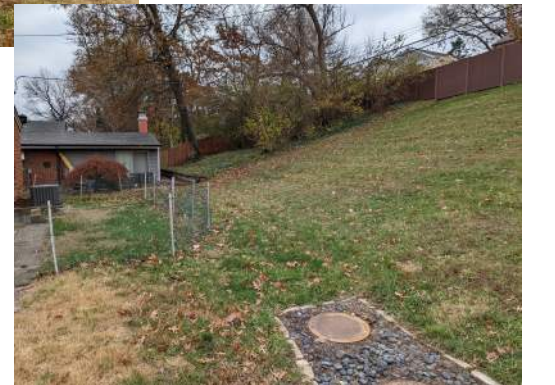
The homes on Stanford Avenue sit about 18 feet higher than the homes on Balson Ave. Between the houses is at a 3:1 slope. The flow path from the backyards to the front yards on Balson Ave is inadequate, causing frequent flooding to at least two of the homes on Balson Ave. The drainage area to the back of the homes is about 1.3 acres.

Looking west in the backyard of 7838 Balson Ave. The house is on the right.

Looking east towards the backyards of two homes; 7832 Balson Ave is the house with the fence and 7828 Balson Ave is the house with the retaining wall.

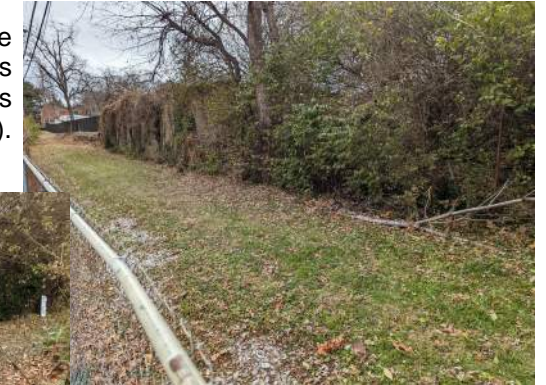
The property north of the Grenville Subdivision sits about 6-10 feet above the backyards of several houses. About 3.3 acres of drainage reaches the backyards of 1561 to 1573 Westmont Place.

Looking northwest towards the strip of ROW between homes (on the left) and the business to the north (on the right).

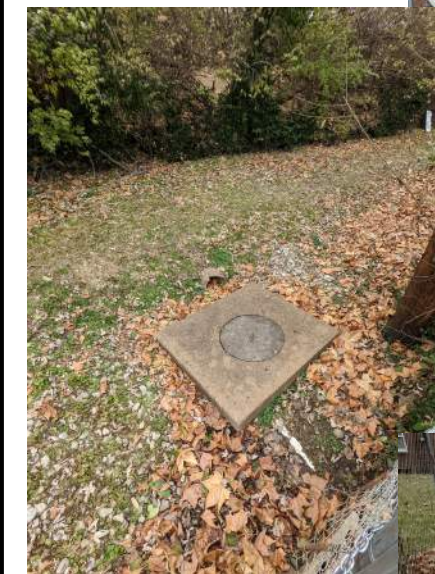
There is an inlet behind 1561, but only about half of a side is able to accept water due to grading issues. Note the inlet appears to be in a strip of ROW between the houses and business.

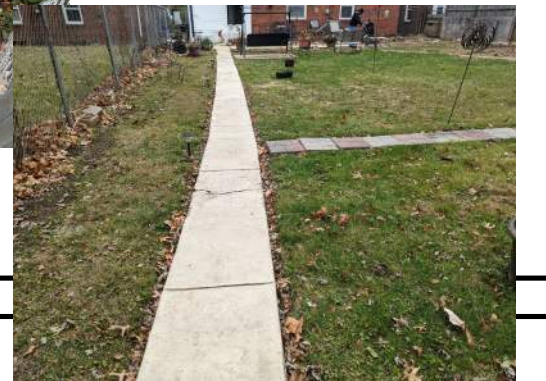
Looking towards the inlet north of #1561. Due to grading, the inlet does not appear to collect much runoff.

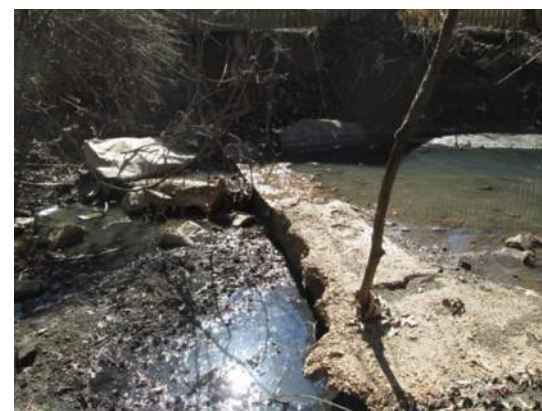
Concrete-encased private sanitary sewer lateral at 7587 Amherst is exposed and possibly leaking. The stream profile drops 2 feet across the lateral.

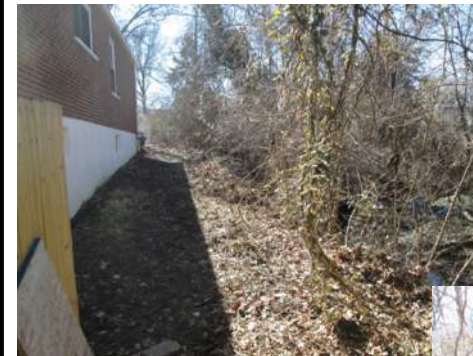
The 13-foot high eroding bank at 7591 Amherst is 9 feet from the home (measured from the top of bank).

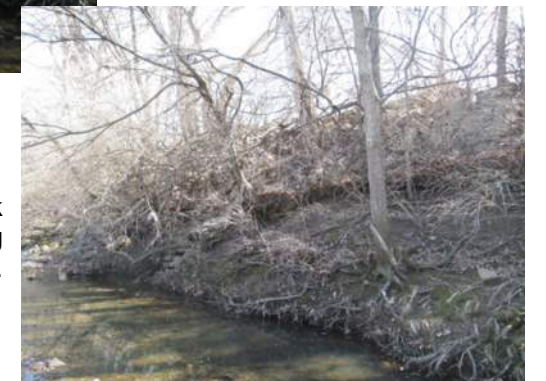
The foundation of a 6-foot high mid-slope fence is eroded and the fence is collapsing. It appears that riprap was added from the top of slope to address an area of gulley erosion, but this riprap is sliding down the bank. The weight of this riprap is contributing to the fence failure.

On the right descending bank are the eroding bank, collapsing fence, and sliding riprap.

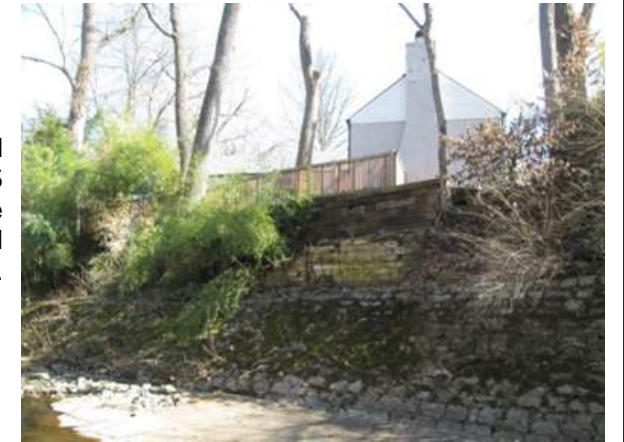
Problem Description:
 A 16-foot high bank with a combination of public and private walls is compromised and a house located only 7 feet from the top of wall is at risk. The wood tie wall is compromised, but the lower 6-feet of the bank of the Rider des Peres at this location is a WPA hand-placed stone wall, which appears stable.

Wood tie wall and WPA block wall. 7425 Shaftesbury Ave is the house behind the wall in the photo.

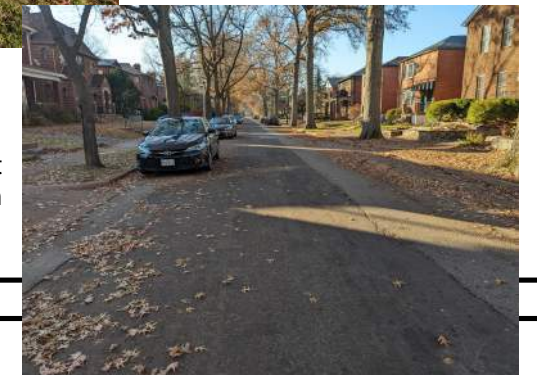
Looking east along Amherst Ave towards the inlets between 7033/7029 Amherst Ave.

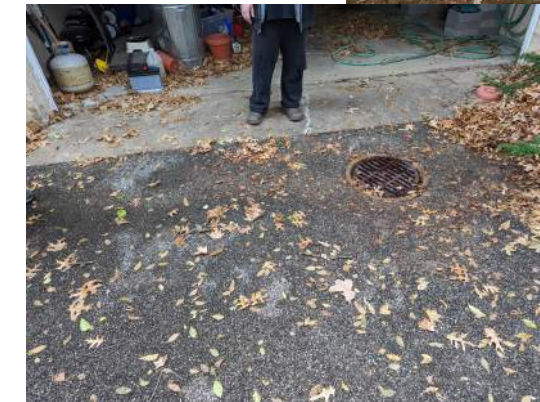
Looking at the ground in front of the driveway at 8436 Old Bonhomme Rd.

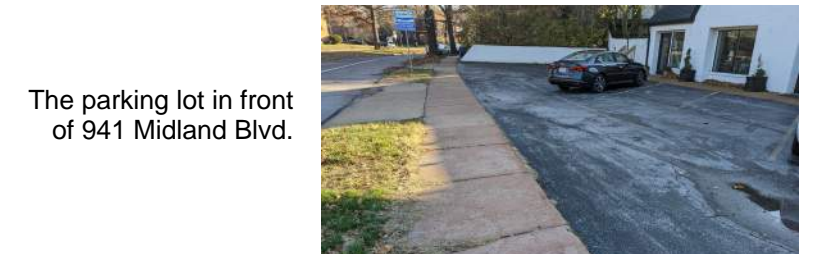
Problem Description:
 The commercial building at 941 Midland Blvd has been flooded by ponded water in the street. The owner indicated that when this happens, the inlets won't drain. Investigation is necessary to determine if the flooding issue is due to inlet capacity, pipe capacity, or high tailwater from the River Des Peres, or a combination of these issues.

The parking lot in front of 941 Midland Blvd.

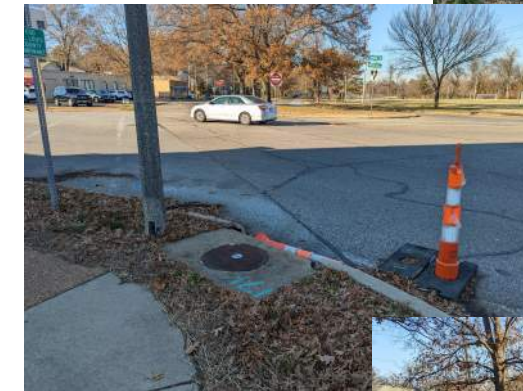
Looking north towards the inlet at the southwest corner of Midland Blvd and Balson Ave.

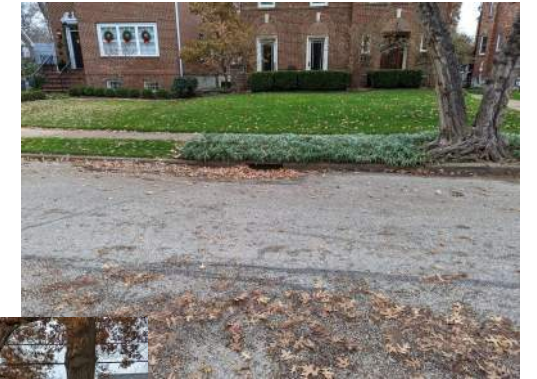
Residents say that the low point on W Point Ct floods constantly. The street does not have a distinct crown. Asphalt patching has made the street uneven in some places. There are 4 inlets near the low point, but non appear very efficient. There is not a well-defined sag and inlets appear to clog easily with leaves.

Looking towards the grated curb inlet with side intake between #416 and 414. The side intake is rather narrow and the grate is clogged with leaves.

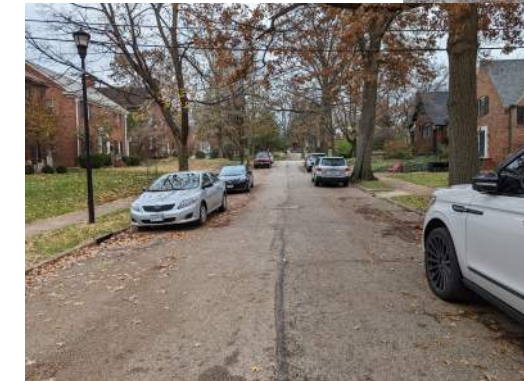
Looking south towards the inlets in front of #414 and 415. Both of these inlets are grated with a side intake.

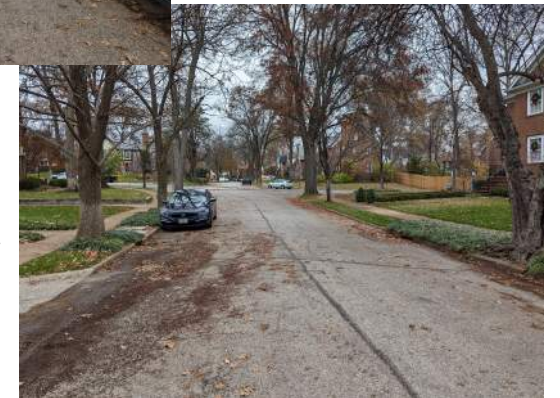
Looking north towards the northern two inlets on W Point Ct. Both are grated inlets with side intakes.

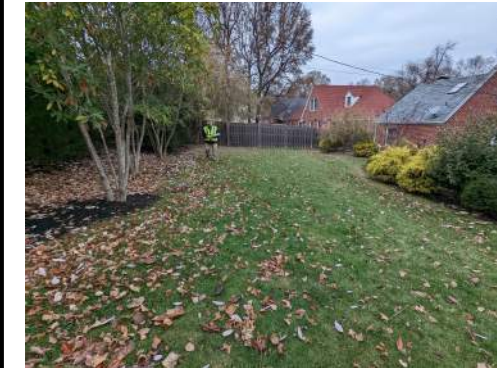
Looking north between #7924 and 7928 towards erosion and a yard drain.

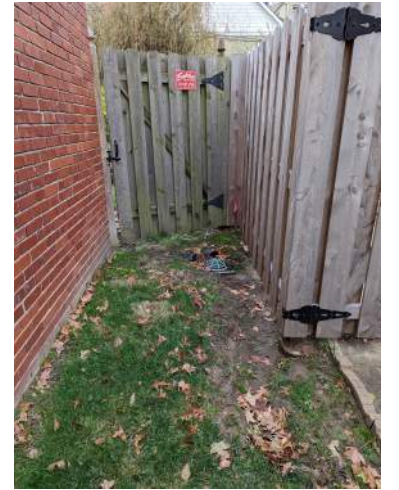
Looking west in the backyard of 7924 Lafon Pl. The house is out of frame on the right. The yard slopes towards the back of the house.

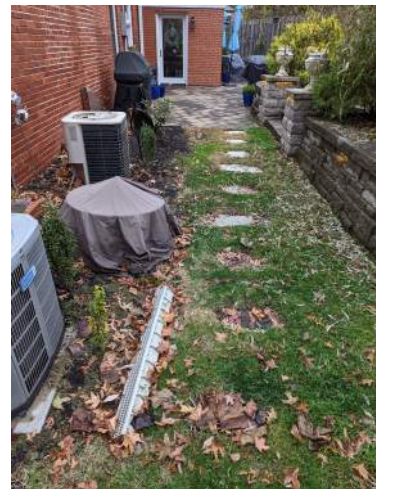
Looking east along the back of 7924 Lafon Pl. A yard drain was installed in an attempt to reduce ponding near the house.

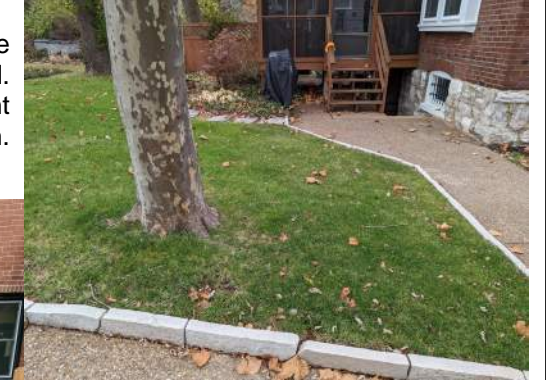
Looking west towards the backyard at 7258 Lindell Blvd. The stairwell to the basement is under the porch.

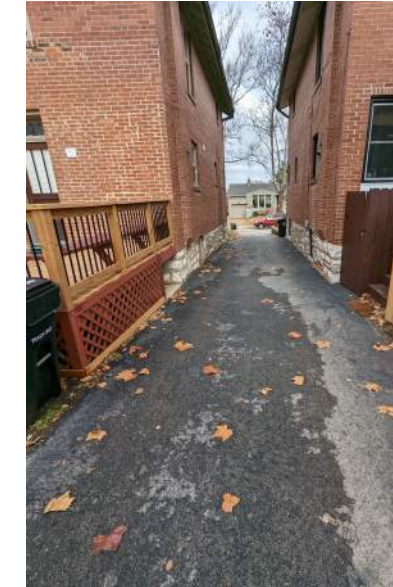
Looking north between #7252 (on the left) and #7250 (on the right). Basement windows are within 1-3 inches of the driveway - a potential source of flooding to the basements.

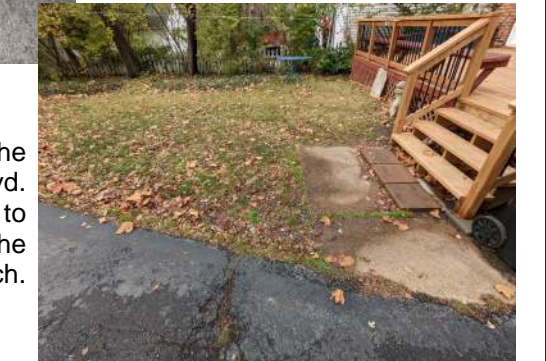
Looking west towards the backyard at 7252 Lindell Blvd. Ponding occurs near the steps to the patio. There is a stairwell to the basement under the porch.

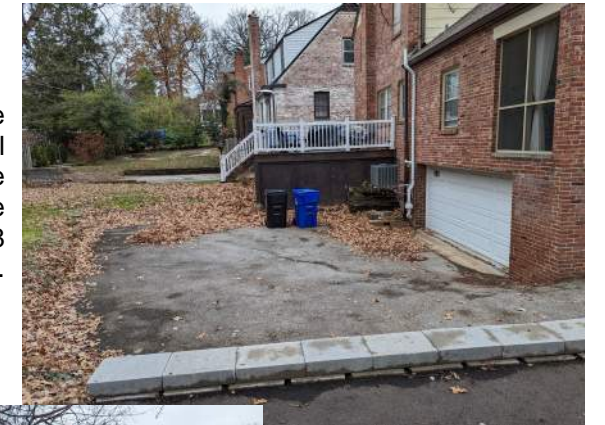
Looking towards the backyard of 8132 Cornell Ct; the basement garage has flooded since it is the low point of about 1.8 acres.

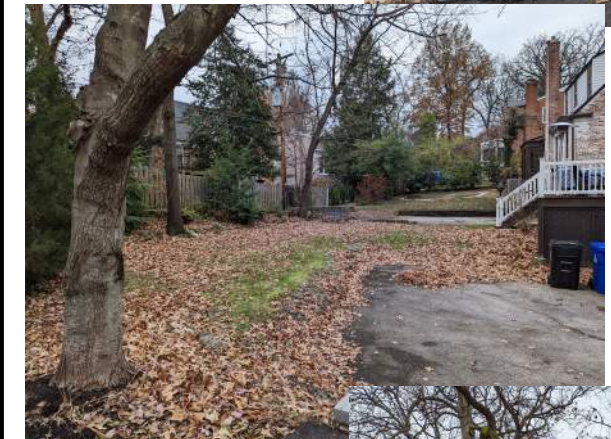
Looking west towards the backyard of #8132.

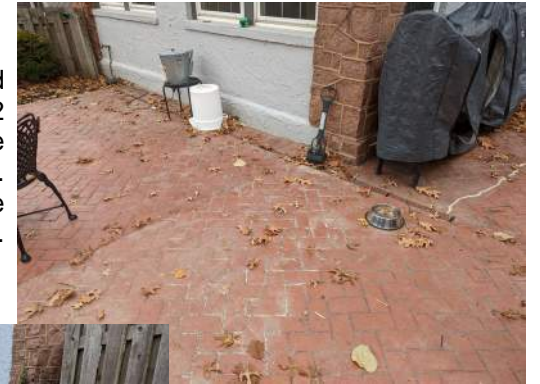
A slotted drain was installed by the homeowner at 7232 Northmoor Dr to reduce ponding against the house. This type of private drainage is common in the area.

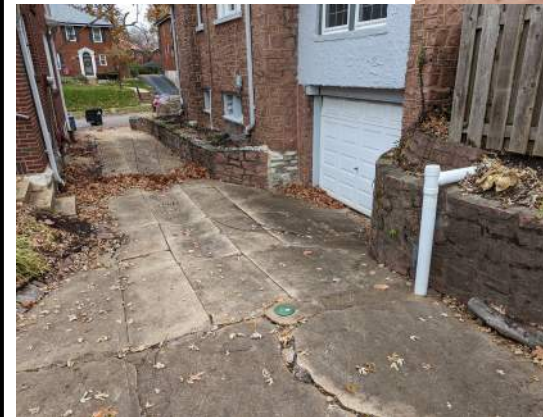
Looking north between #7236 (on the left) and #7232 (on the right). The tuck-under garage is at risk of flooding since the main flow path for water in the backyards is to flow down this driveway.
