Storm Water Commission  
6801 Delmar Boulevard, University City, Missouri 63130,  
Phone: (314) 505-8560, Fax: (314) 862-0694

## MINUTES OF THE STORMWATER COMMISSION April 4, 2023

TO: Darren Girdler, Director of Public Works  
 Mirela Celaj, CFM, Assistant Director of Public Works  
 FROM: Stormwater Master Plan Team (HR Green and Reitz & Jens)  
 SUBJECT: University City Stormwater Master Plan  
*Public versus Private – Recommended Definition* Scope of work Task 2.2  
 DATE: February 28, 2023

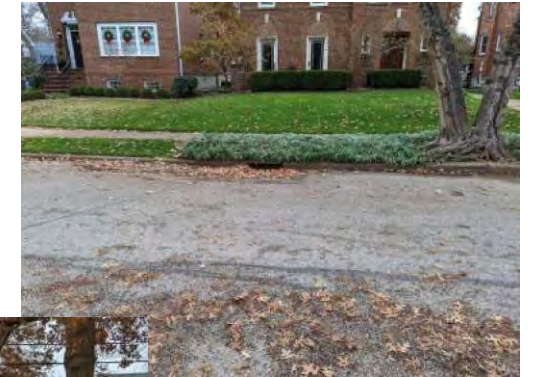
Looking towards the grated curb inlet with side intake between #416 and 414. The side intake is rather narrow and the grate is clogged with leaves.

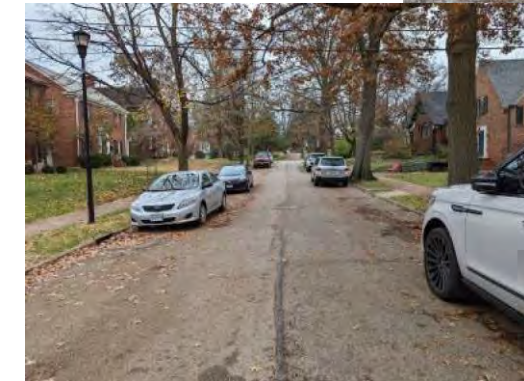
Looking south towards the inlets in front of #414 and 415. Both of these inlets are grated with a side intake.

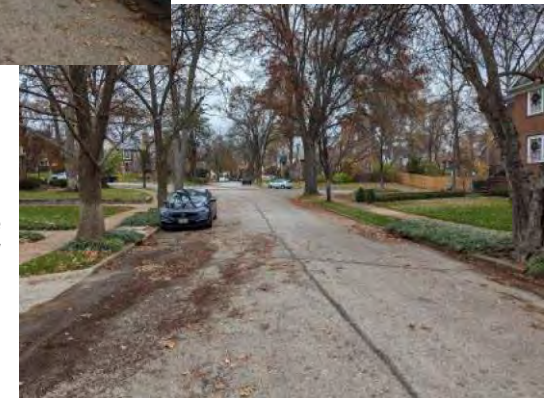
Looking north towards the northern two inlets on W Point Ct. Both are grated inlets with side intakes.

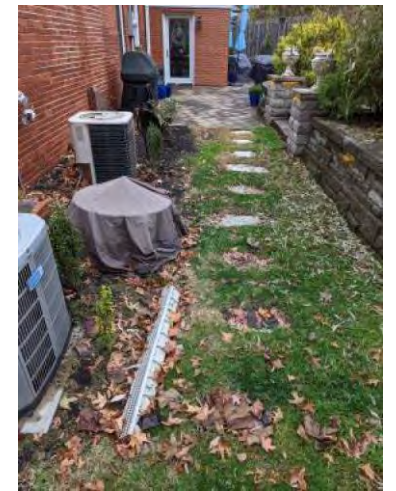
Looking east along the back of 7924 Lafon Pl. A yard drain was installed in an attempt to reduce ponding near the house.
