**AGENDA
COMMISSION ON STORM WATER ISSUES
SPECIAL MEETING
HEMAN PARK COMMUNITY CENTER
975 PENNSYLVANIA
Monday, June 12, 2023,
3:30 PM**

❖ Stormwater Master Plan, Continue Discussions

TO: Darren Girdler, Director of Public Works
 Mirela Celaj, CFM, Assistant Director of Public Works
 FROM: Stormwater Master Plan Team (HR Green and Reitz & Jens)
 SUBJECT: University City Stormwater Master Plan
Public versus Private – Recommended Definition Scope of work Task 2.2
 DATE: February 28, 2023

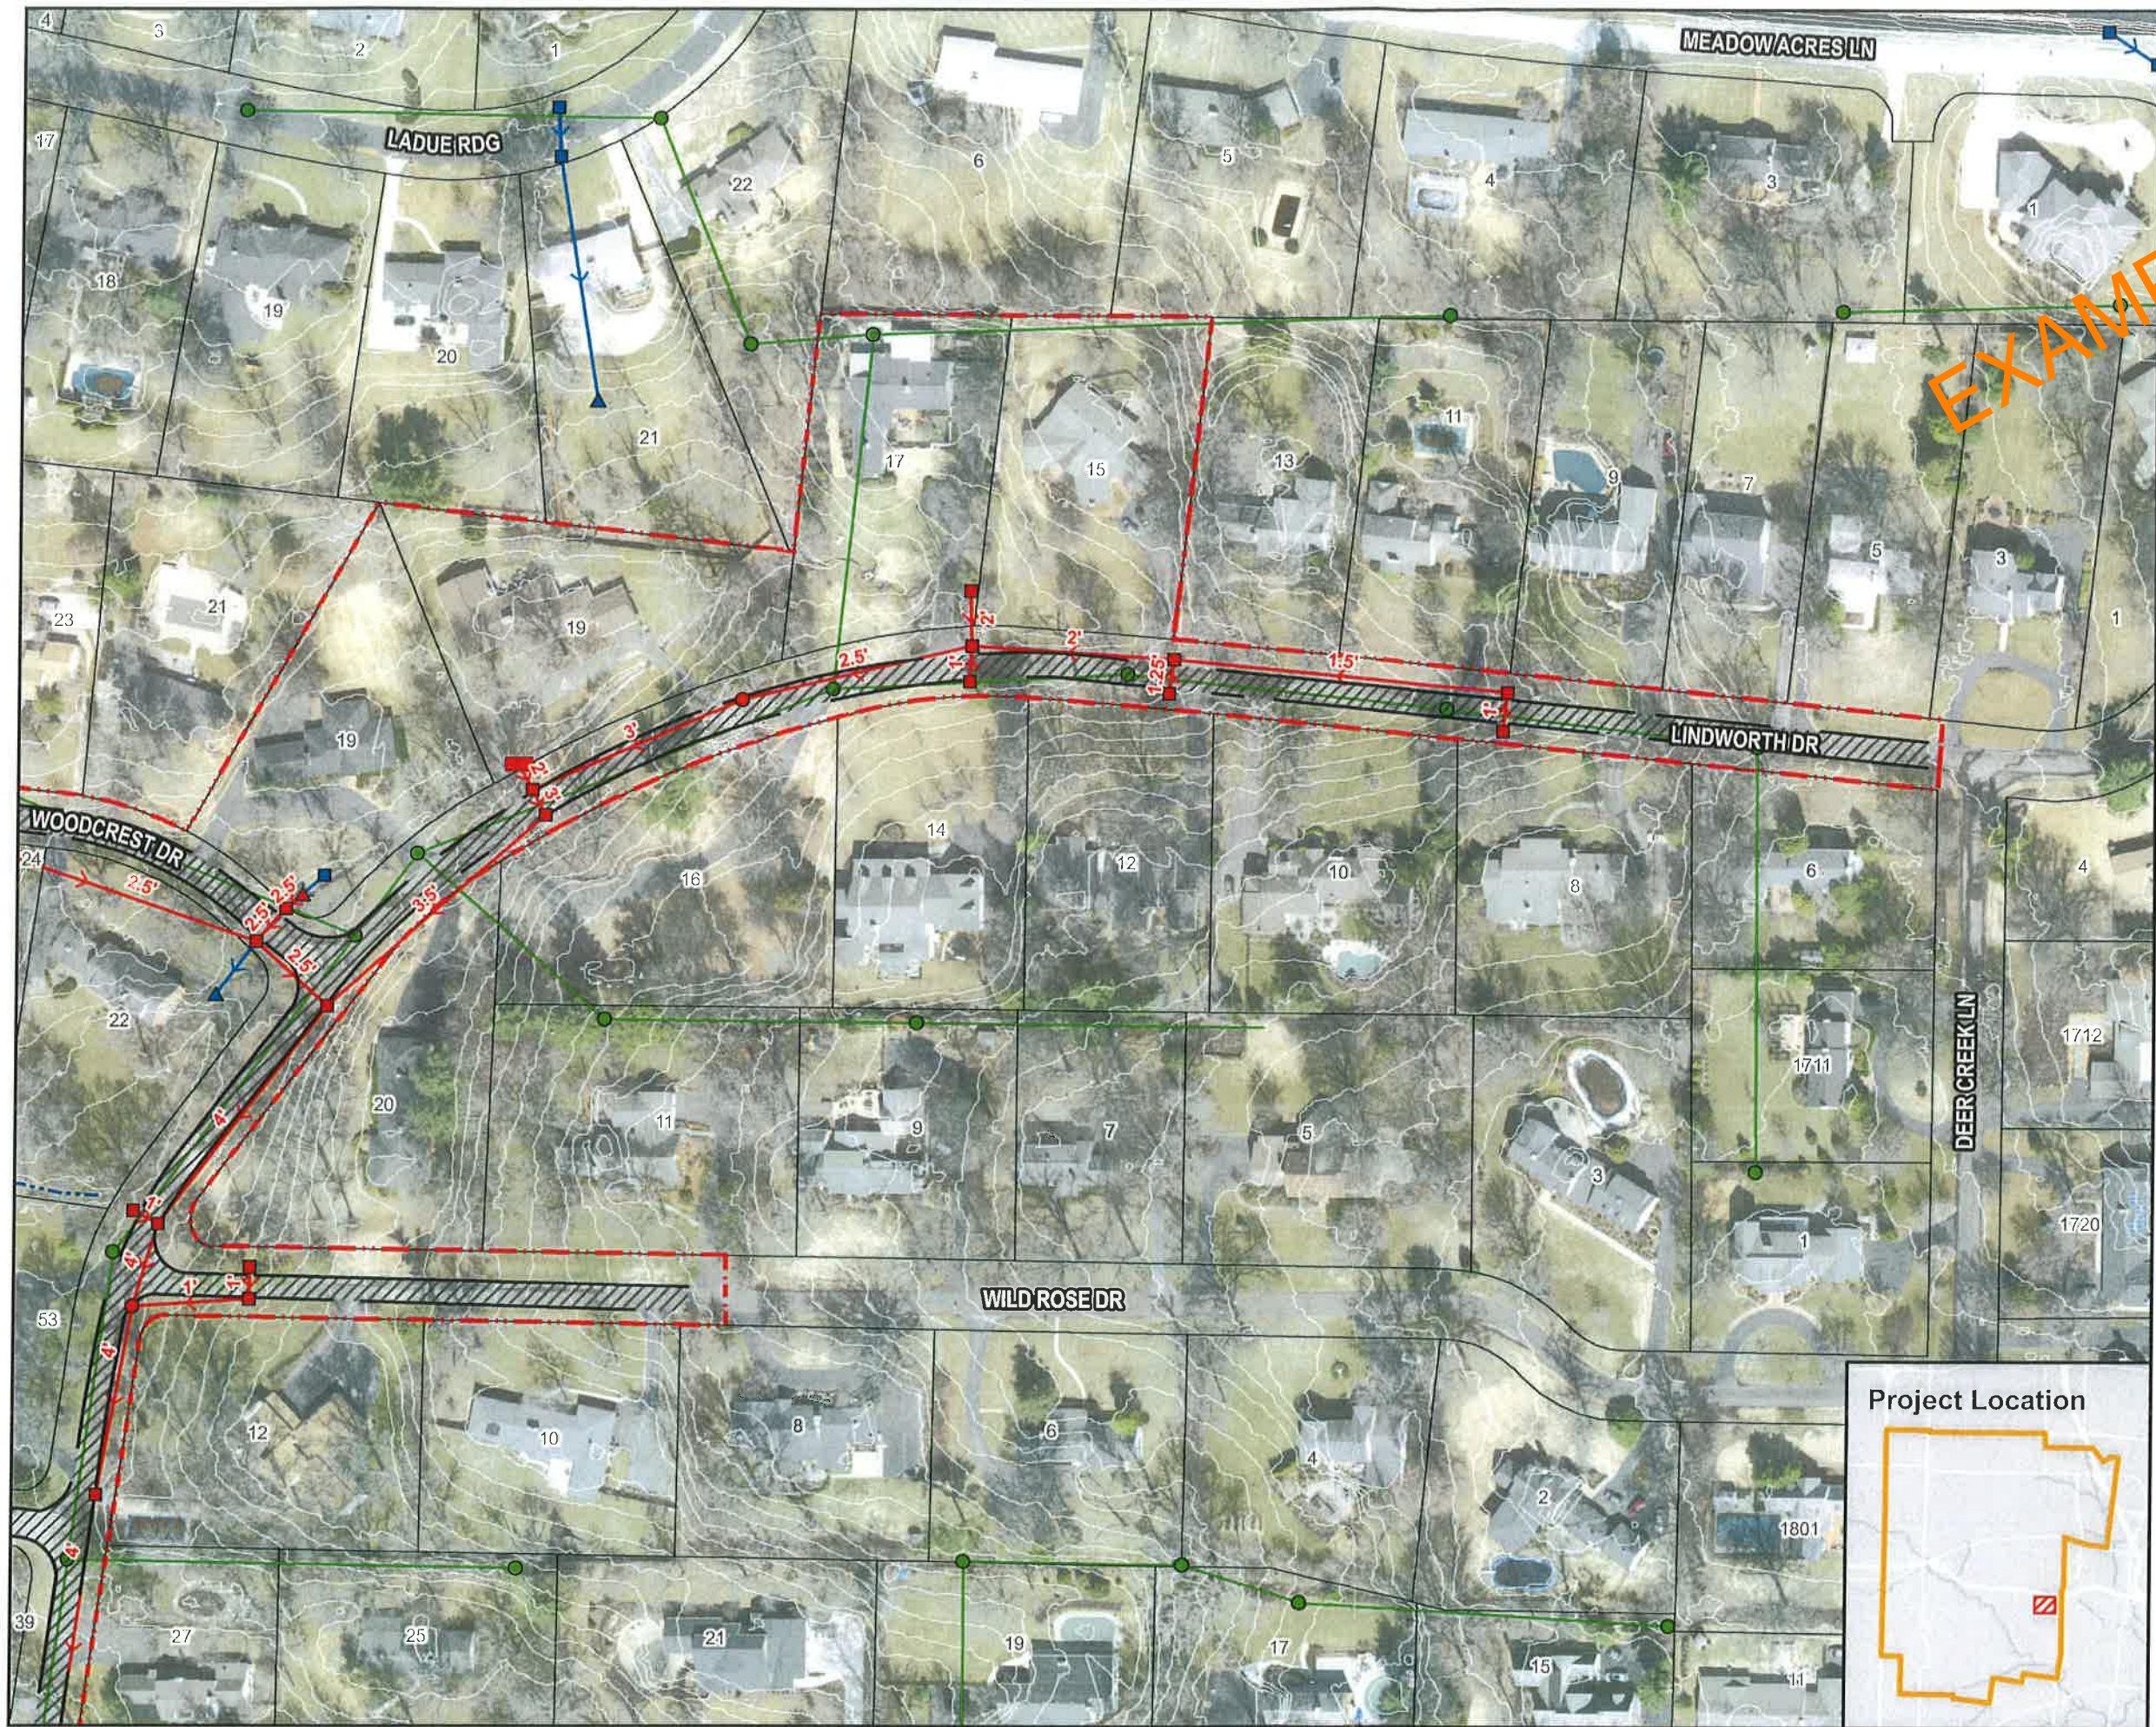
Problem Description
Yard and roadway flooding due to an inadequate drainage system that relies on sinkholes.

Proposed Solution Description
Storm sewer improvements to alleviate flooding from sinkholes not draining fast enough.

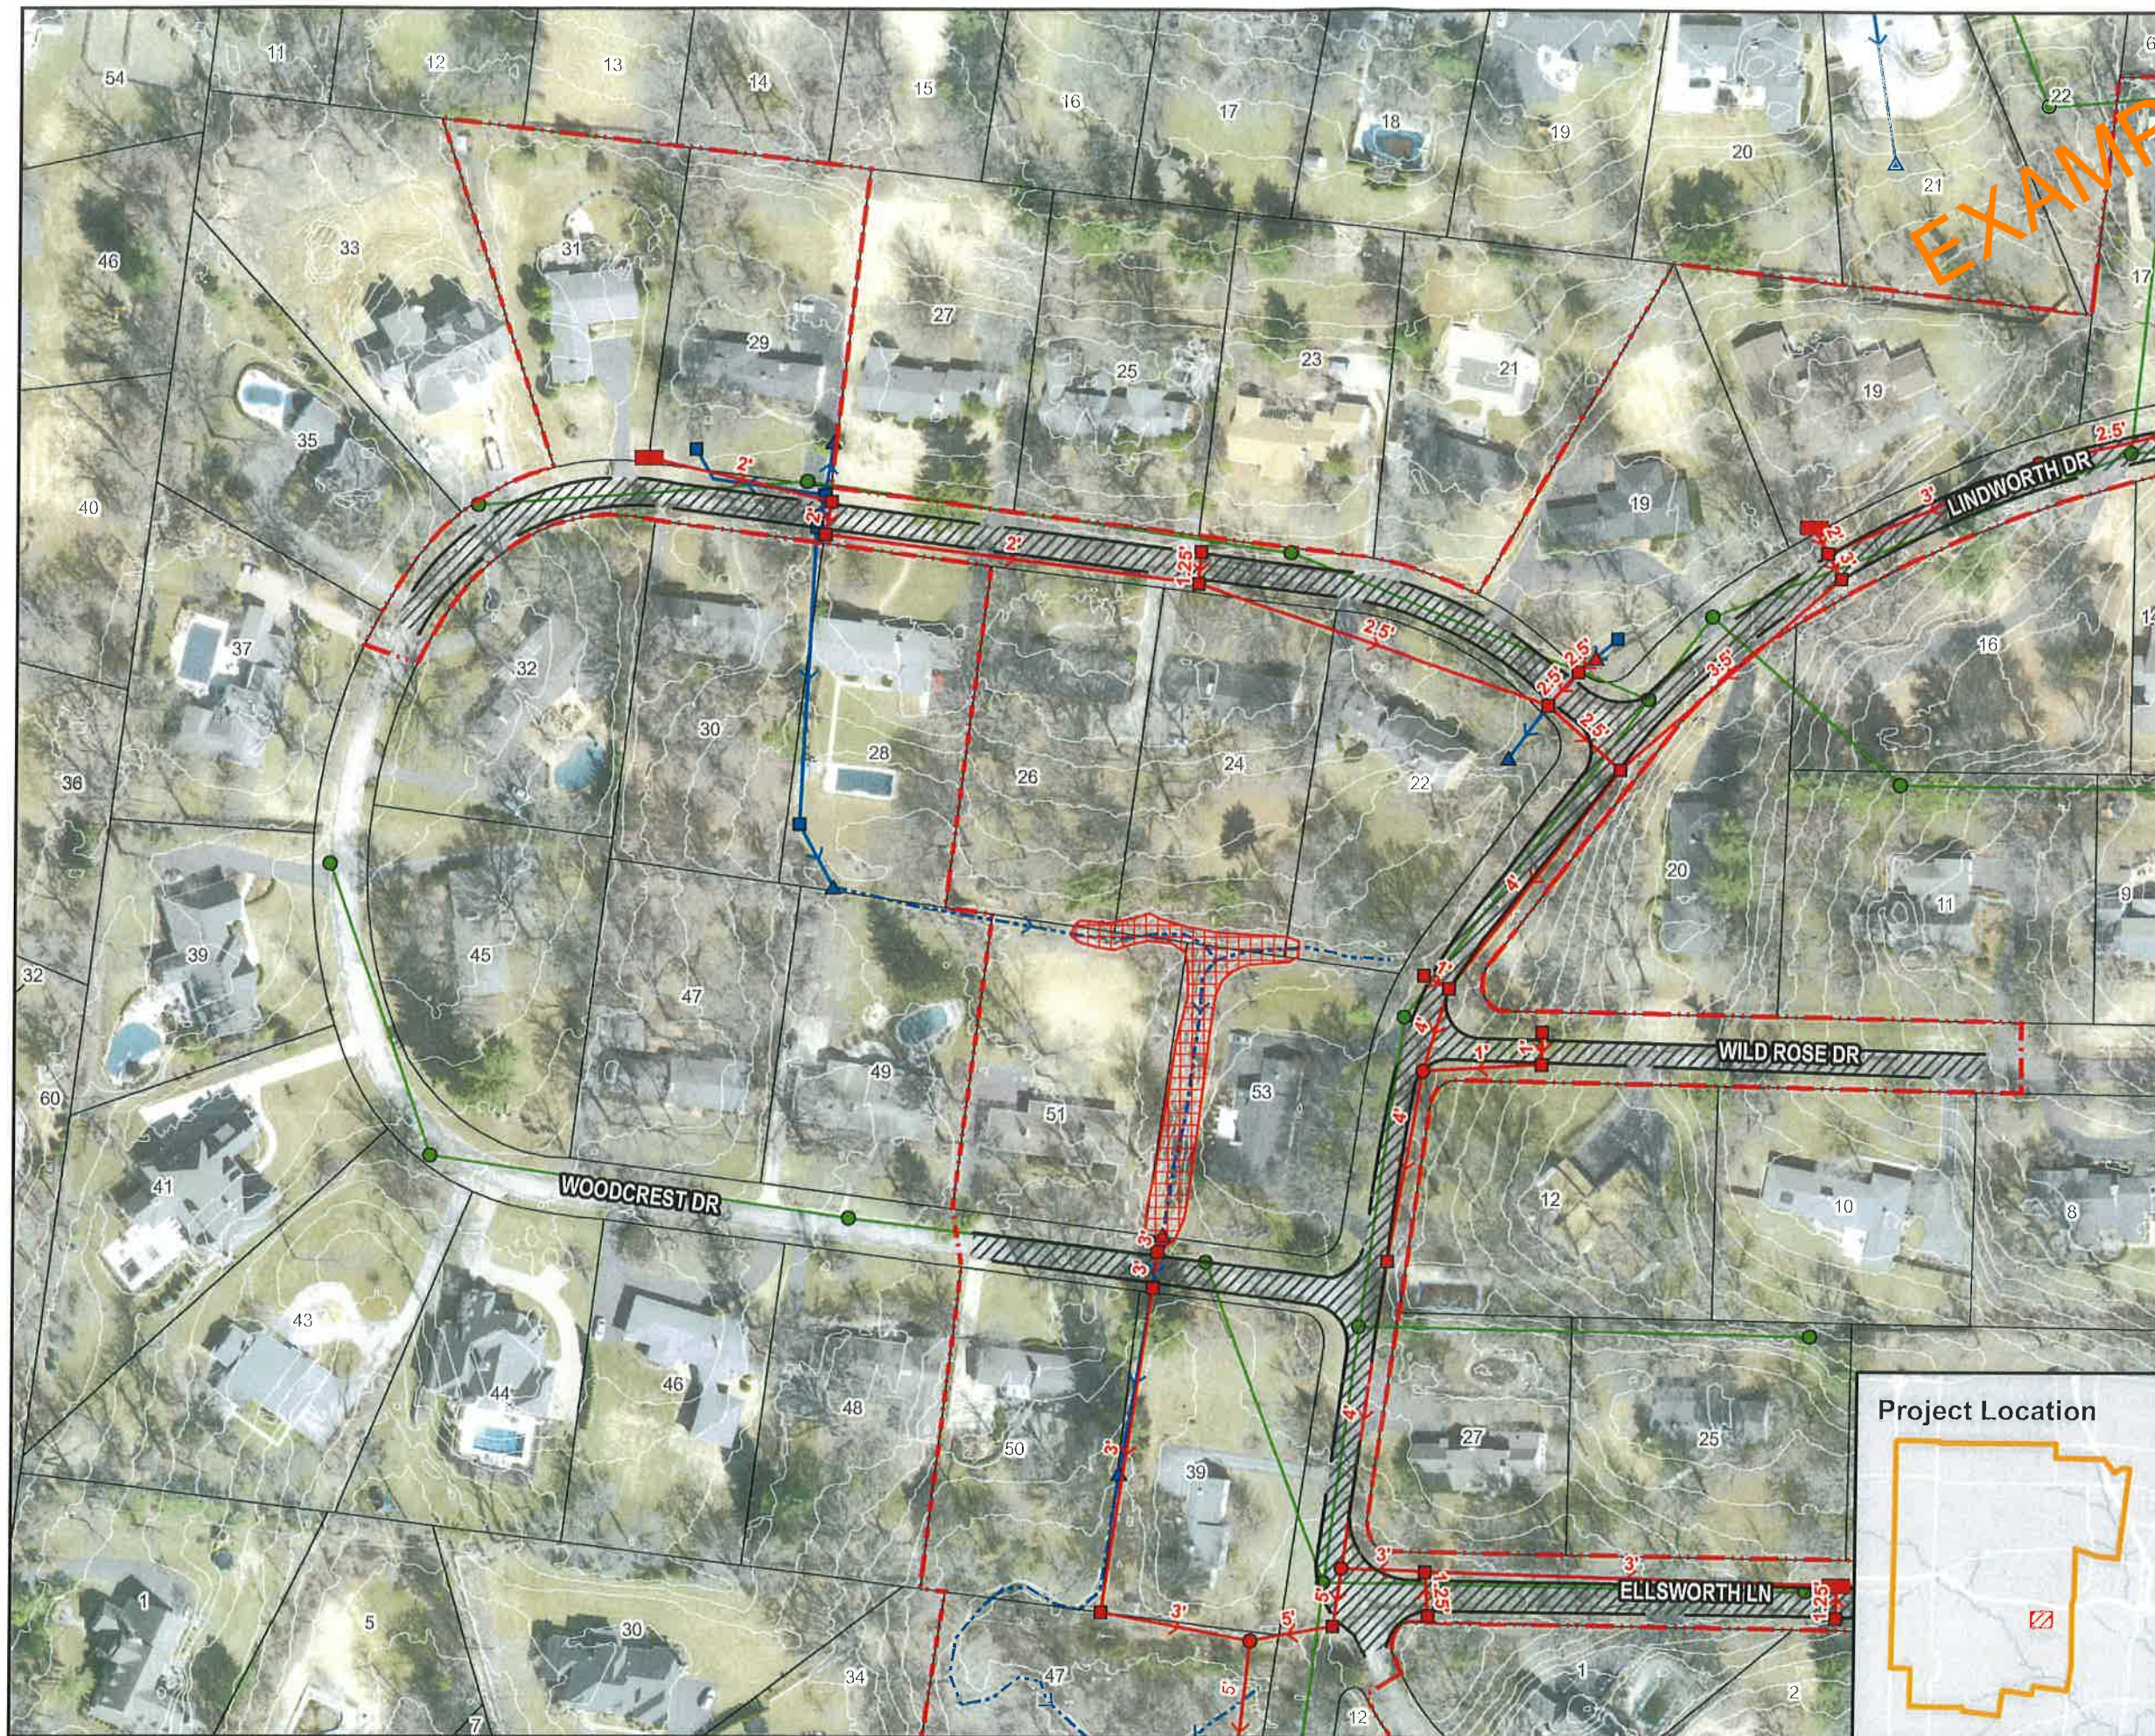
Problem Description
Yard and roadway flooding due to an inadequate drainage system that relies on sinkholes.

Proposed Solution Description
Storm sewer improvements to alleviate flooding from sinkholes not draining fast enough.

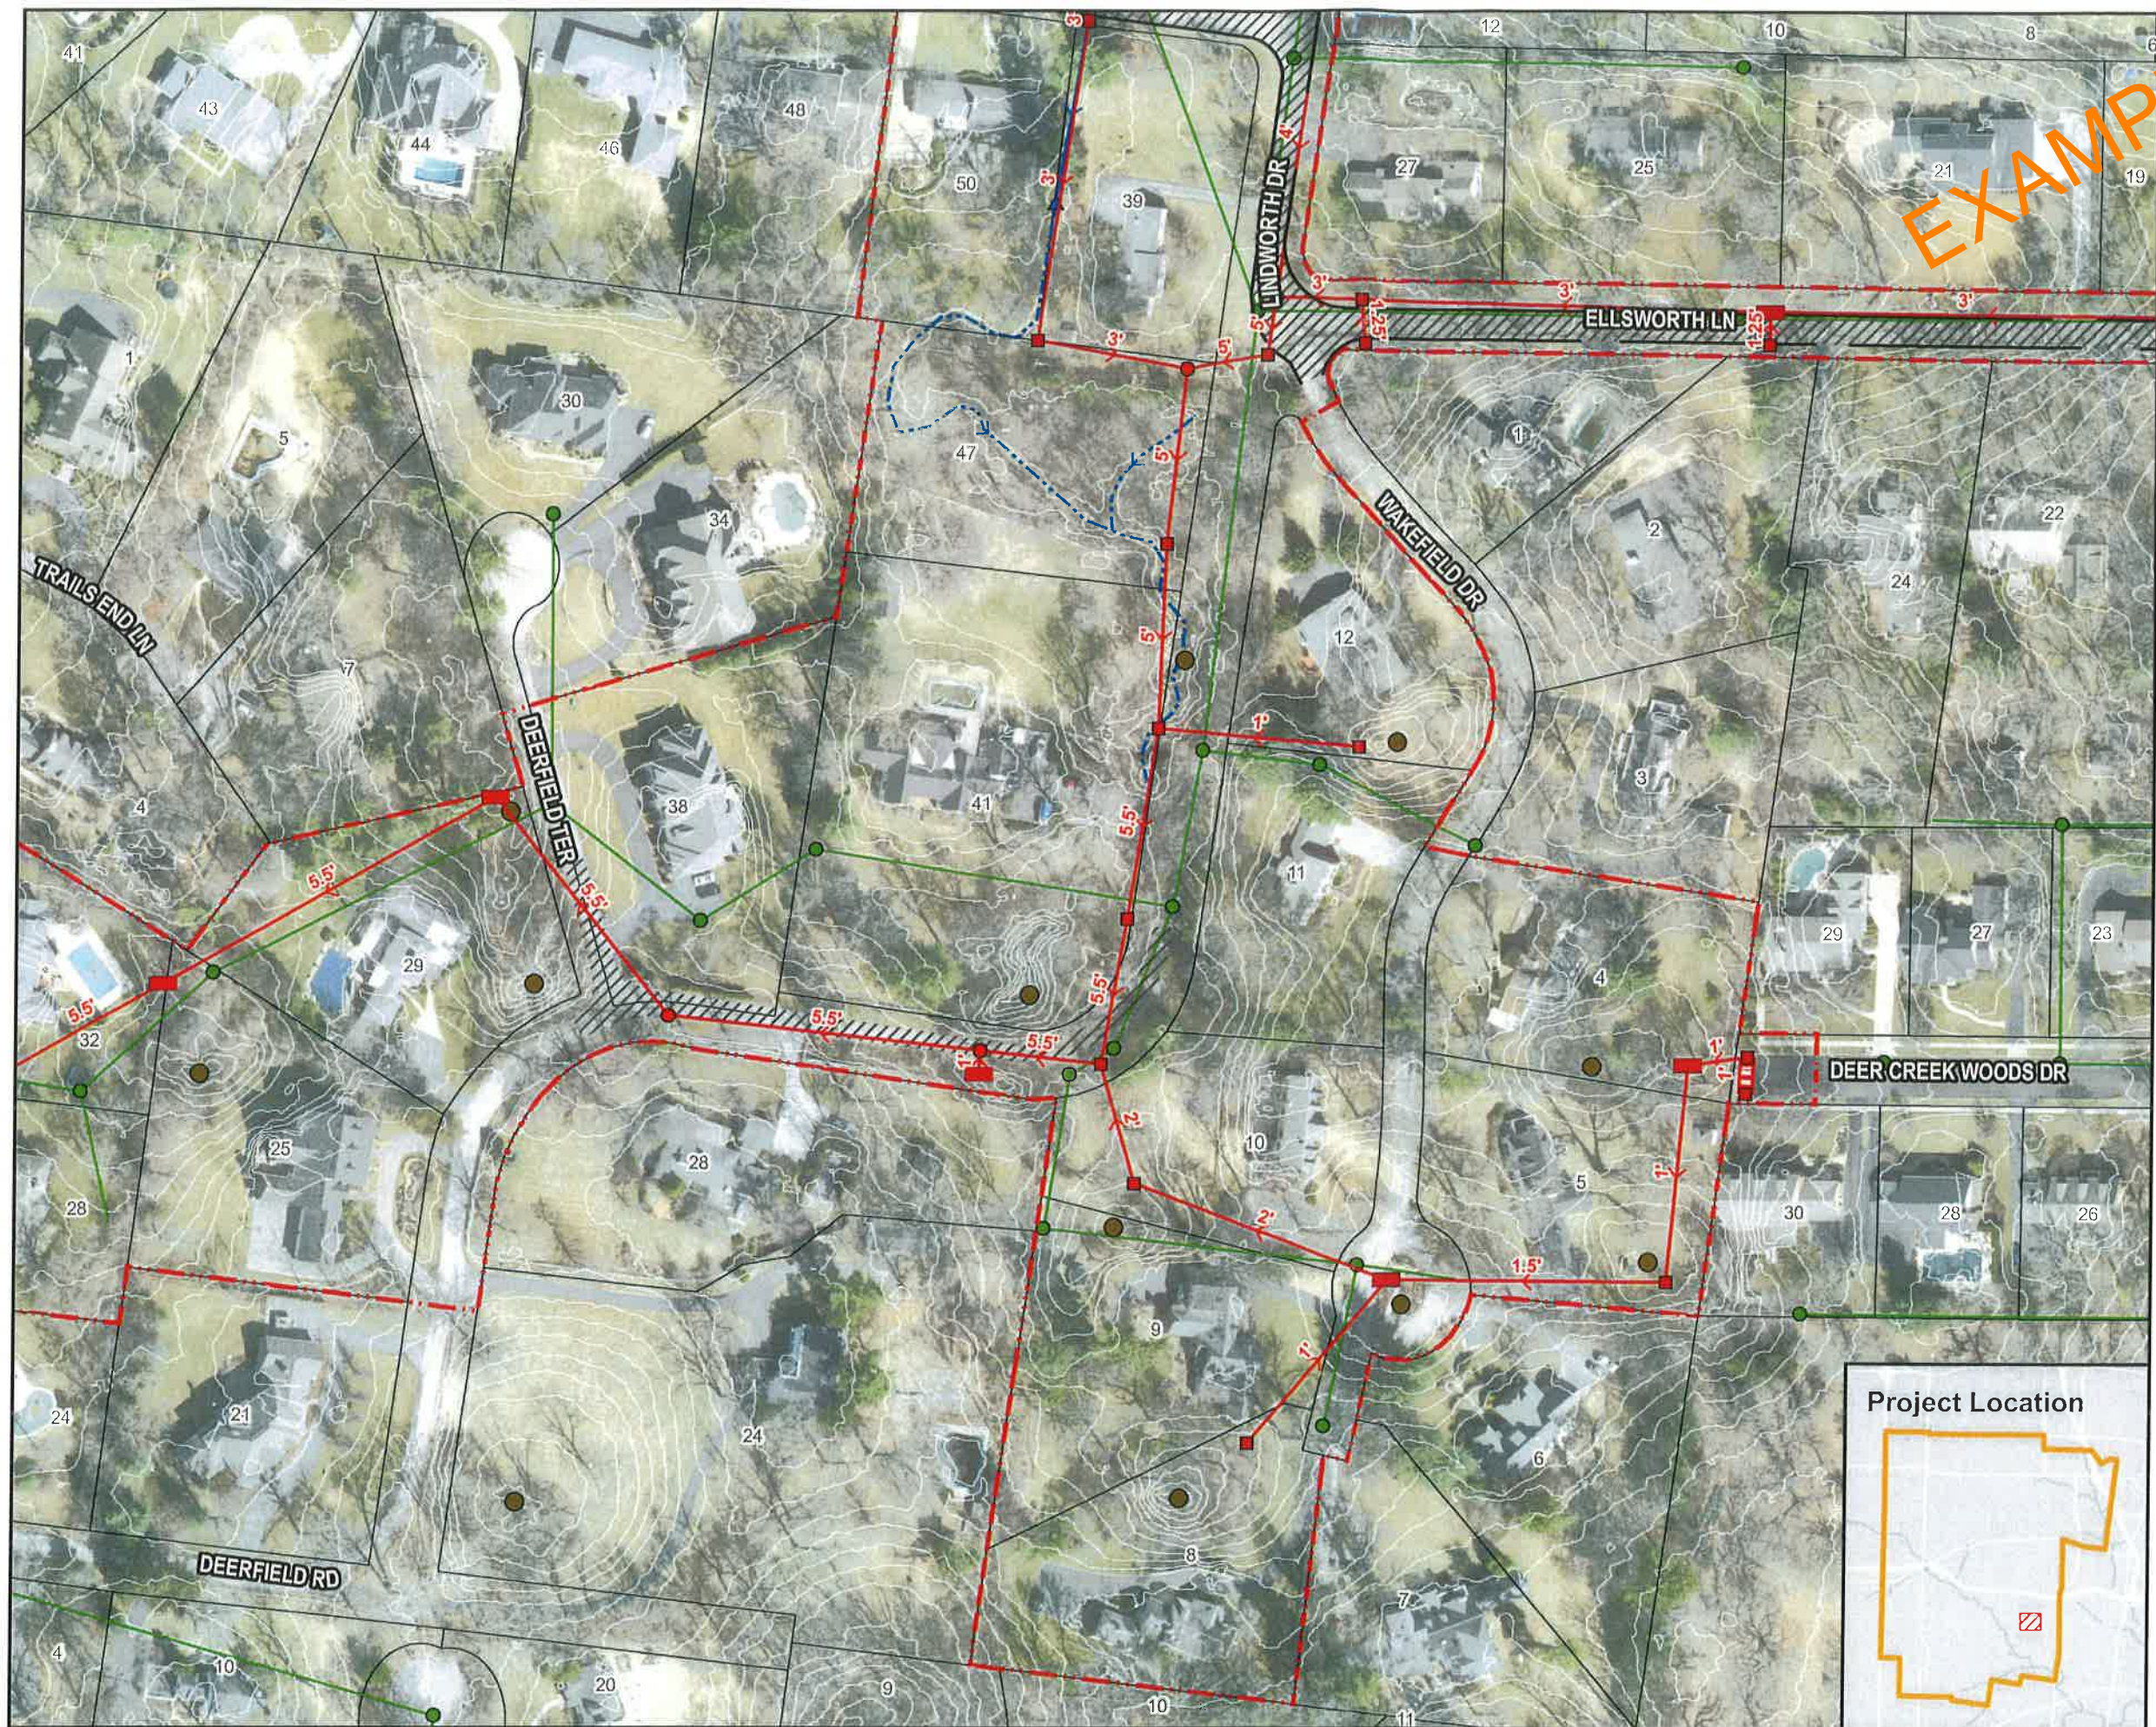
Problem Description
Yard and roadway flooding due to an inadequate drainage system that relies on sinkholes.

Proposed Solution Description
Storm sewer improvements to alleviate flooding from sinkholes not draining fast enough.

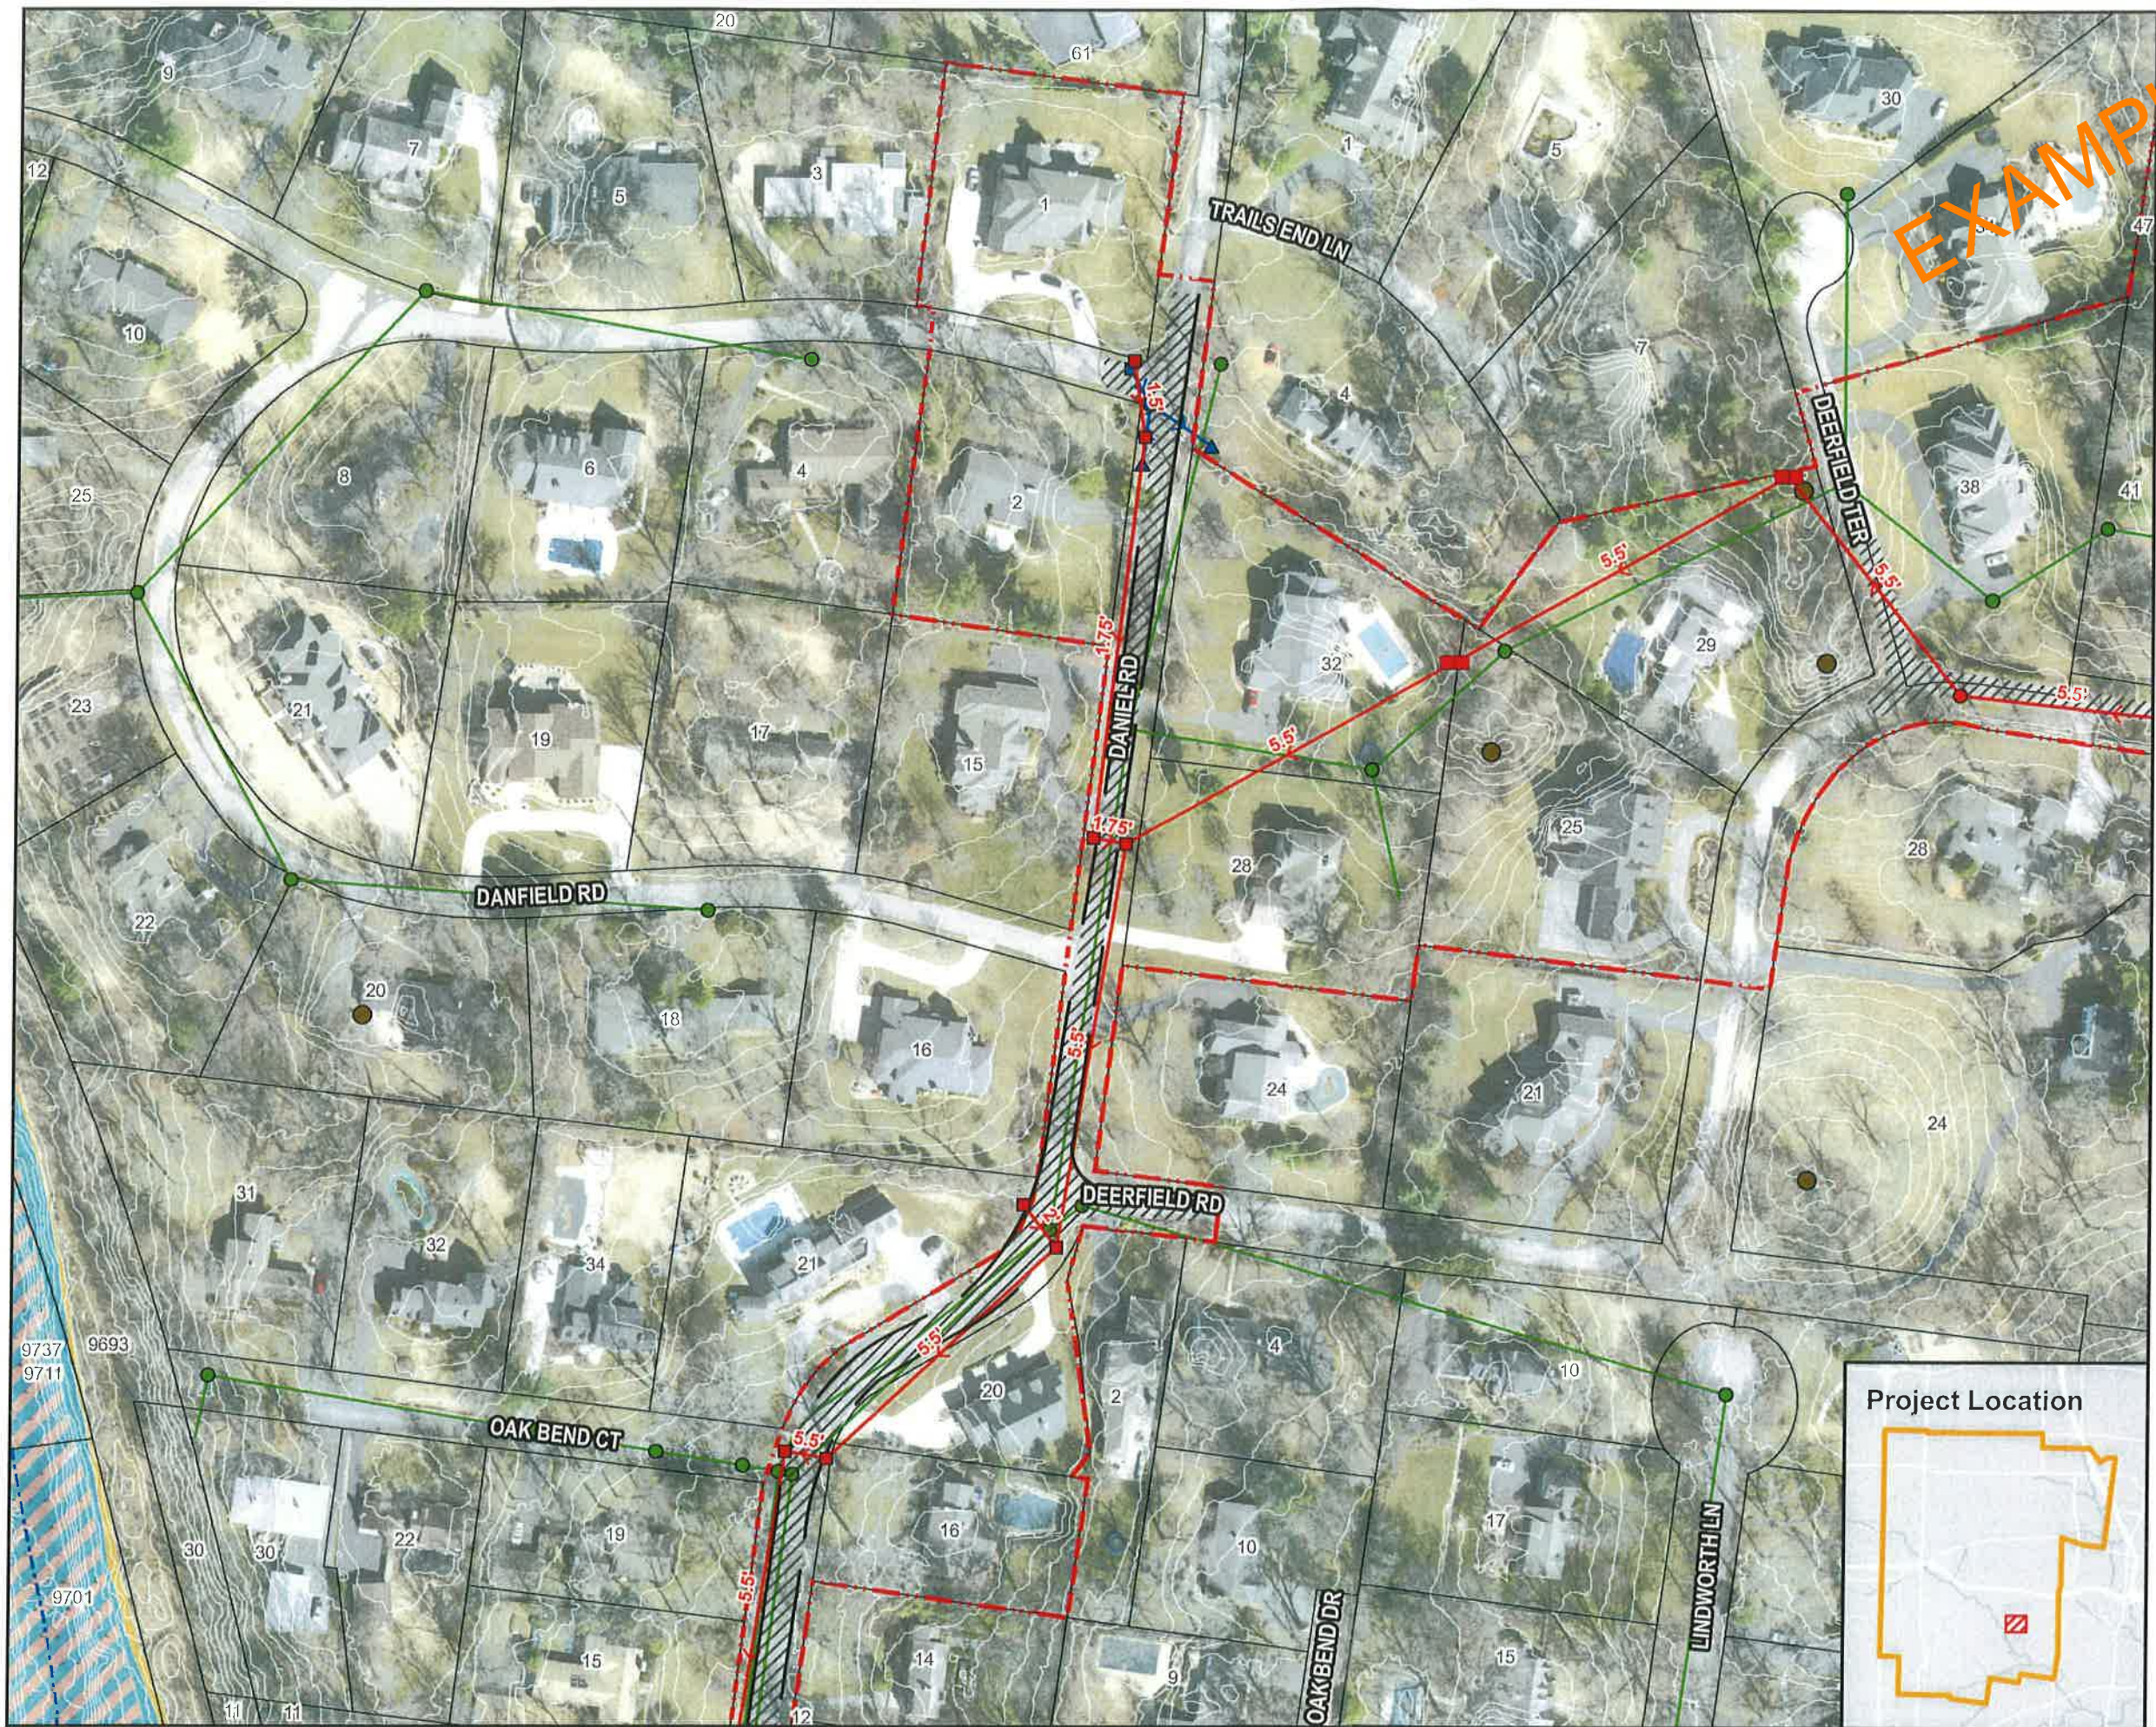
Problem Description
Yard and roadway flooding due to an inadequate drainage system that relies on sinkholes.

Proposed Solution Description
Storm sewer improvements to alleviate flooding from sinkholes not draining fast enough.

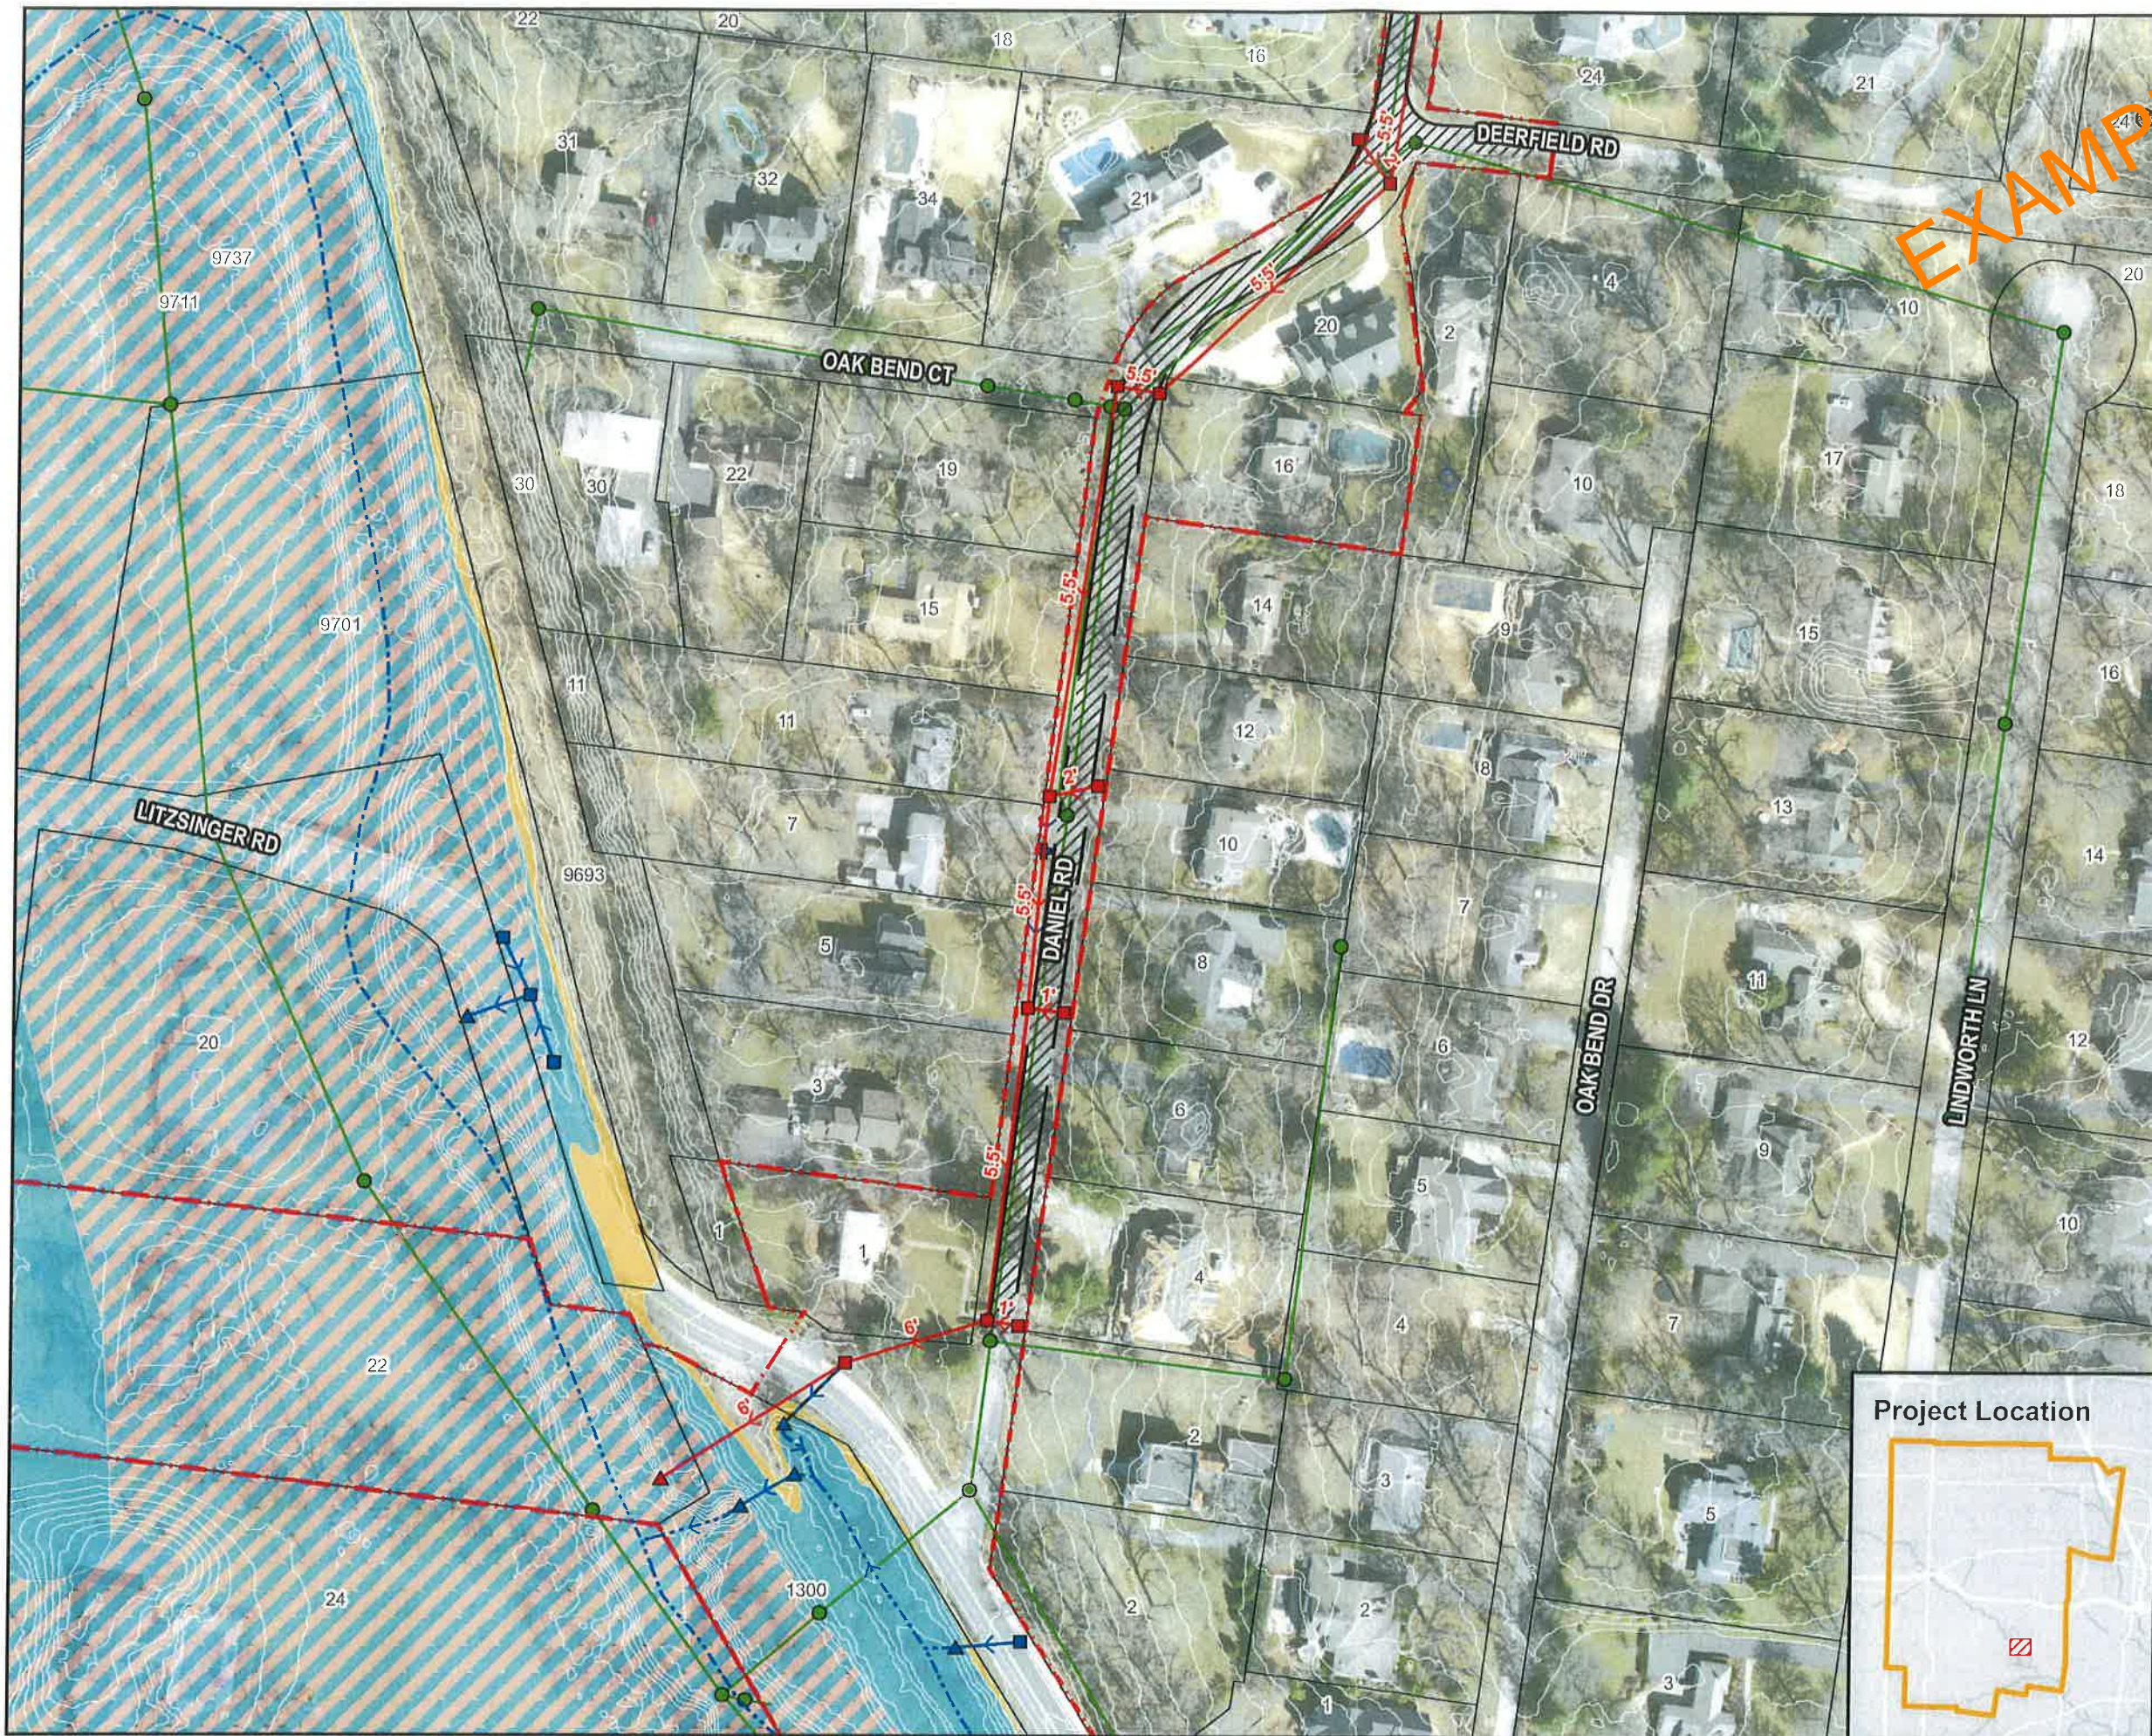
Problem Description
Yard and roadway flooding due to an inadequate drainage system that relies on sinkholes.

Proposed Solution Description
Storm sewer improvements to alleviate flooding from sinkholes not draining fast enough.

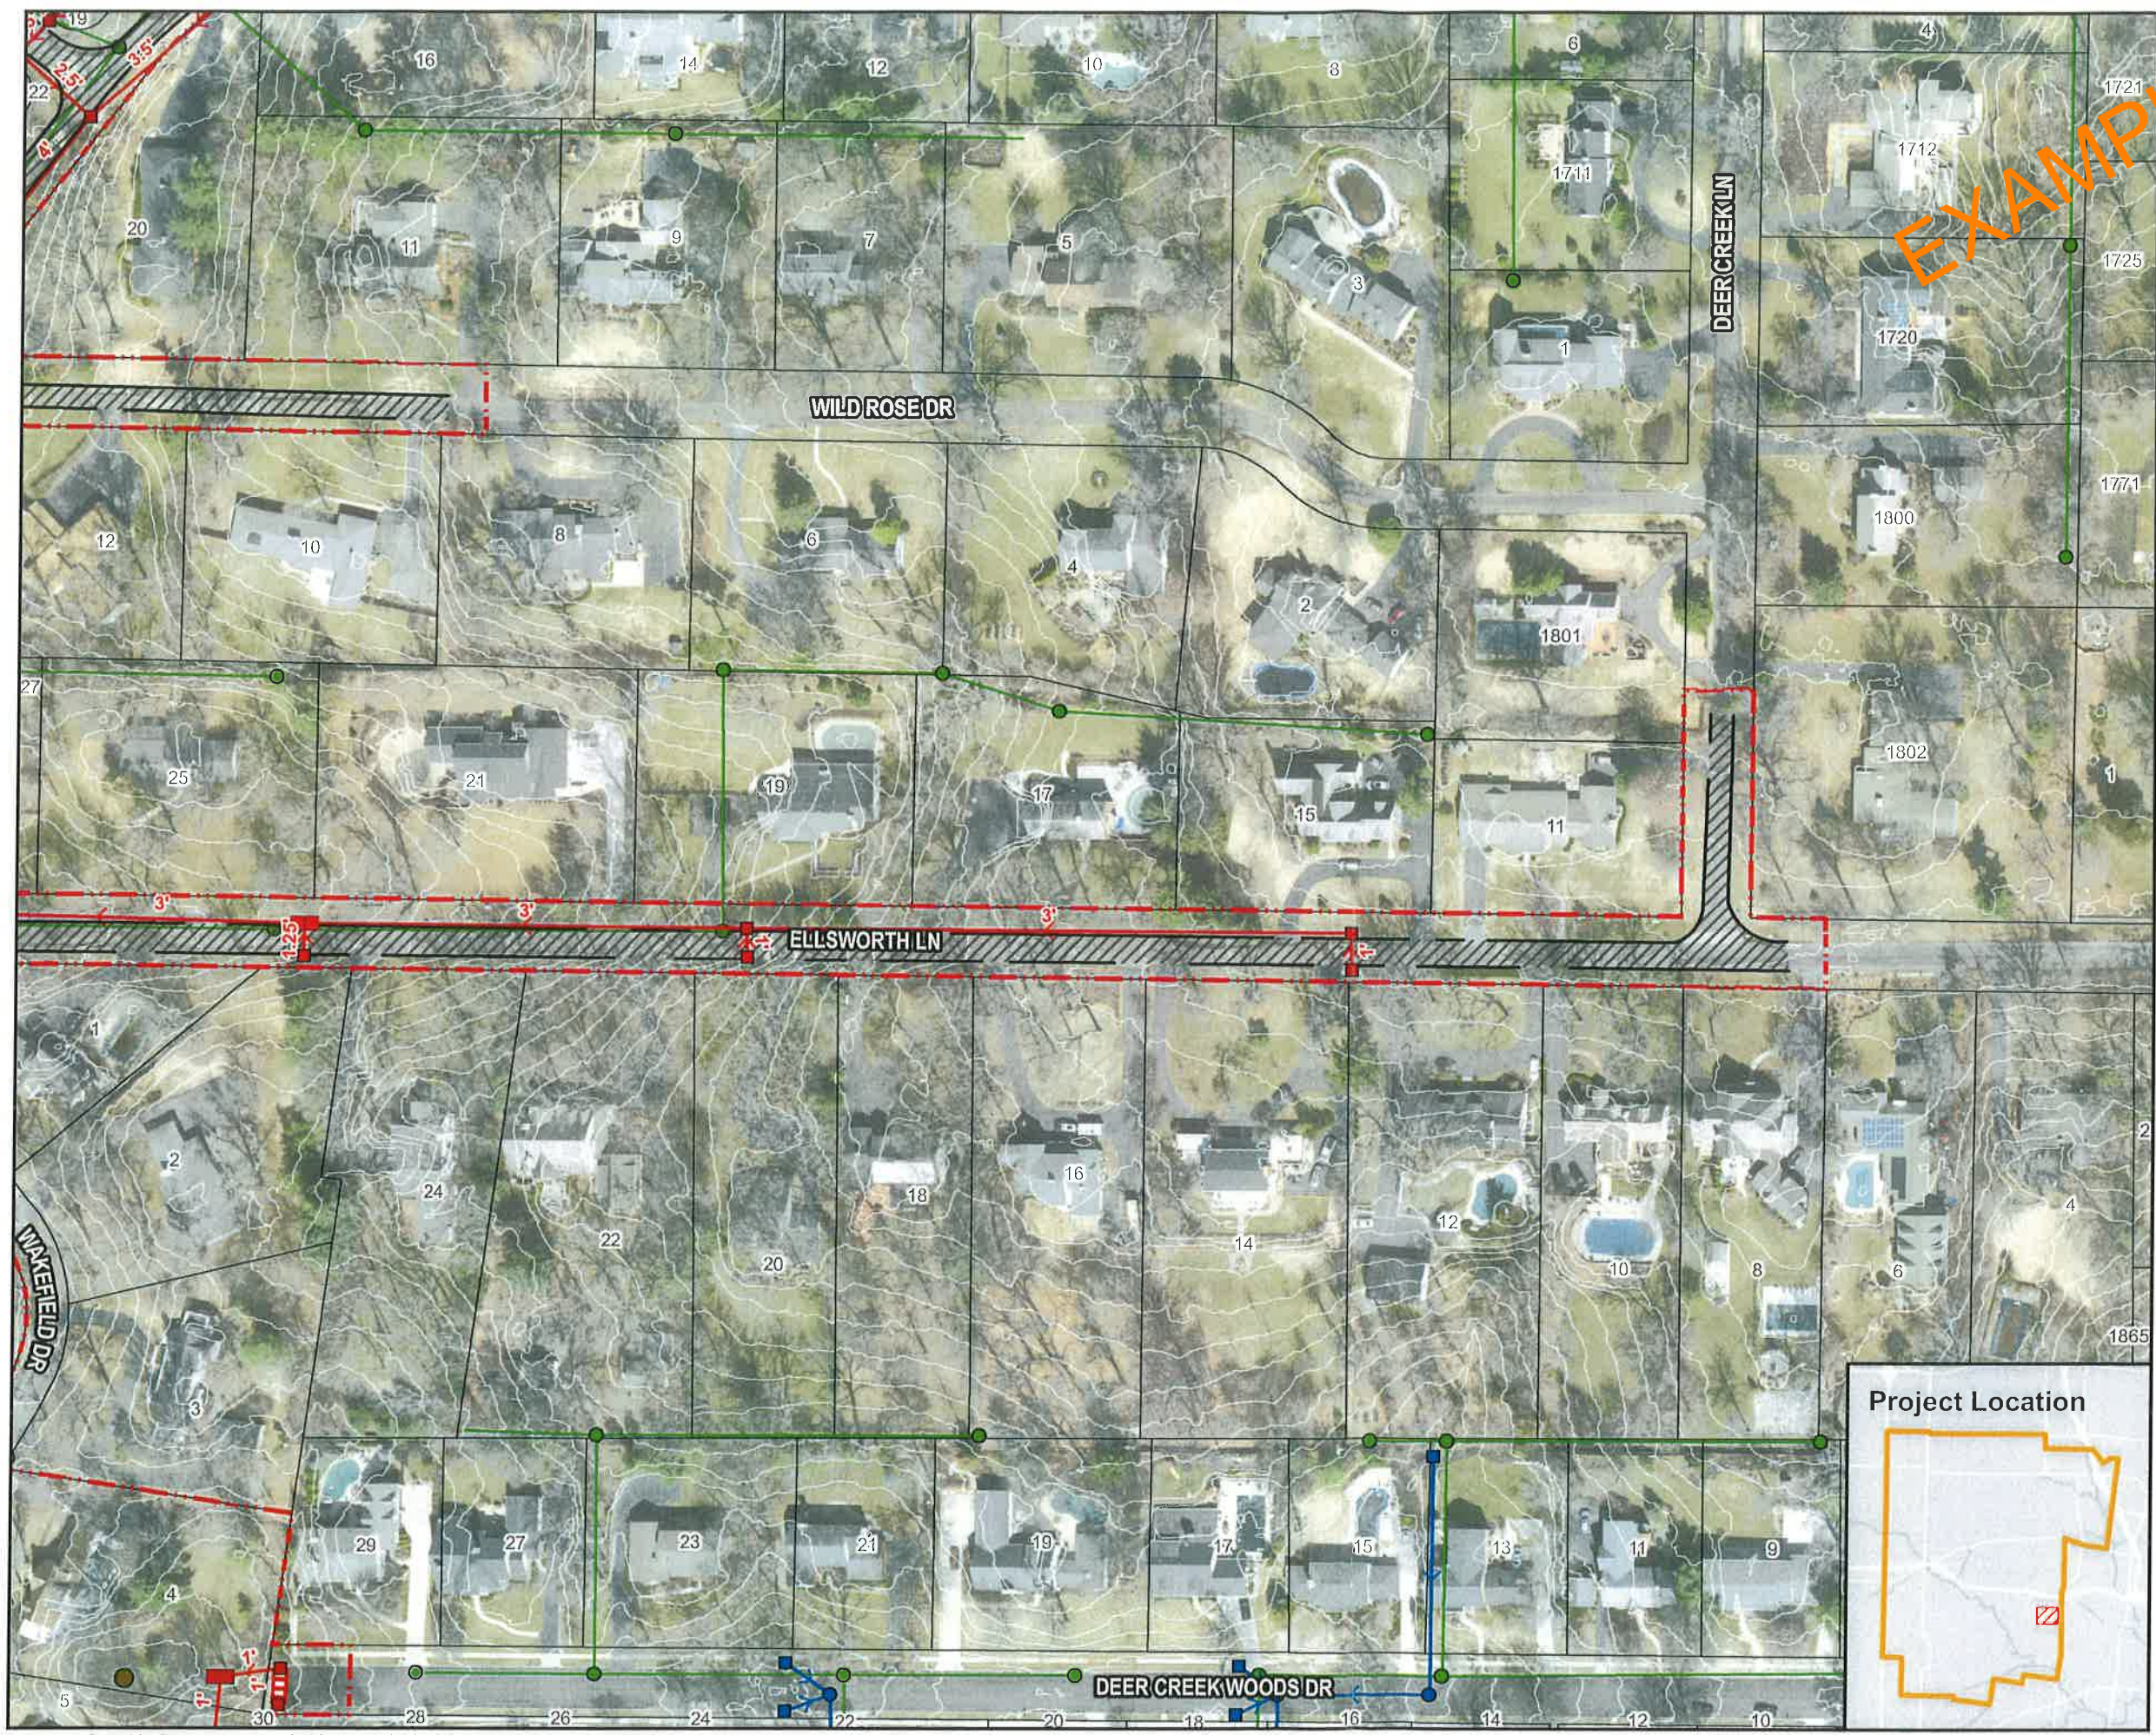
Deerfield/Wakefield

Problem Description
Yard and roadway flooding due to an inadequate drainage system that relies on sinkholes.

Proposed Solution Description
Storm sewer improvements to alleviate flooding from sinkholes not draining fast enough.
