**AGENDA
COMMISSION ON STORM WATER ISSUES
SPECIAL MEETING
HEMAN PARK COMMUNITY CENTER
975 PENNSYLVANIA
Monday, June 12, 2023,
3:30 PM**

❖ Stormwater Master Plan, Continue Discussions

TO: Darren Girdler, Director of Public Works
 Mirela Celaj, CFM, Assistant Director of Public Works
 FROM: Stormwater Master Plan Team (HR Green and Reitz & Jens)
 SUBJECT: University City Stormwater Master Plan
Public versus Private – Recommended Definition Scope of work Task 2.2
 DATE: February 28, 2023

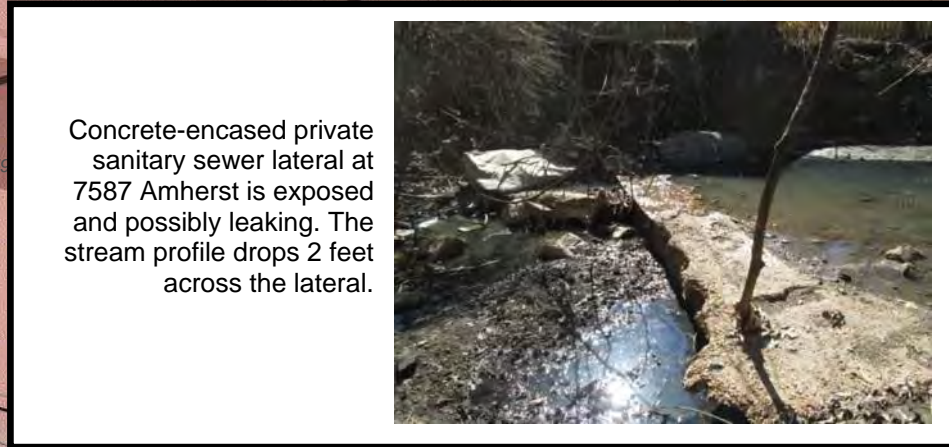
Concrete-encased private sanitary sewer lateral at 7587 Amherst is exposed and possibly leaking. The stream profile drops 2 feet across the lateral.

Concrete-encased private sanitary sewer lateral at 7587 Amherst is exposed and possibly leaking. The stream profile drops 2 feet across the lateral.

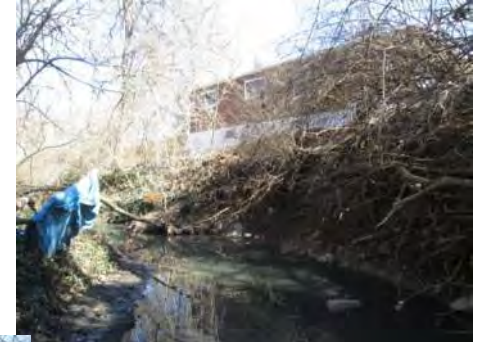
The 13-foot high eroding bank at 7591 Amherst is 9 feet from the home (measured from the top of bank).

The 13-foot high eroding bank at 7591 Amherst is 20 feet from the home (measured from the toe of bank), and has not advanced significantly since 2006, but is considered severe by MSD's bank erosion rating ($V/H=1.46$). The July 26, 2022 flood was above the basement floor of 7591 Amherst and collapsed their fence.

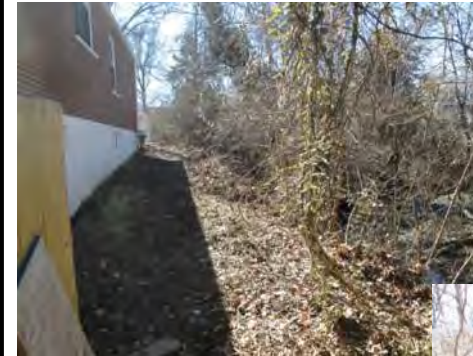
Creek erosion along 7587 Amherst is undermining their fence. The erosion rating at 7587 Amherst is considered a threat to the home ($V/H=0.25$).

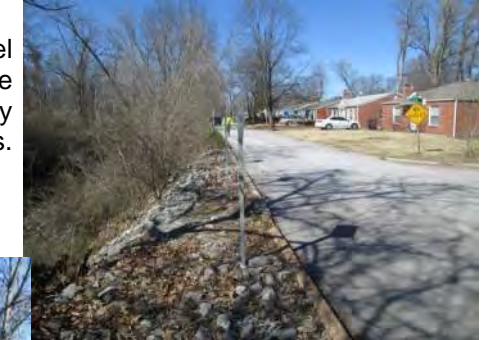
Over-steepened channel banks threaten Mona Drive which provides the only access to 6 houses.

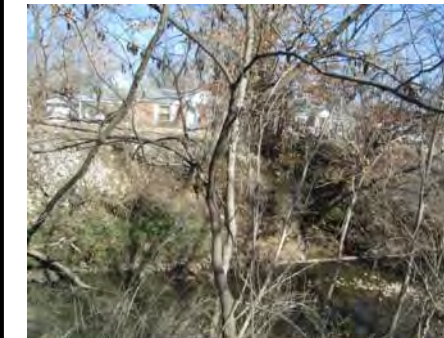
Over-steepened channel banks, and the remains of riprap placed by MSD that has since eroded and slid off the bank.

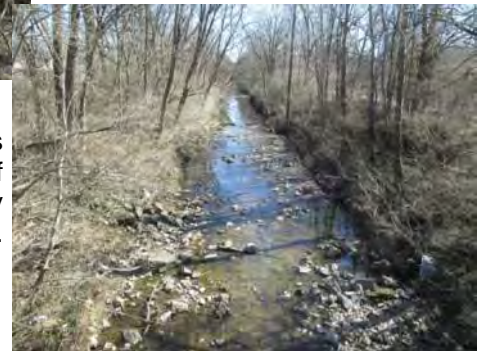
Channel bottom contains riprap, some of which slid off the bank from a previously installed MSD project.

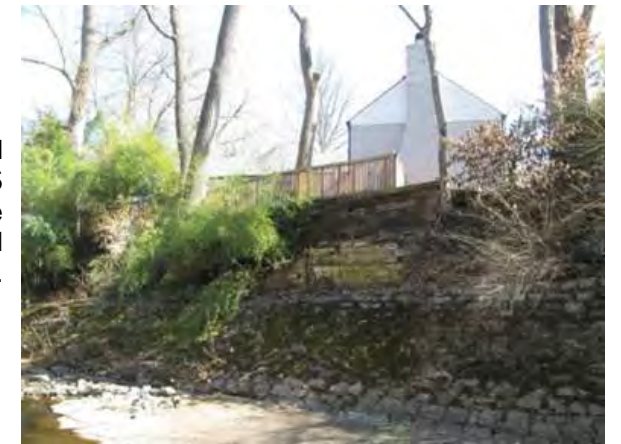
A 16-foot high bank with a combination of public and private walls is compromised and a house located only 7 feet from the top of wall is at risk. The wood tie wall is compromised, but the lower 6-feet of the bank of the Rider des Peres at this location is a WPA hand-placed stone wall, which appears stable.

Wood tie wall and WPA block wall. 7425 Shaftesbury Ave is the house behind the wall in the photo.

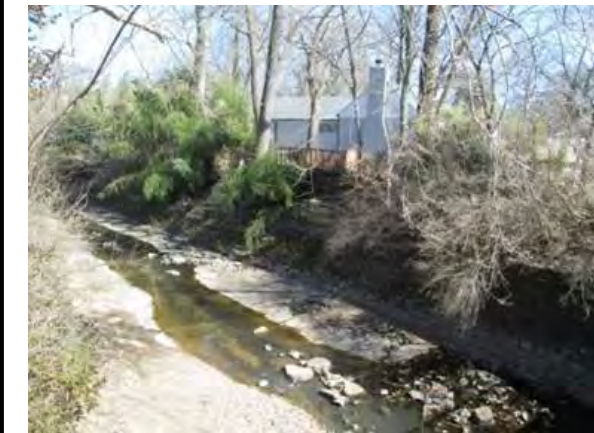
Wood tie wall and WPA block wall, looking downstream.

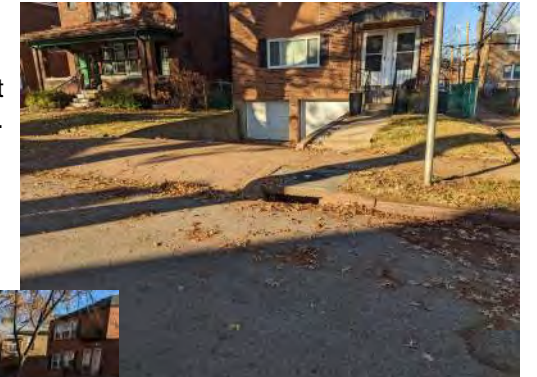
The driveway at 7101 Amherst Ave.

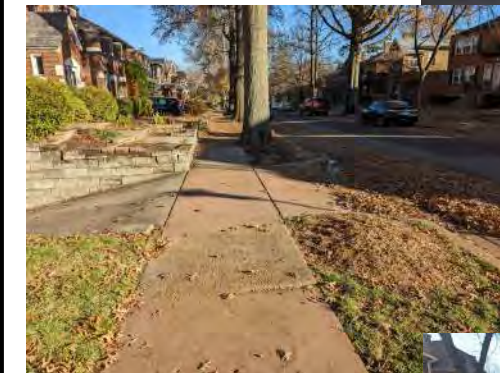
The driveway at 7037 Amherst Ave.

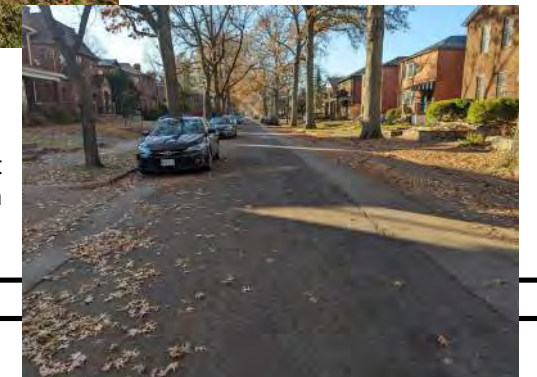
Looking east along Amherst Ave towards the inlets between 7033/7029 Amherst Ave.

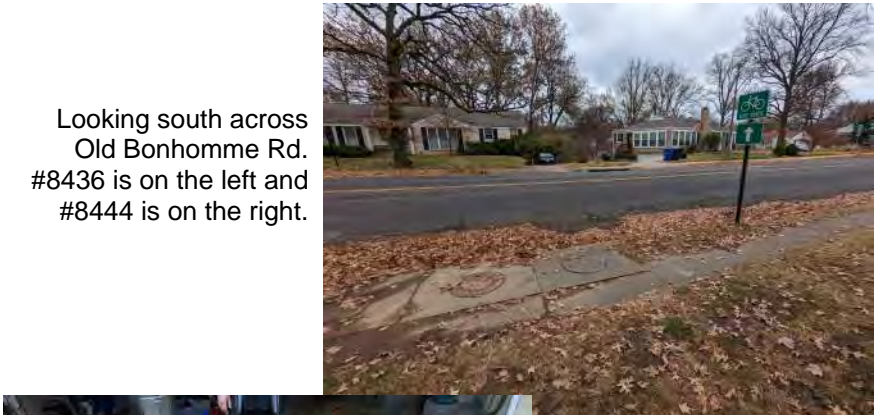
Looking south across Old Bonhomme Rd. #8436 is on the left and #8444 is on the right.

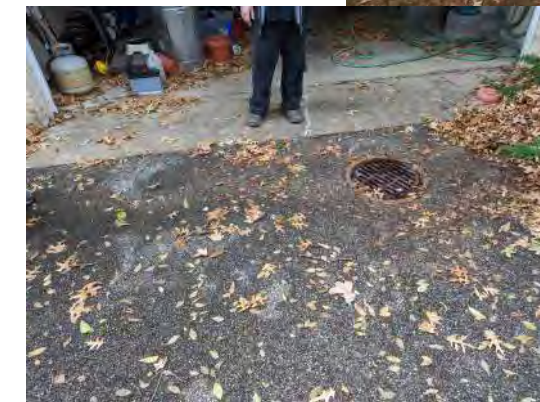
Looking at the ground in front of the driveway at 8436 Old Bonhomme Rd.

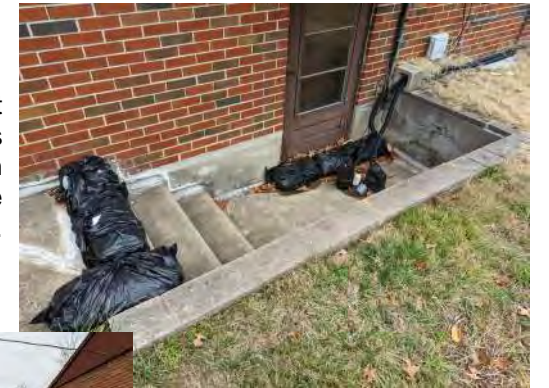
The basement stairwell at 7838 Balson Ave. Sand bags and sump pumps have been added to try to keep the basement from flooding.

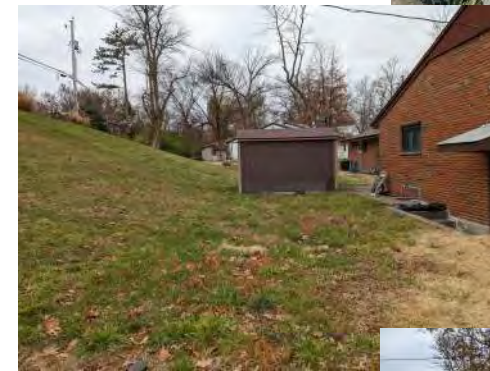
Looking west in the backyard of 7838 Balson Ave. The house is on the right.

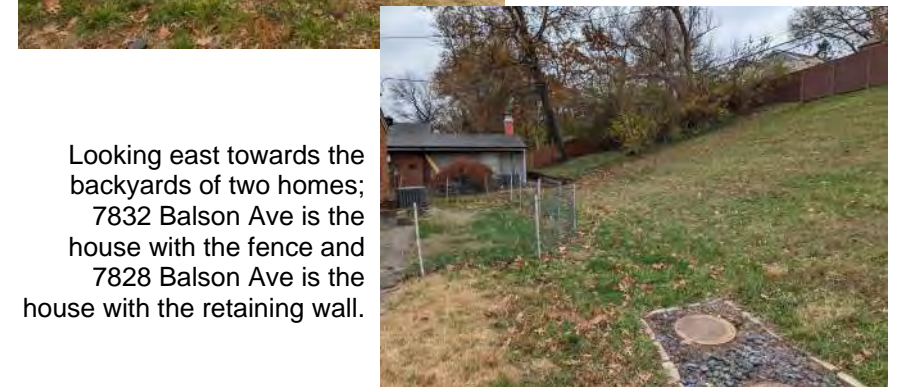
Looking east towards the backyards of two homes; 7832 Balson Ave is the house with the fence and 7828 Balson Ave is the house with the retaining wall.

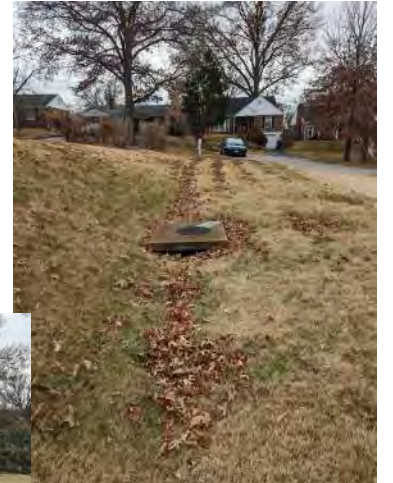
Looking south along the property line between #7353 and 7339.

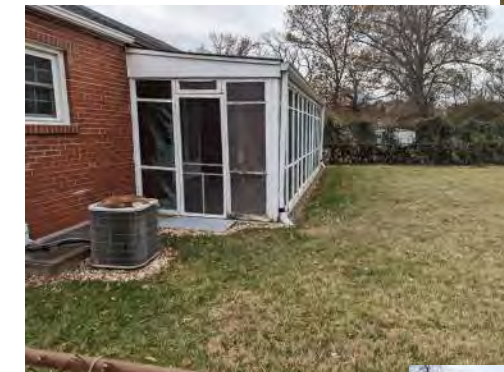
Looking towards the back patio at #7353. Ponded water has nearly reached the threshold of the door into the house (not the door to the screened in patio).

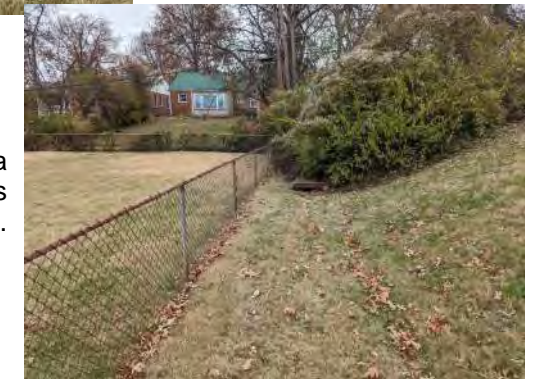
Looking north towards the area inlet in the backyards. #7353's backyard is on the left.

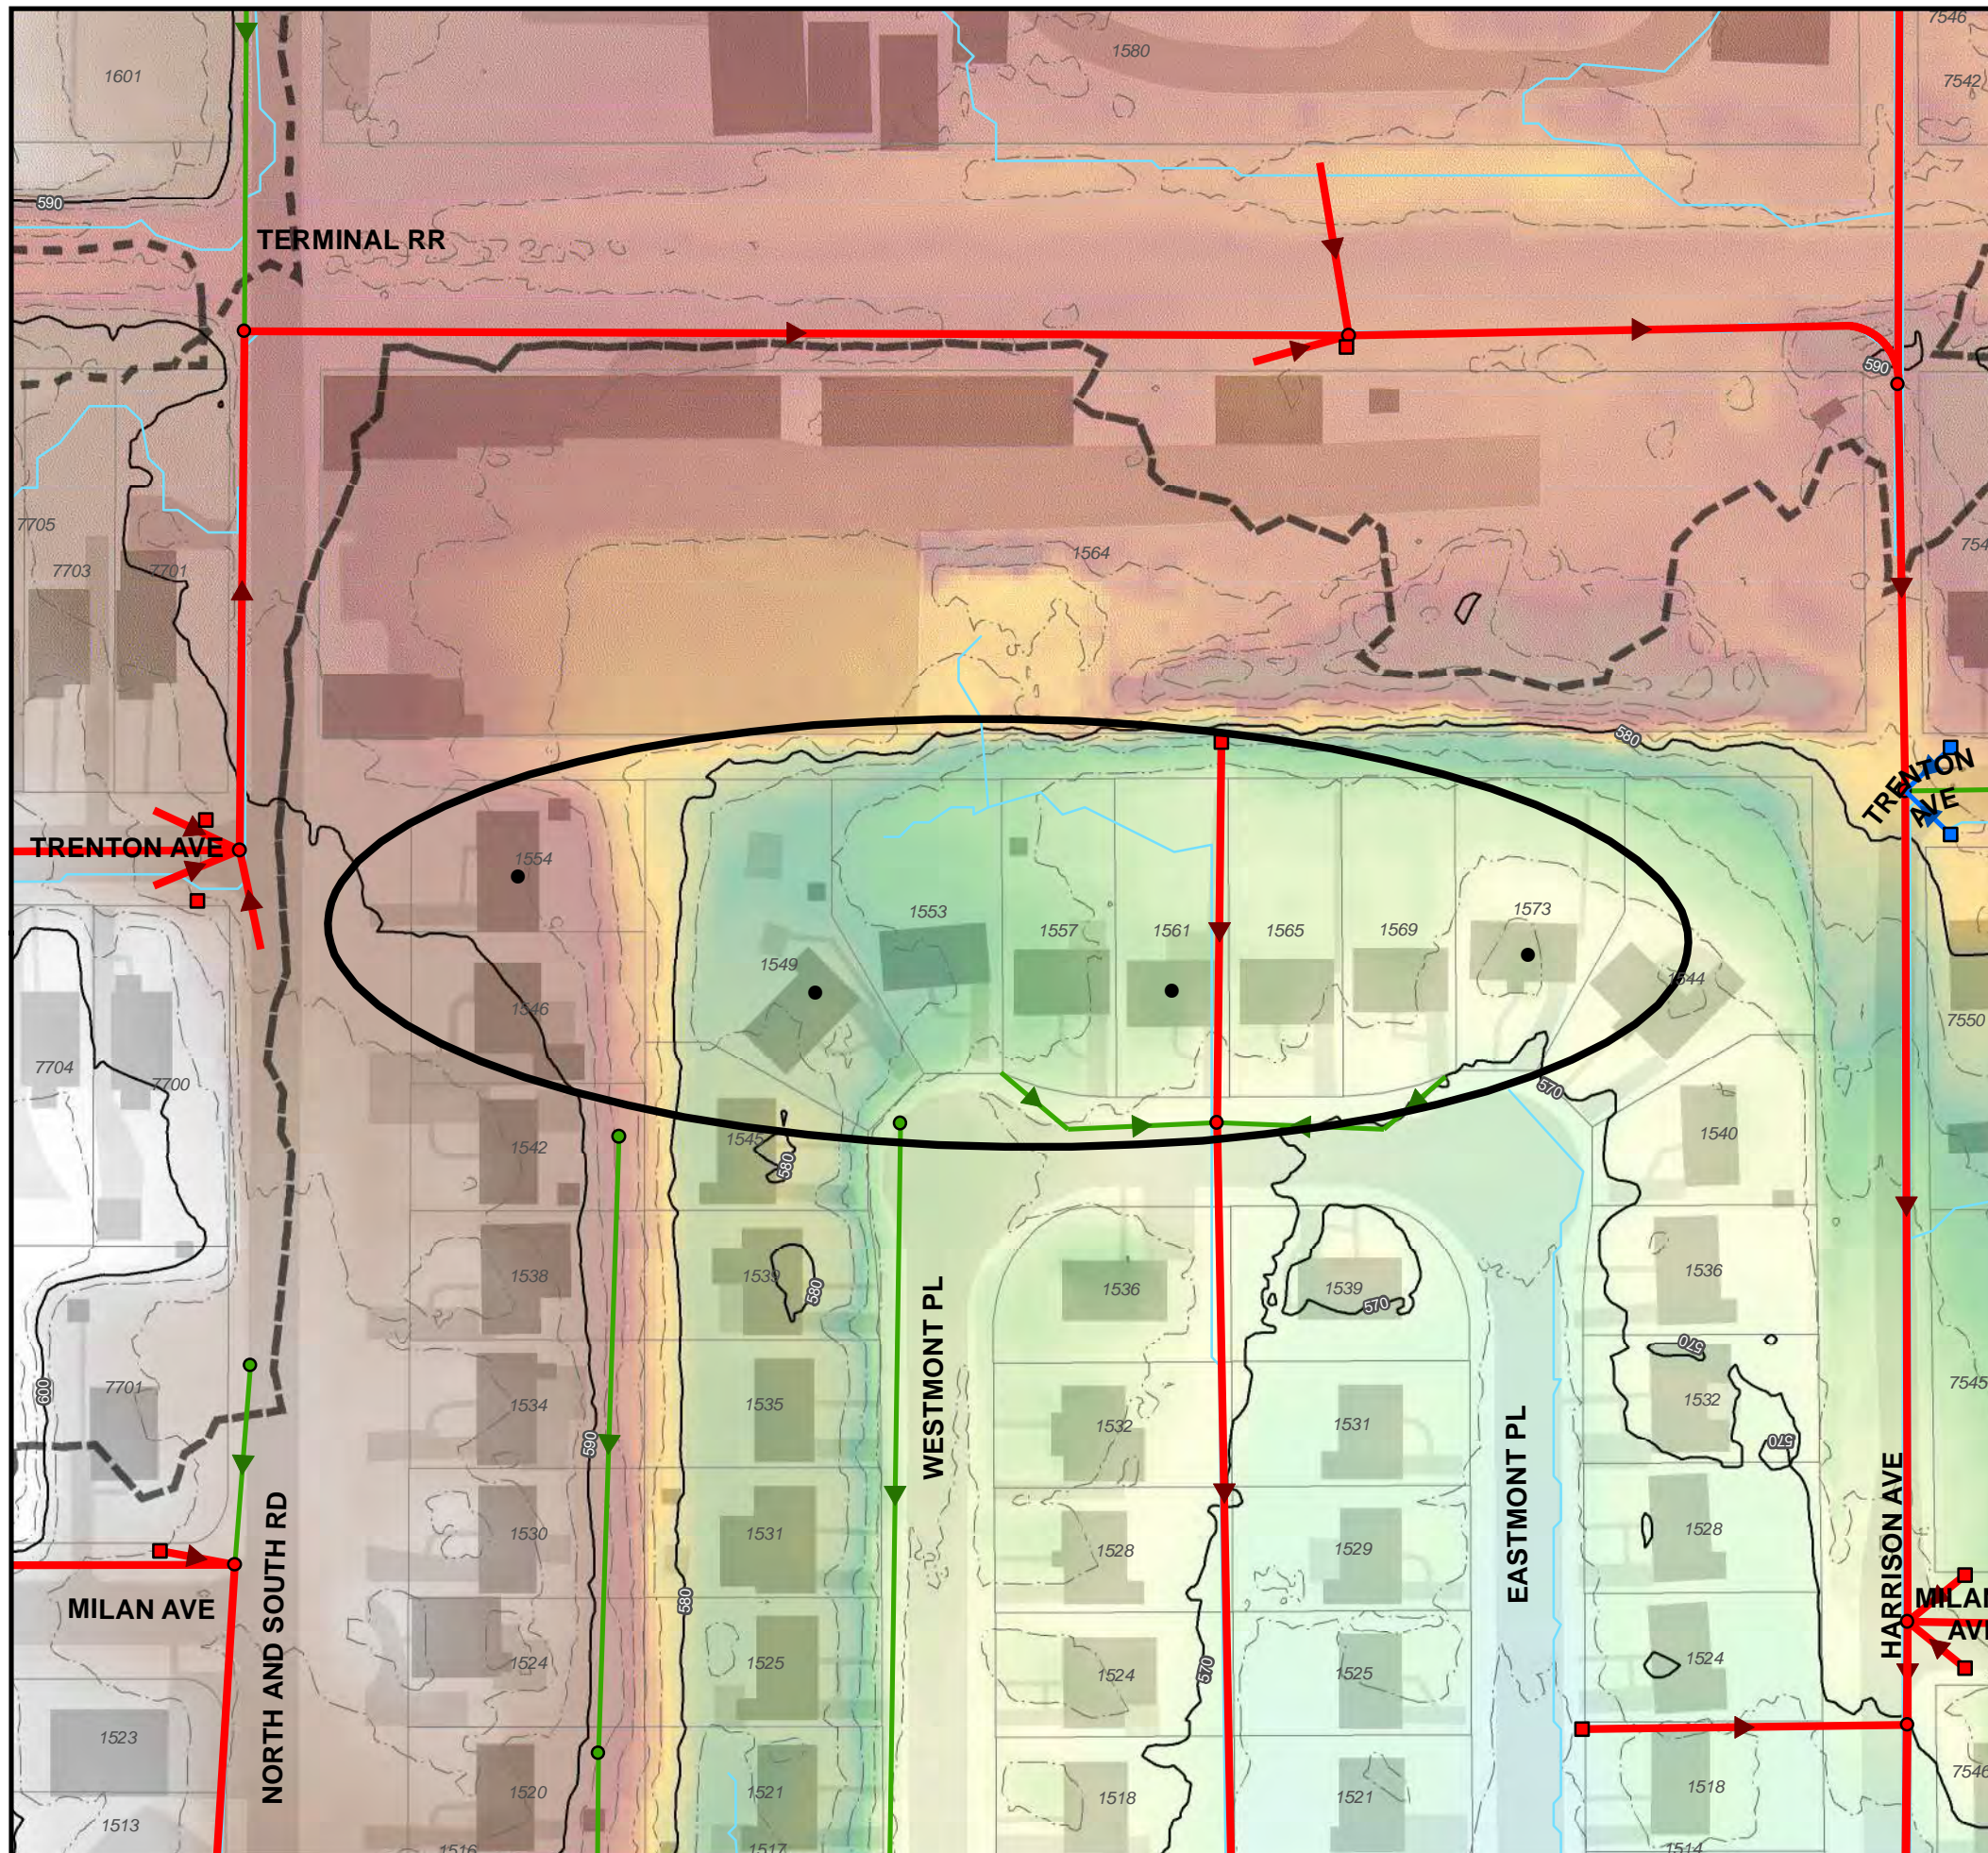
Milan Ave
Ranked #2 in the Backyard Category

The property north of the Grenville Subdivision sits about 6-10 feet above the backyards of several houses. About 3.3 acres of drainage reaches the backyards of 1561 to 1573 Westmont Place.

There is an inlet behind 1561, but only about half of a side is able to accept water due to grading issues. Note the inlet appears to be in a strip of ROW between the houses and business.

There is an inlet behind 1561, but only about half of a side is able to accept water due to grading issues. Note the inlet appears to be in a strip of ROW between the houses and business.

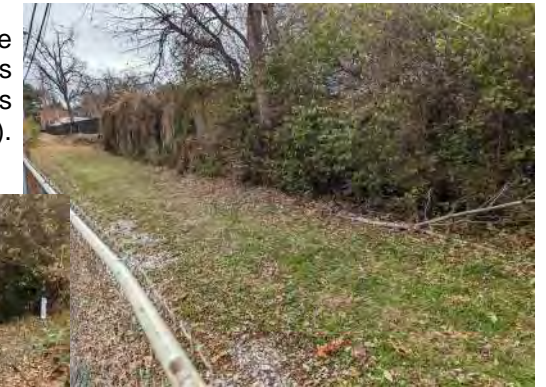
Looking northwest towards the strip of ROW between homes (on the left) and the business to the north (on the right).

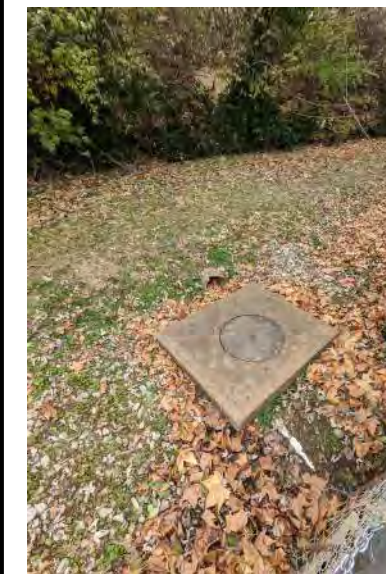
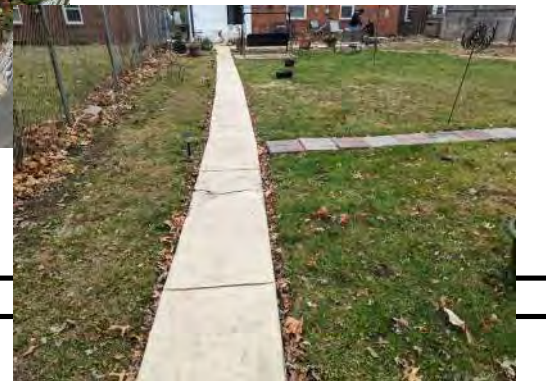
Looking towards the inlet north of #1561. Due to grading, the inlet does not appear to collect much runoff.

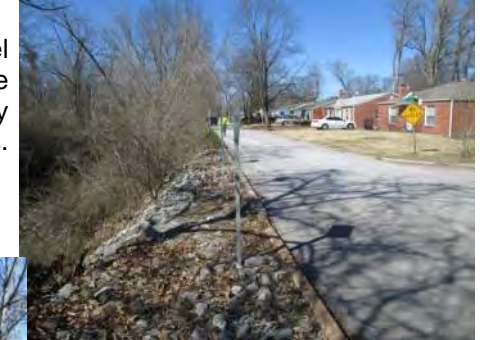
A 700-foot reach of the River des Peres is over-steepened and actively eroding. The top of bank is 16-feet high and has eroded to within 5 feet of the curb line of Mona Drive. The north end of Mona Drive is the only road access/egress for six homes. Using MSD's erosion rating, the street is more severely threatened (V/H=0.44) than the homes (V/H=0.18). MSD installed riprap along portions of Mona Drive in approximately 2017, but most of this riprap has since eroded and slid off the bank. An additional 600-foot reach of bank along the downstream end of Mona Drive is somewhat more stable. The homes along Mona Drive flooded on July 26, 2022.

Over-steepened channel banks threaten Mona Drive which provides the only access to 6 houses.

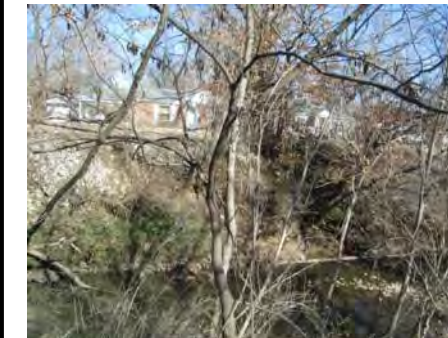
Over-steepened channel banks, and the remains of riprap placed by MSD that has since eroded and slid off the bank.

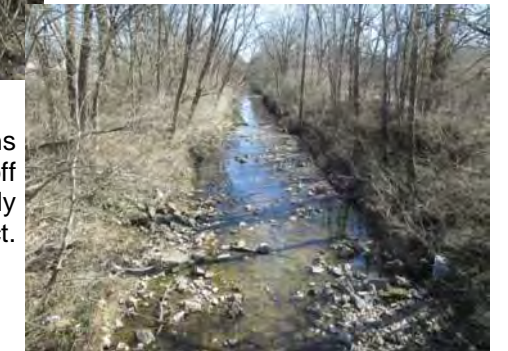
Channel bottom contains riprap, some of which slid off the bank from a previously installed MSD project.

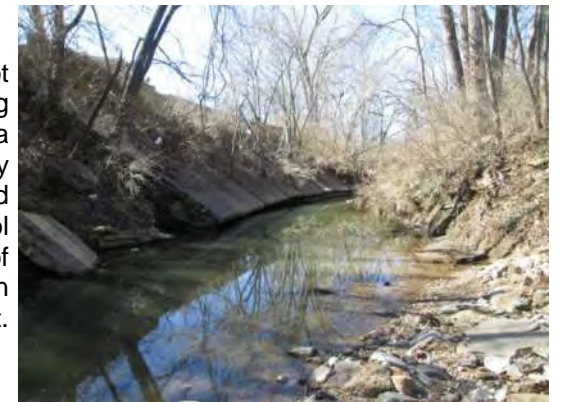
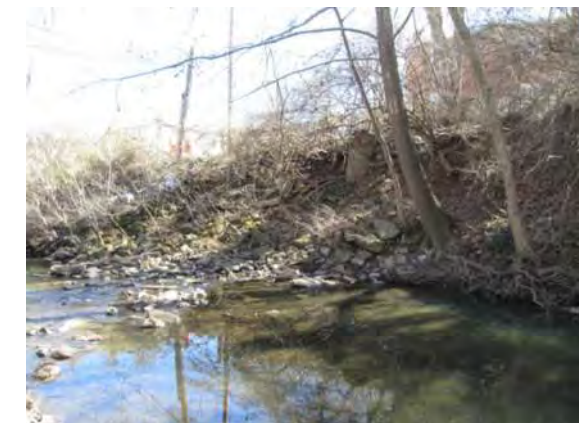
An approximately 175-foot reach of the right-descending river bank is lined with a concrete slab, but the integrity of the concrete is compromised by a 3-foot deep scour pool along the toe of bank. Failure of slab will likely cause failure in the parking lot.

MSD infrastructure along the right-descending river bank is threatened by bank erosion including a combined sewer manhole, a combined sewer overflow (CSO) structure, and a storm sewer outflow structure.

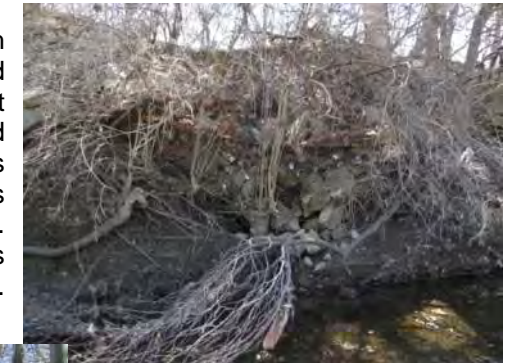
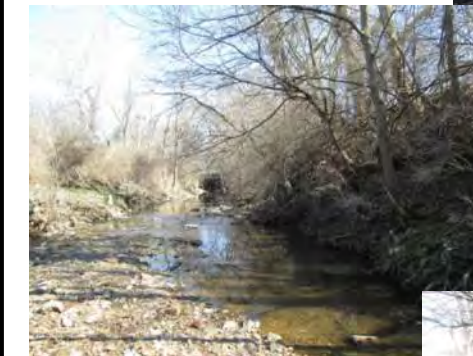
The foundation of a 6-foot high mid-slope fence is eroded and the fence is collapsing. It appears that riprap was added from the top of slope to address an area of gulley erosion, but this riprap is sliding down the bank. The weight of this riprap is contributing to the fence failure.

On the right descending bank are the eroding bank, collapsing fence, and sliding riprap.

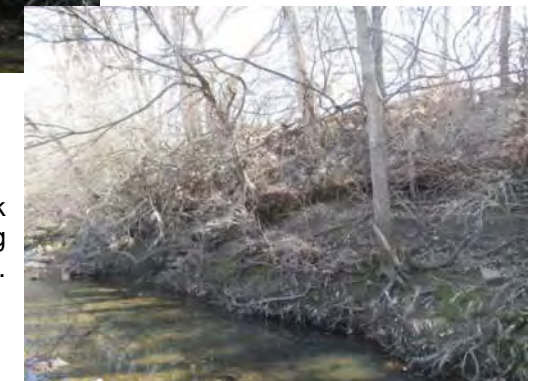
On the right descending bank are the eroding bank, collapsing fence, and sliding riprap.

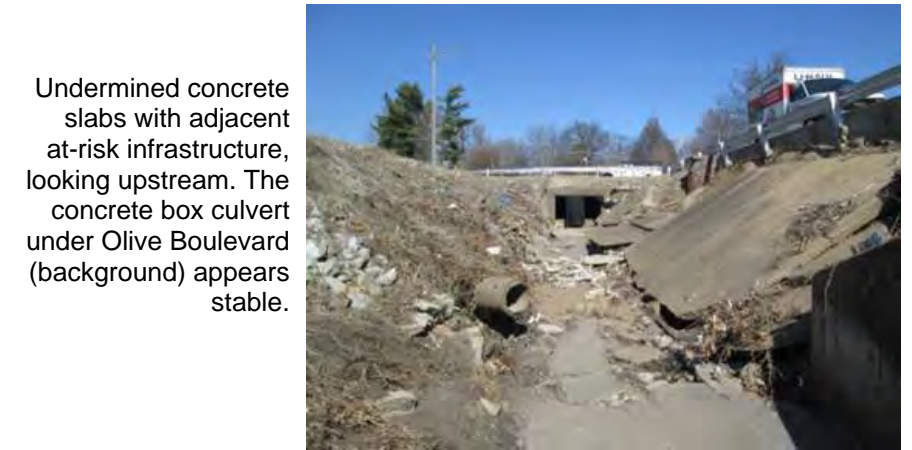
Problem Description:
Concrete slabs lining a tributary to the River des Peres are undermined and have failed, looking upstream. The foundation of the concrete-curb adjacent U-Haul parking lot is exposed on the east side of the channel. At-risk infrastructure includes the commercial parking lot, an inlet manhole, and a pipe outfall.

Undermined concrete slabs with adjacent at-risk infrastructure, looking upstream. The concrete box culvert under Olive Boulevard (background) appears stable.

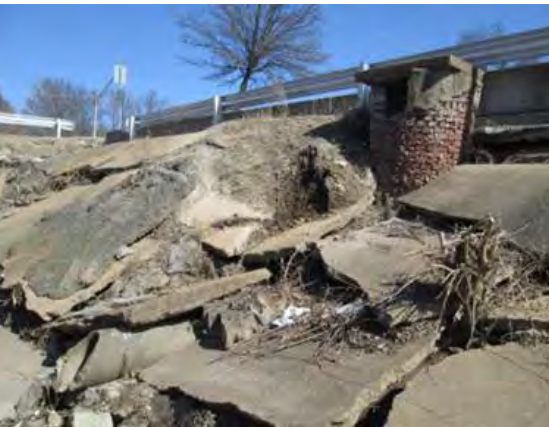
Exposed foundation of the adjacent parking lot.

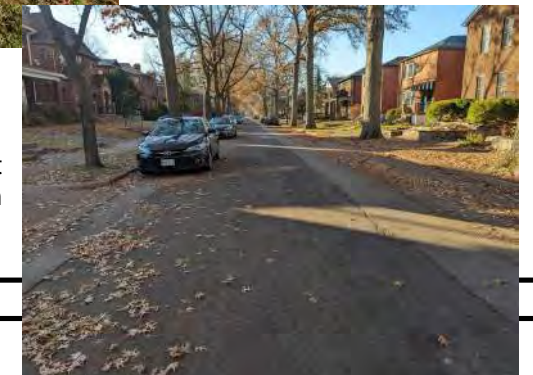
Looking east along Amherst Ave towards the inlets between 7033/7029 Amherst Ave.

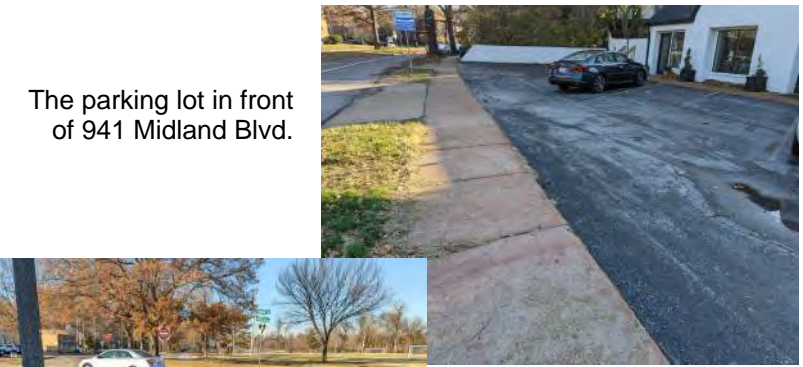
Problem Description:
 The commercial building at 941 Midland Blvd has been flooded by ponded water in the street. The owner indicated that when this happens, the inlets won't drain. Investigation is necessary to determine if the flooding issue is due to inlet capacity, pipe capacity, or high tailwater from the River Des Peres, or a combination of these issues.

The parking lot in front of 941 Midland Blvd.

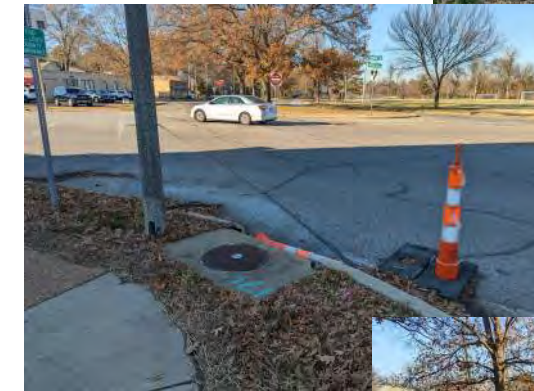
Looking north towards the inlet at the southwest corner of Midland Blvd and Balson Ave.

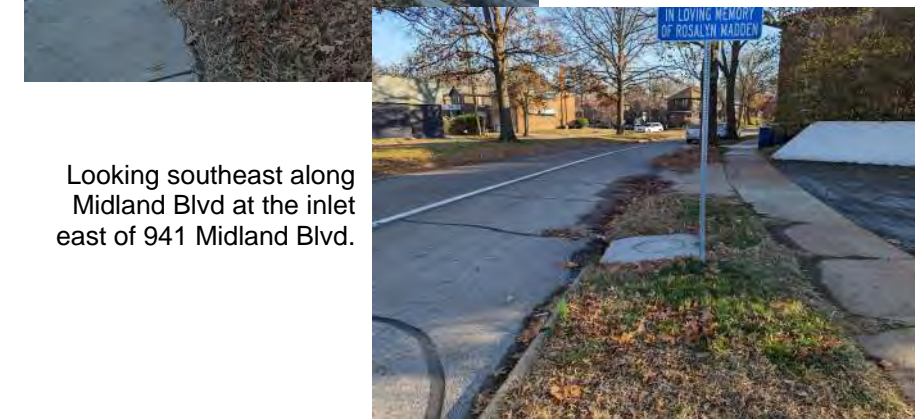
Looking southeast along Midland Blvd at the inlet east of 941 Midland Blvd.

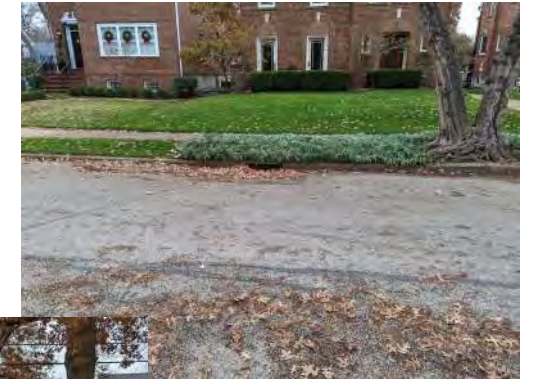
Residents say that the low point on W Point Ct floods constantly. The street does not have a distinct crown. Asphalt patching has made the street uneven in some places. There are 4 inlets near the low point, but non appear very efficient. There is not a well-defined sag and inlets appear to clog easily with leaves.

Looking towards the grated curb inlet with side intake between #416 and 414. The side intake is rather narrow and the grate is clogged with leaves.

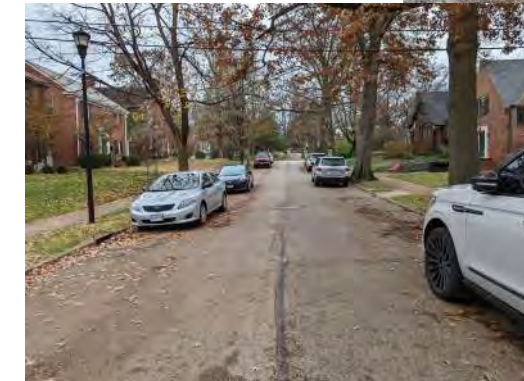
Looking south towards the inlets in front of #414 and 415. Both of these inlets are grated with a side intake.

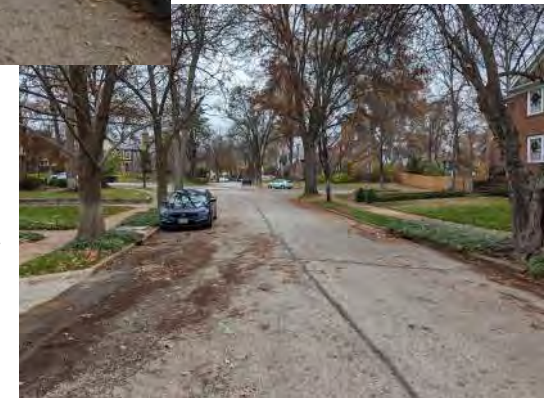
Looking north towards the northern two inlets on W Point Ct. Both are grated inlets with side intakes.

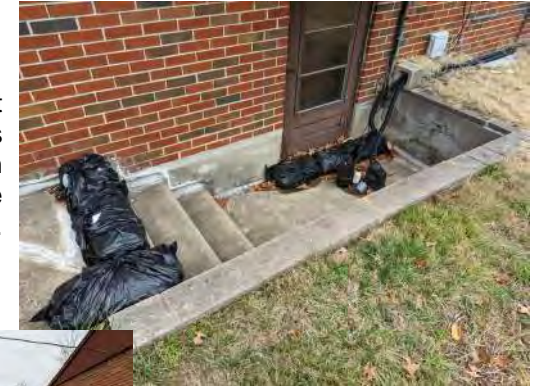
The basement stairwell at 7838 Balson Ave. Sand bags and sump pumps have been added to try to keep the basement from flooding.

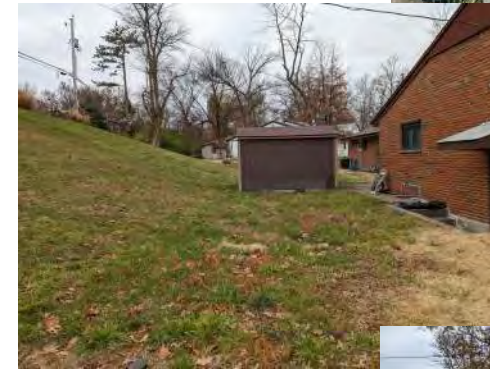
Looking west in the backyard of 7838 Balson Ave. The house is on the right.

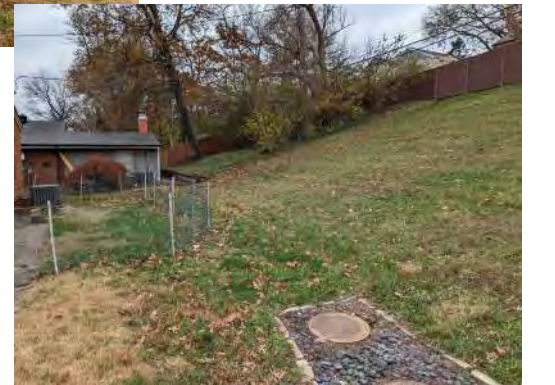
Looking east towards the backyards of two homes; 7832 Balson Ave is the house with the fence and 7828 Balson Ave is the house with the retaining wall.

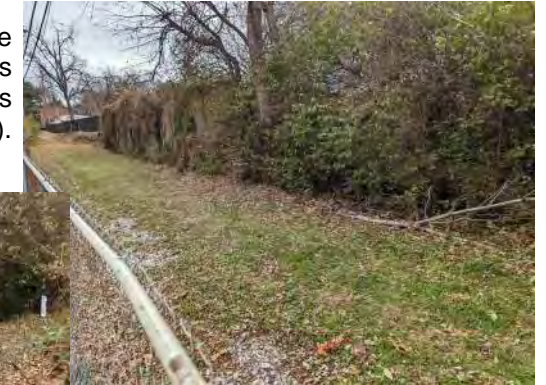
Looking northwest towards the strip of ROW between homes (on the left) and the business to the north (on the right).

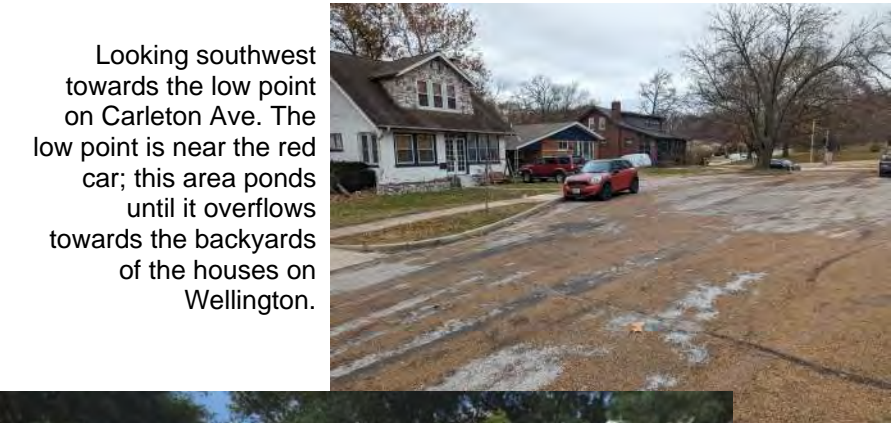
It should be noted that there is a low point on the south end of the cul-de-sac for Carleton Ave which contributes to the drainage area; however, this area is not as significant as the contributing drainage area which includes the yards and homes of the surrounding properties.

Looking southwest towards the low point on Carleton Ave. The low point is near the red car; this area ponds until it overflows towards the backyards of the houses on Wellington.

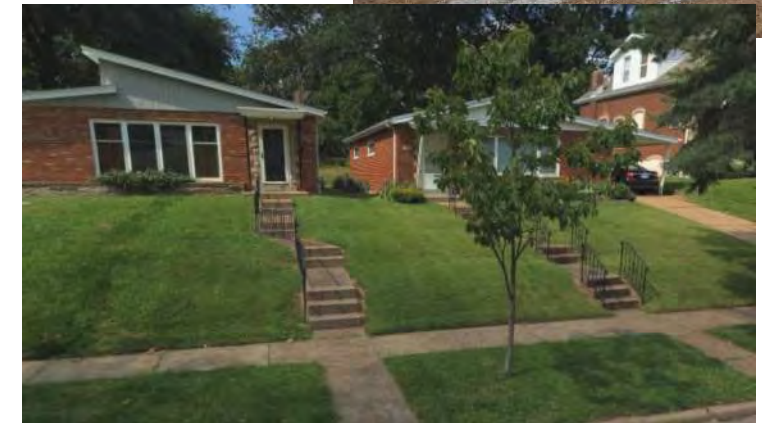
Looking north between #7423 (on the left) and #7419 (on the right). The space between houses may convey some of the runoff from the backyards, but the grading and available space is insufficient.

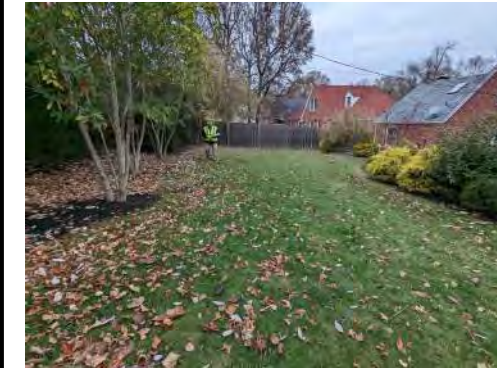
Looking north between #7924 and 7928 towards erosion and a yard drain.

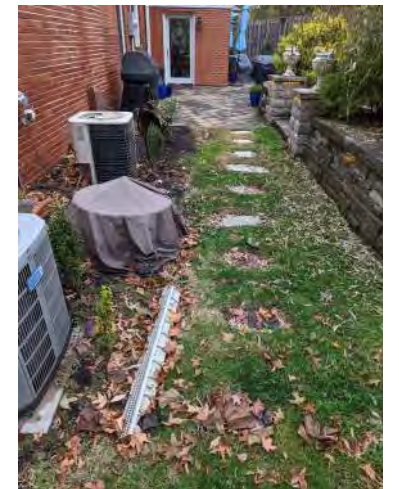
Looking east along the back of 7924 Lafon Pl. A yard drain was installed in an attempt to reduce ponding near the house.

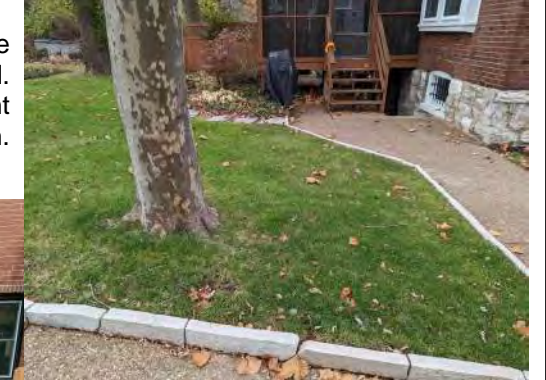
Looking west towards the backyard at 7258 Lindell Blvd. The stairwell to the basement is under the porch.

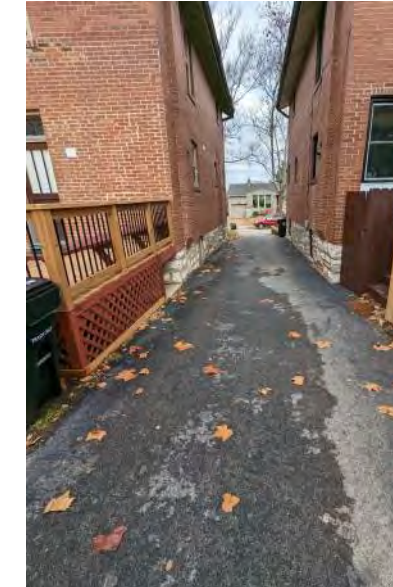
Looking north between #7252 (on the left) and #7250 (on the right). Basement windows are within 1-3 inches of the driveway - a potential source of flooding to the basements.

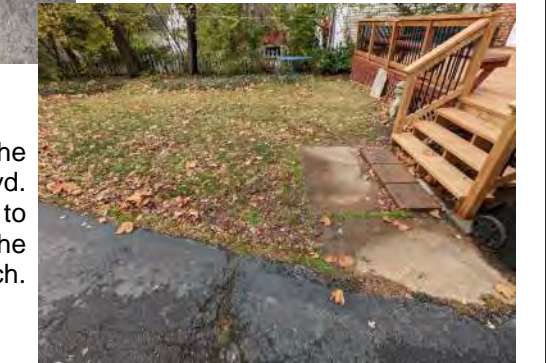
Looking west towards the backyard at 7252 Lindell Blvd. Ponding occurs near the steps to the patio. There is a stairwell to the basement under the porch.

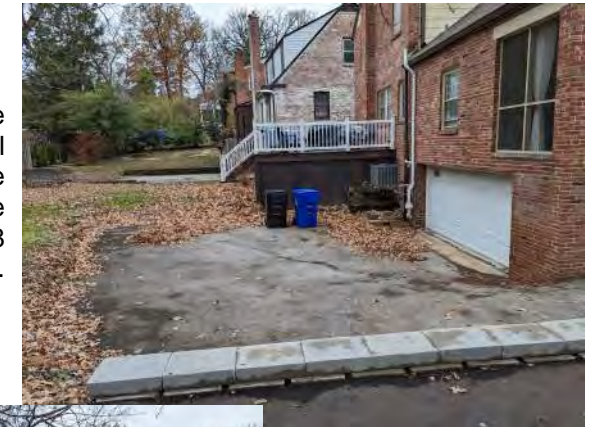
Looking towards the backyard of 8132 Cornell Ct; the basement garage has flooded since it is the low point of about 1.8 acres.

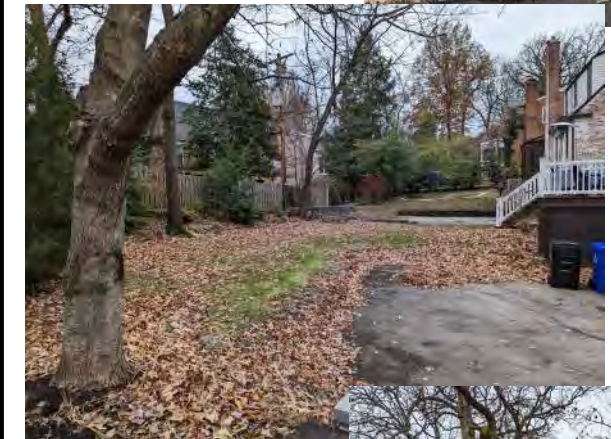
Looking west towards the backyard of #8132.

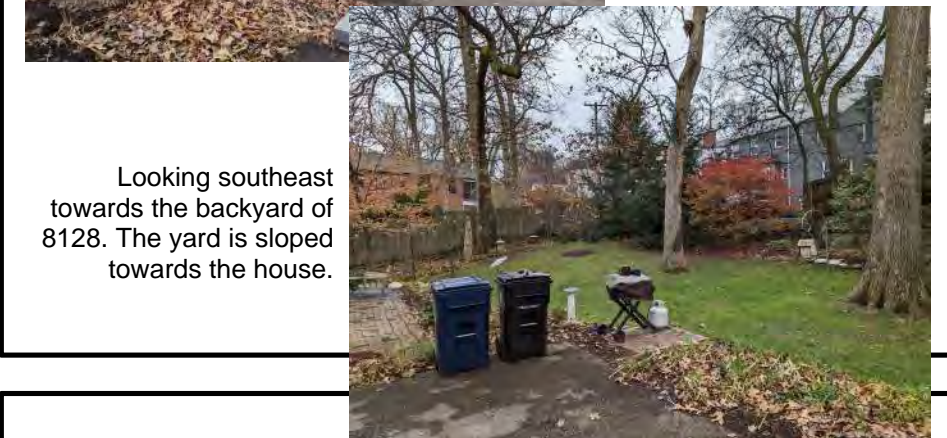
Looking southeast towards the backyard of 8128. The yard is sloped towards the house.

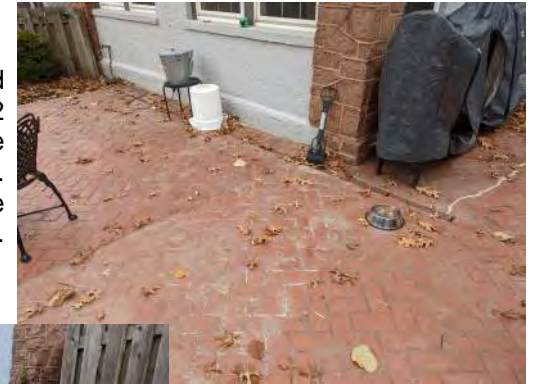
A slotted drain was installed by the homeowner at 7232 Northmoor Dr to reduce ponding against the house. This type of private drainage is common in the area.

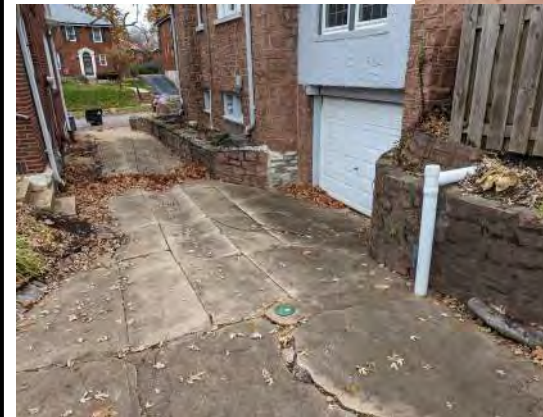
Looking north between #7236 (on the left) and #7232 (on the right). The tuck-under garage is at risk of flooding since the main flow path for water in the backyards is to flow down this driveway.

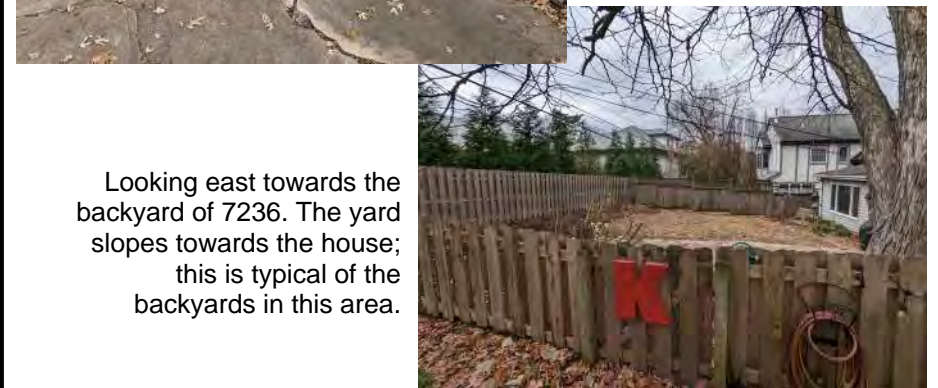
Looking east towards the backyard of 7236. The yard slopes towards the house; this is typical of the backyards in this area.

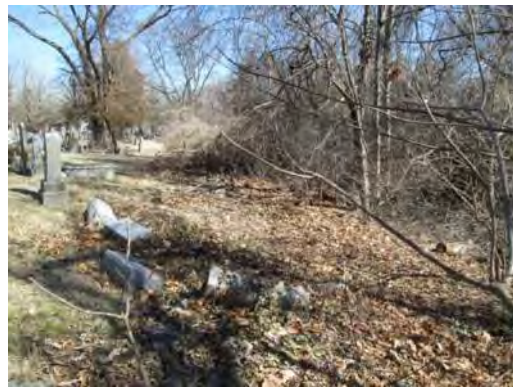
Gravestones at the B'Nai Amoona cemetery along the top of the creek bank have been damaged possibly as a result of bank erosion.

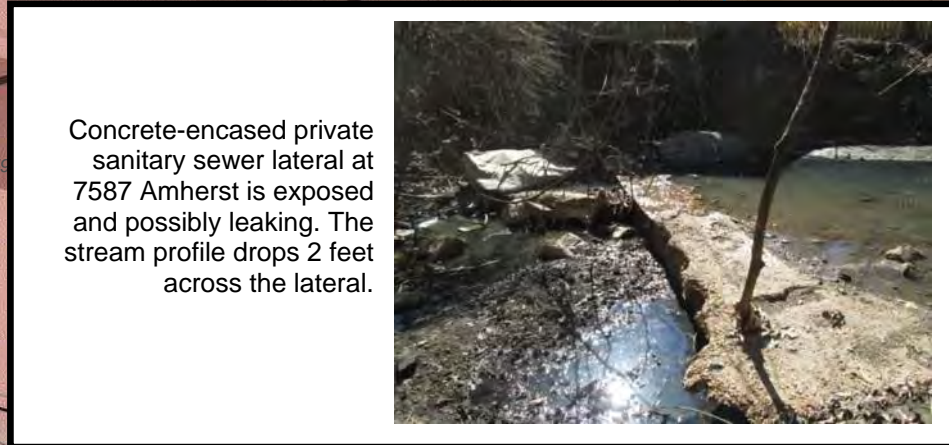
Concrete-encased private sanitary sewer lateral at 7587 Amherst is exposed and possibly leaking. The stream profile drops 2 feet across the lateral.

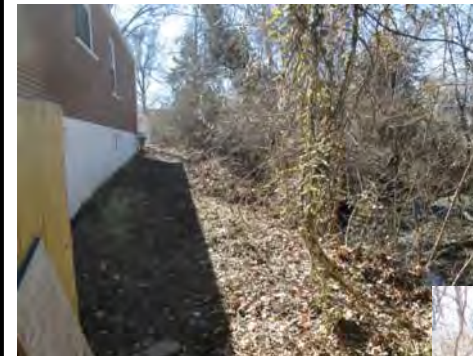
The 13-foot high eroding bank at 7591 Amherst is 9 feet from the home (measured from the top of bank).

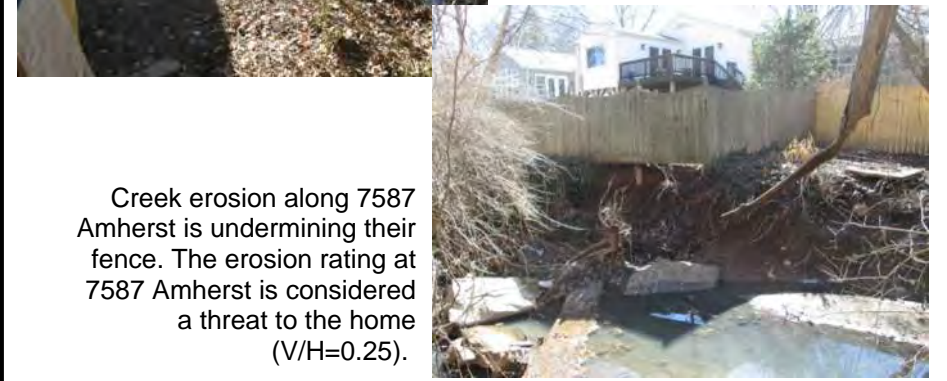
Creek erosion along 7587 Amherst is undermining their fence. The erosion rating at 7587 Amherst is considered a threat to the home (V/H=0.25).

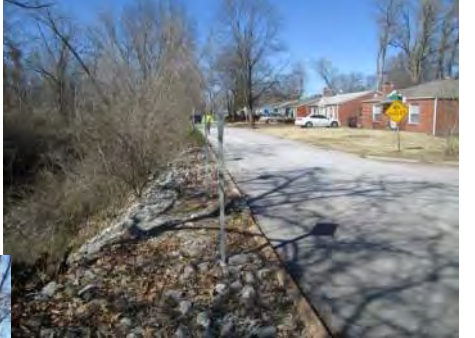
Over-steepened channel banks threaten Mona Drive which provides the only access to 6 houses.

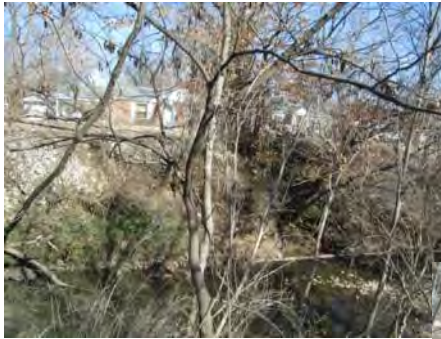
Over-steepened channel banks, and the remains of riprap placed by MSD that has since eroded and slid off the bank.

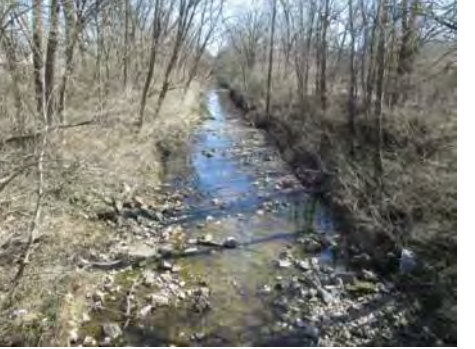
Channel bottom contains riprap, some of which slid off the bank from a previously installed MSD project.

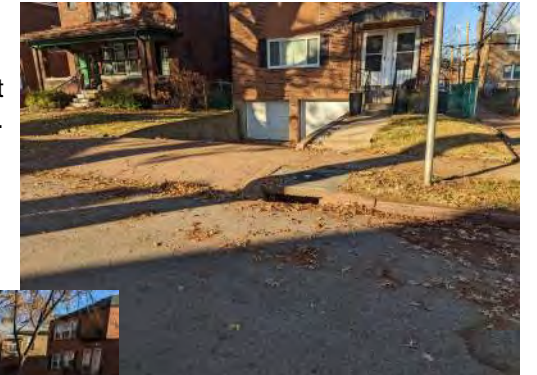
The driveway at 7101 Amherst Ave.

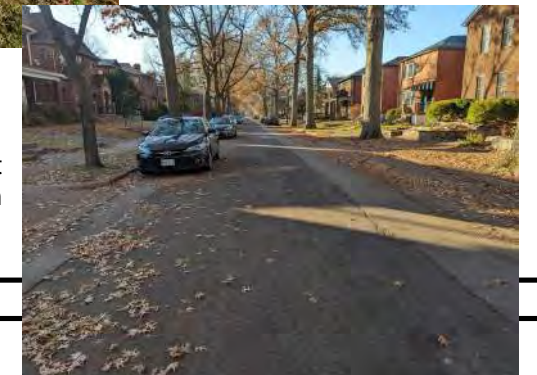
Looking east along Amherst Ave towards the inlets between 7033/7029 Amherst Ave.

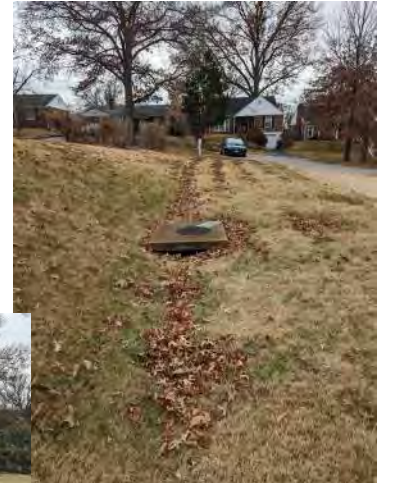
Looking south along the property line between #7353 and 7339.

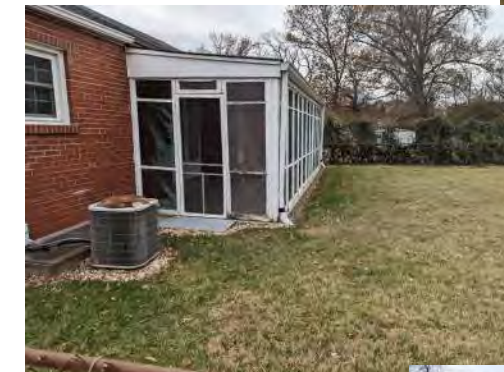
Looking towards the back patio at #7353. Ponded water has nearly reached the threshold of the door into the house (not the door to the screened in patio).

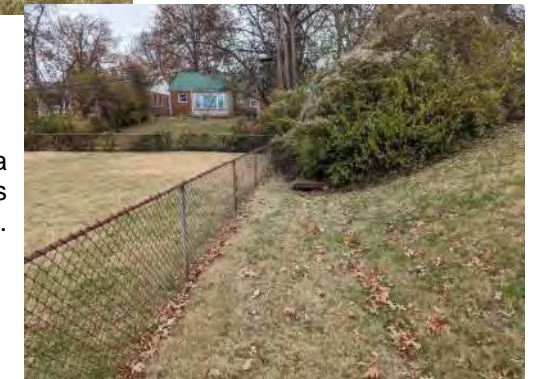
Looking north towards the area inlet in the backyards. #7353's backyard is on the left.
