**AGENDA
COMMISSION ON STORM WATER ISSUES
SPECIAL MEETING
HEMAN PARK COMMUNITY CENTER
975 PENNSYLVANIA
Monday, June 12, 2023,
3:30 PM**

❖ Stormwater Master Plan, Continue Discussions

TO: Darren Girdler, Director of Public Works
 Mirela Celaj, CFM, Assistant Director of Public Works
 FROM: Stormwater Master Plan Team (HR Green and Reitz & Jens)
 SUBJECT: University City Stormwater Master Plan
Public versus Private – Recommended Definition Scope of work Task 2.2
 DATE: February 28, 2023

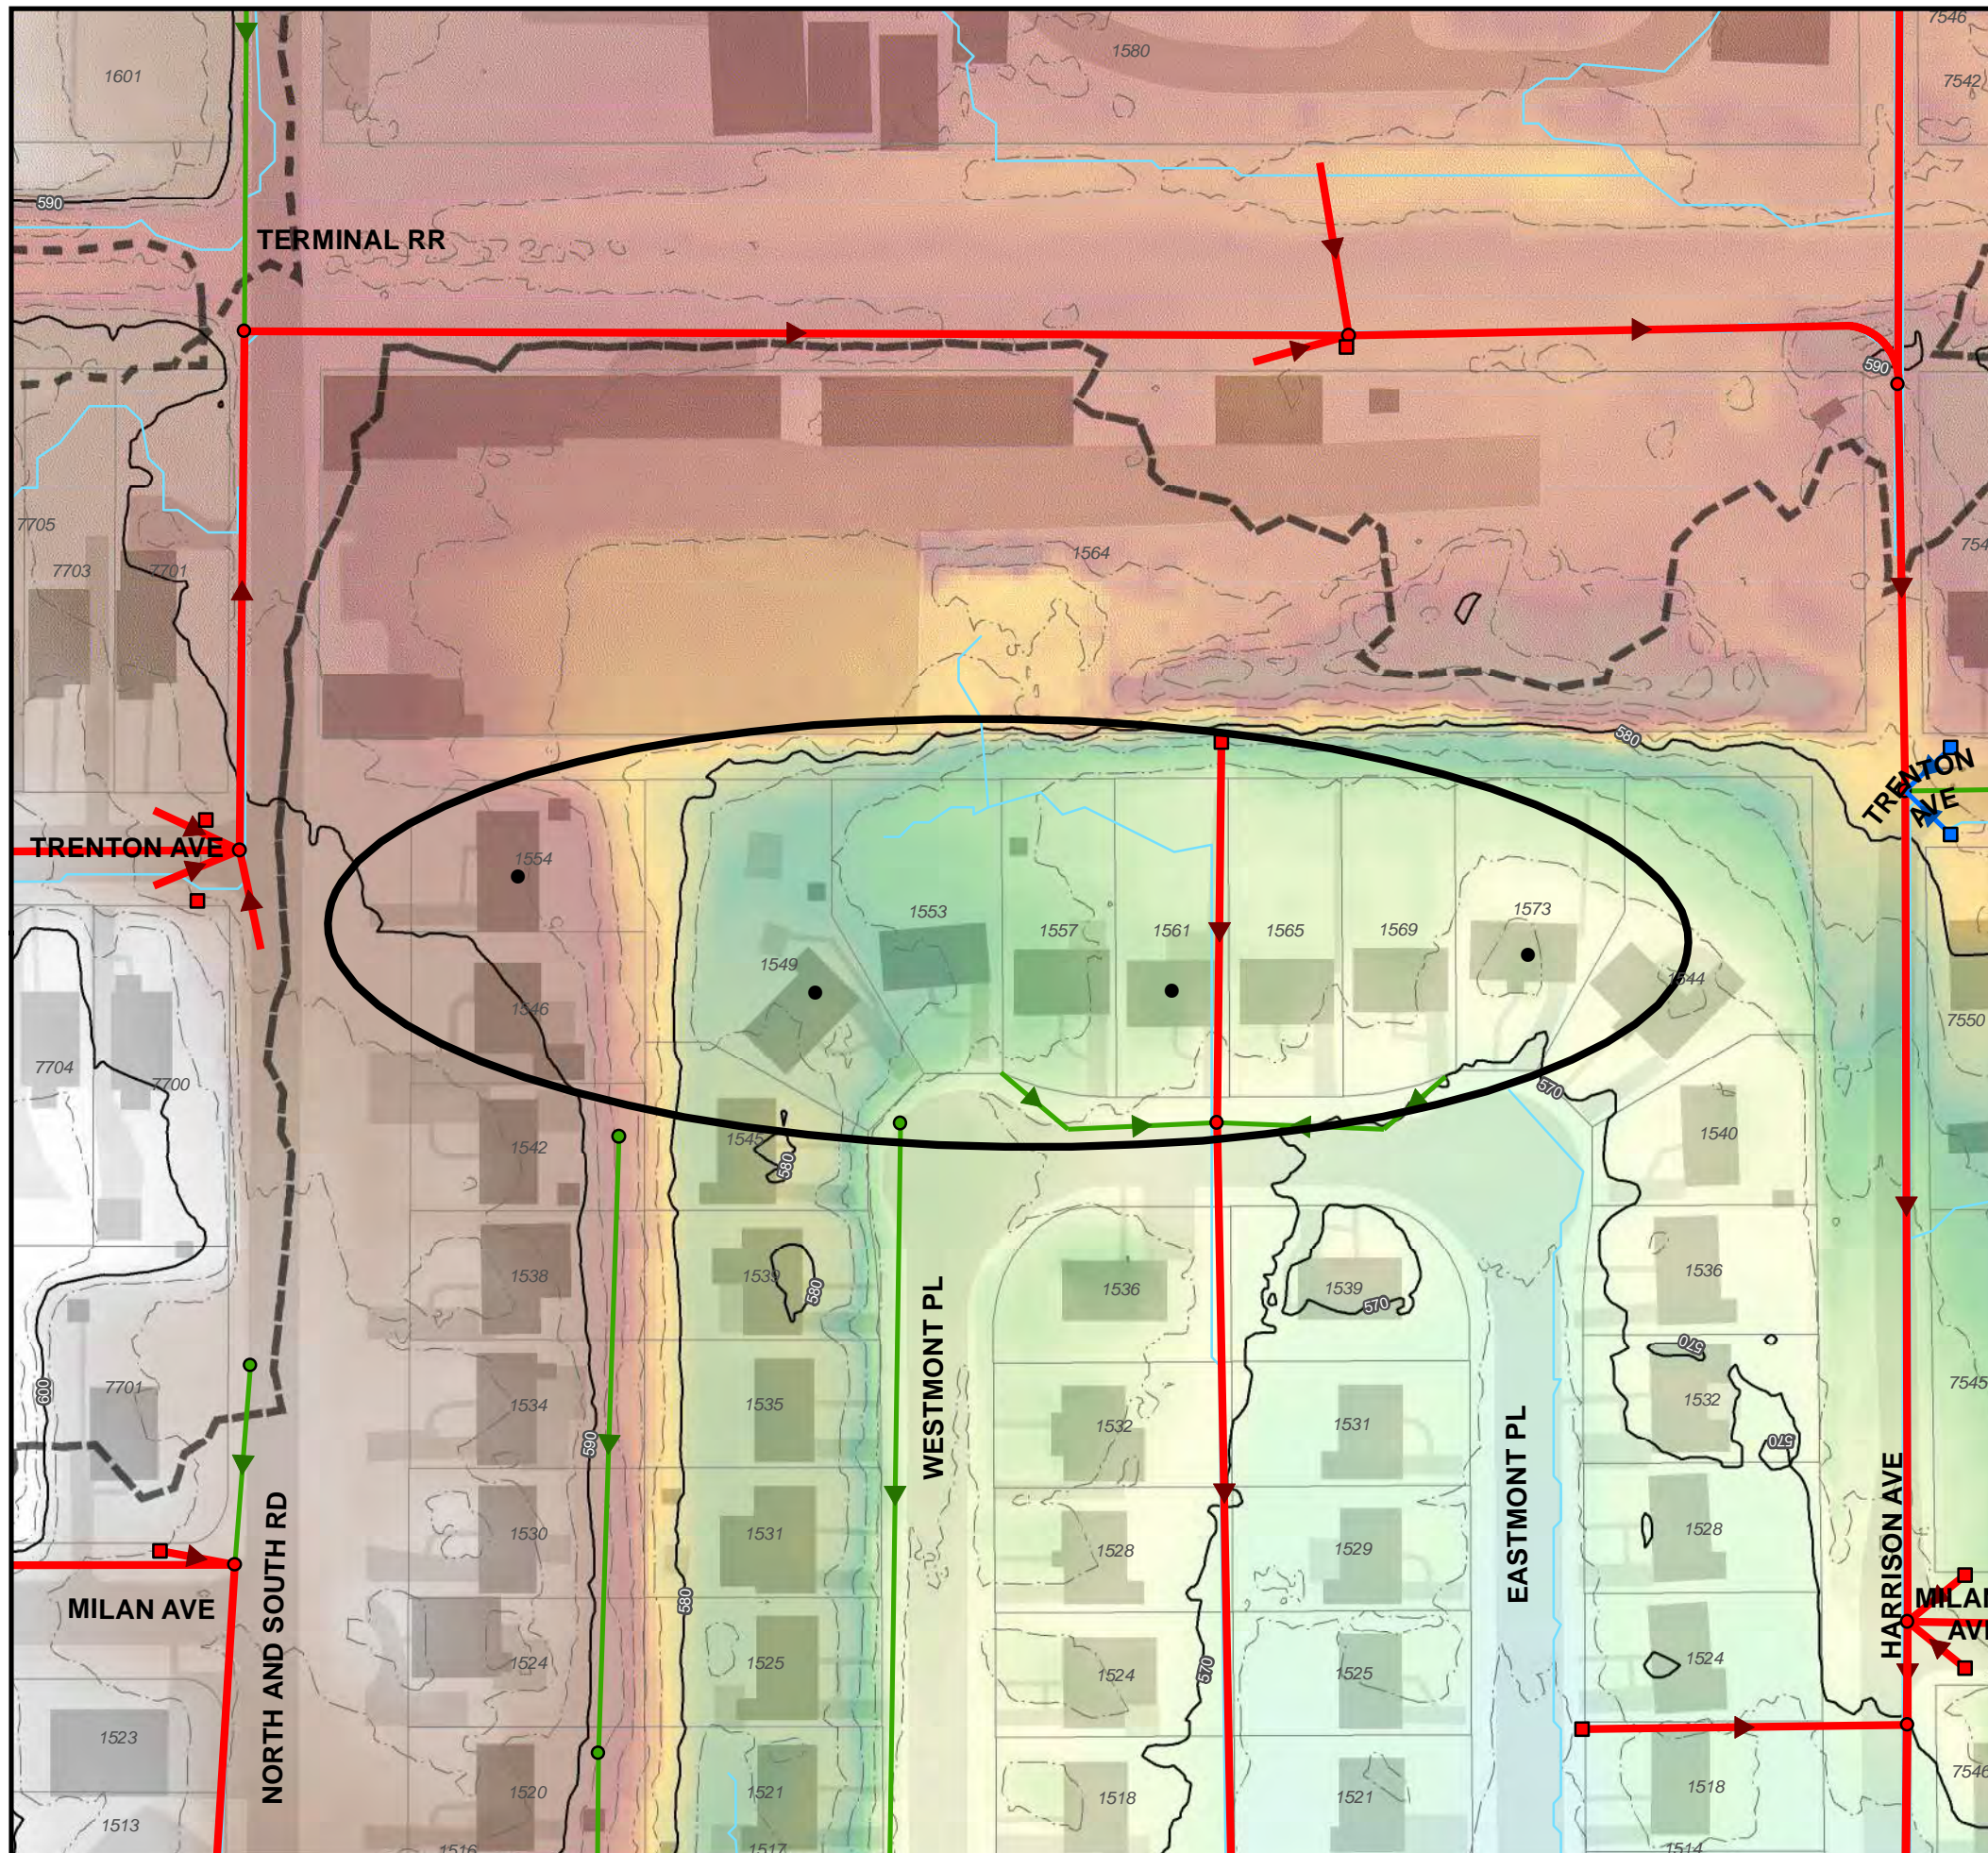
Milan Ave
Ranked #2 in the Backyard Category

About 3 acres of drainage flows to the backyard at 7353 Milan Ave. An area inlet just east of the backyard clogs easily and may also have inadequate capacity. Water backs up, flooding the entire yard until it can flow east. Water has nearly reached the threshold of the back door to the house. The basement has flooded from both seepage and overland flow in 2014, 2015, and 2022.

About 3 acres of drainage flows to the backyard at 7353 Milan Ave. An area inlet just east of the backyard clogs easily and may also have inadequate capacity. Water backs up, flooding the entire yard until it can flow east. Water has nearly reached the threshold of the back door to the house. The basement has flooded from both seepage and overland flow in 2014, 2015, and 2022.

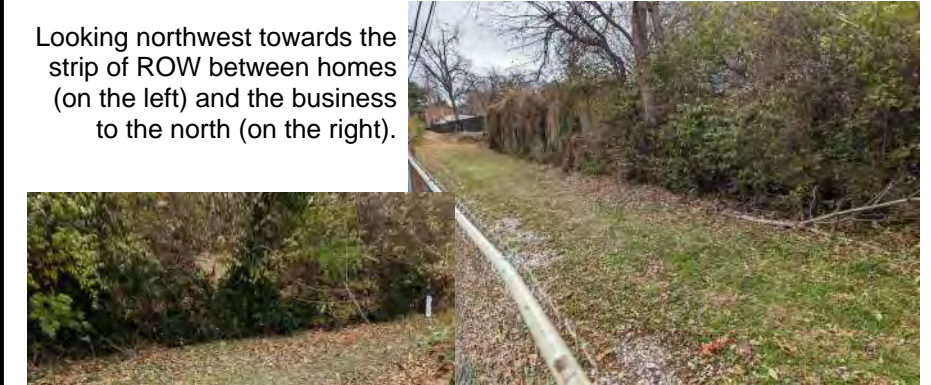
Looking northwest towards the strip of ROW between homes (on the left) and the business to the north (on the right).

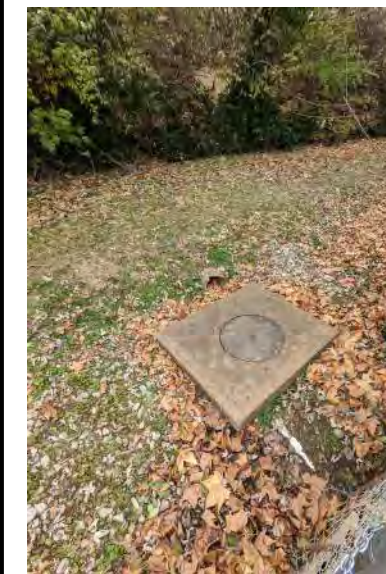
Looking towards the inlet north of #1561. Due to grading, the inlet does not appear to collect much runoff.

There is an inlet behind 1561, but only about half of a side is able to accept water due to grading issues. Note the inlet appears to be in a strip of ROW between the houses and business.

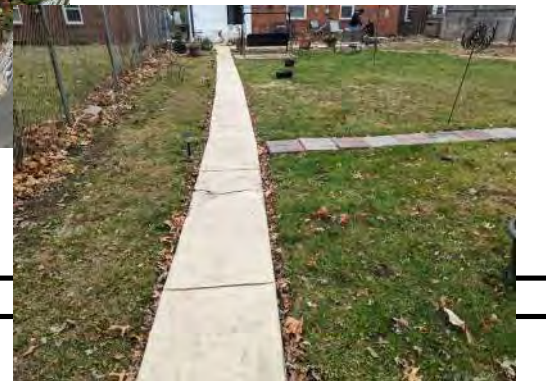
Looking south towards the backyard at #1561.

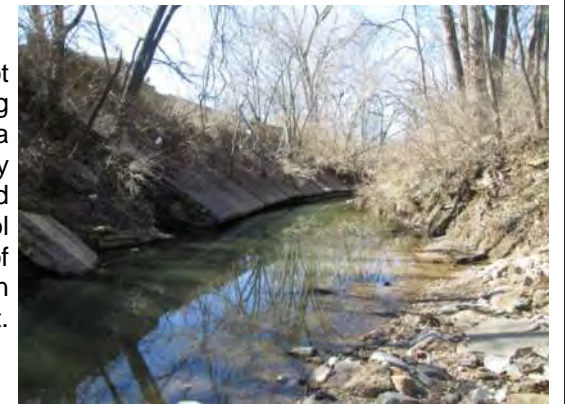
An approximately 175-foot reach of the right-descending river bank is lined with a concrete slab, but the integrity of the concrete is compromised by a 3-foot deep scour pool along the toe of bank. Failure of slab will likely cause failure in the parking lot.

A 500-foot reach of the River des Peres is actively eroding. The top of bank is 18-feet high is threatening residential buildings and parking lots located along Wild Cherry and Wild Plum Lanes. Using MSD's erosion rating, the parking lot is more severely threatened (V/H=0.56) than the apartment buildings (V/H=0.2 to 0.4).

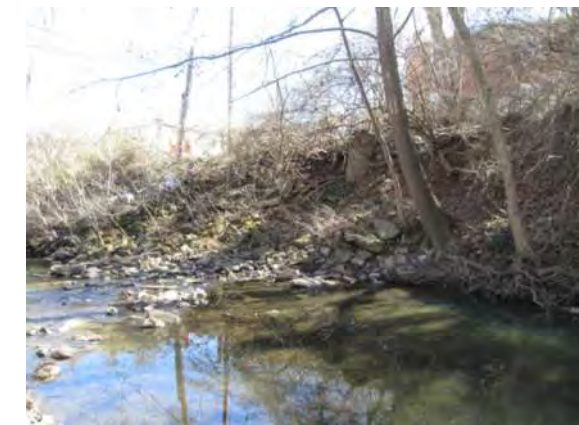
MSD infrastructure along the right-descending river bank is threatened by bank erosion including a combined sewer manhole, a combined sewer overflow (CSO) structure, and a storm sewer outflow structure.

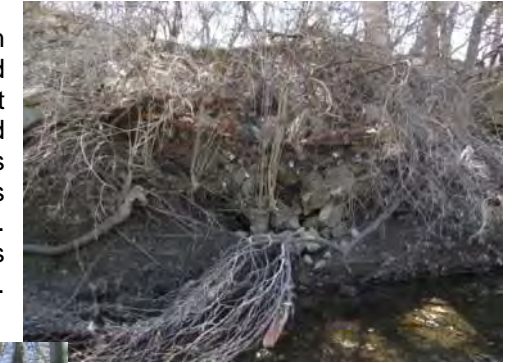
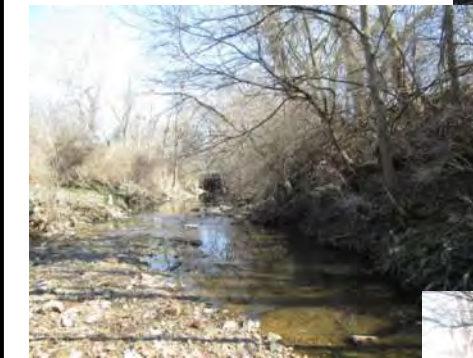
On the right descending bank are the eroding bank, collapsing fence, and sliding riprap.

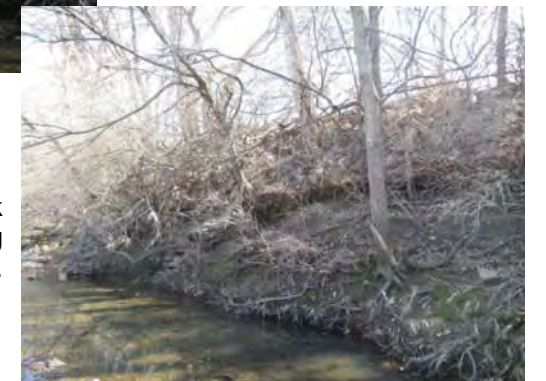
On the right descending bank are the eroding bank, collapsing fence, and sliding riprap.

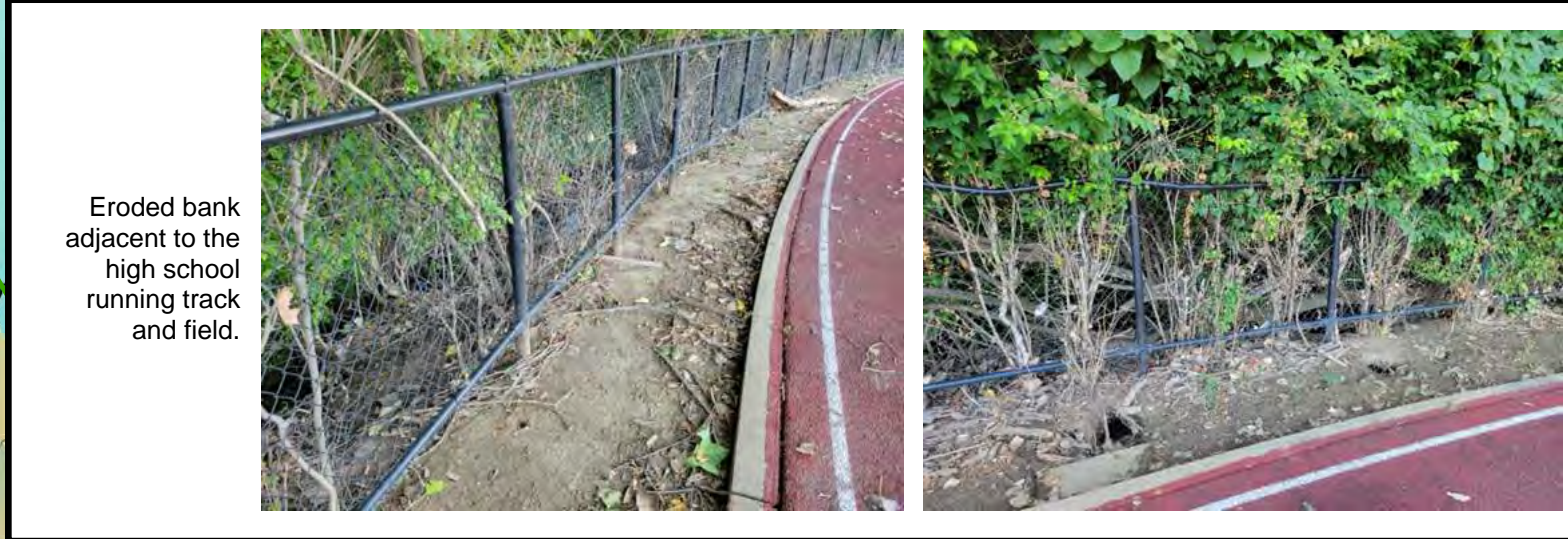
Eroded bank adjacent to the high school running track and field.

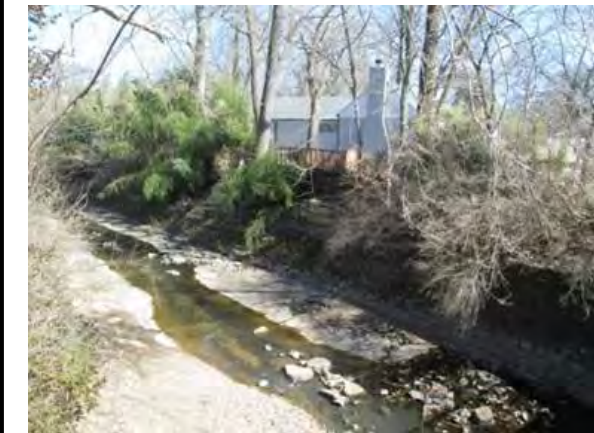
Wood tie wall and WPA block wall, looking downstream.

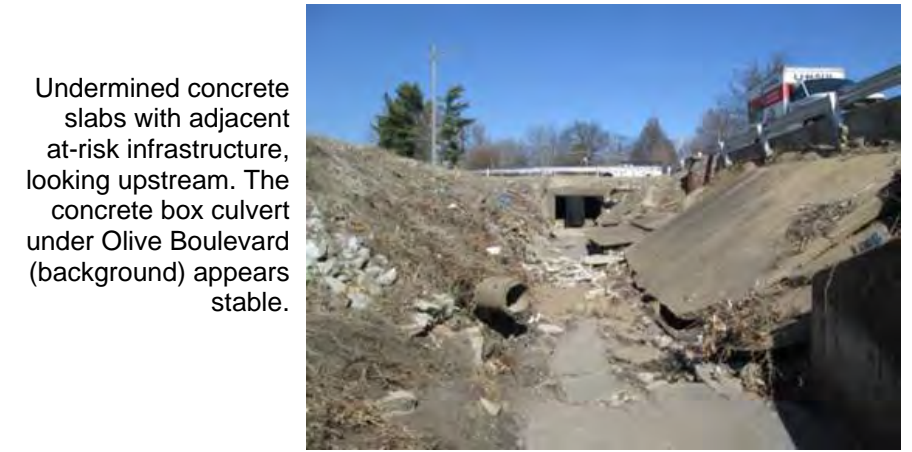
Undermined concrete slabs with adjacent at-risk infrastructure, looking upstream. The concrete box culvert under Olive Boulevard (background) appears stable.

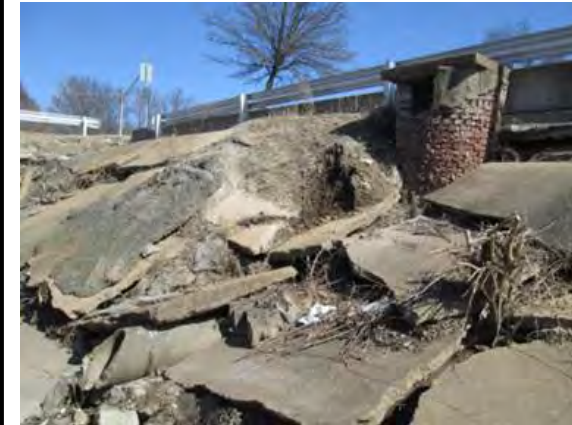
Exposed foundation of the adjacent parking lot.

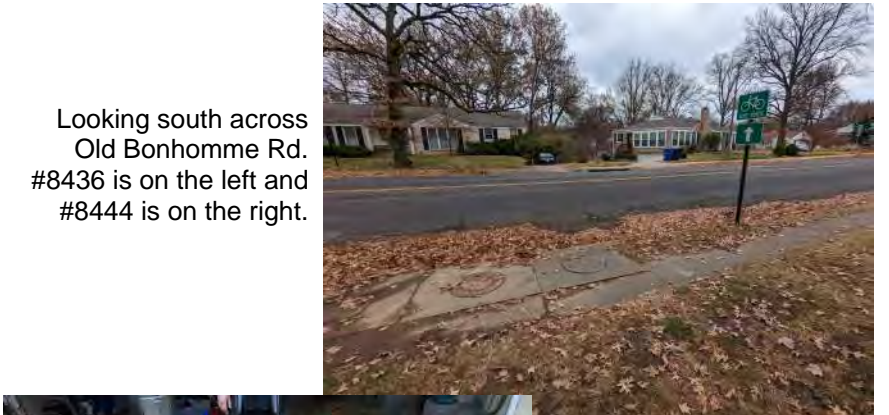
Looking south across Old Bonhomme Rd. #8436 is on the left and #8444 is on the right.

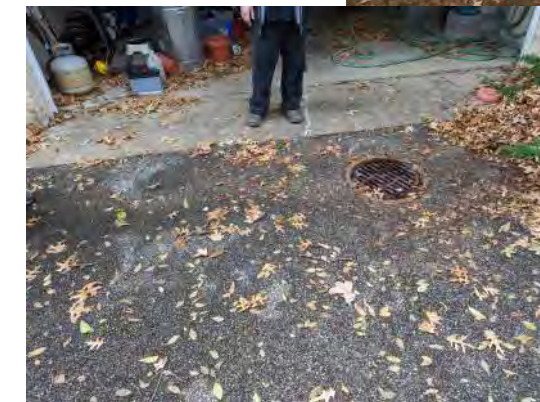
Looking at the ground in front of the driveway at 8436 Old Bonhomme Rd.

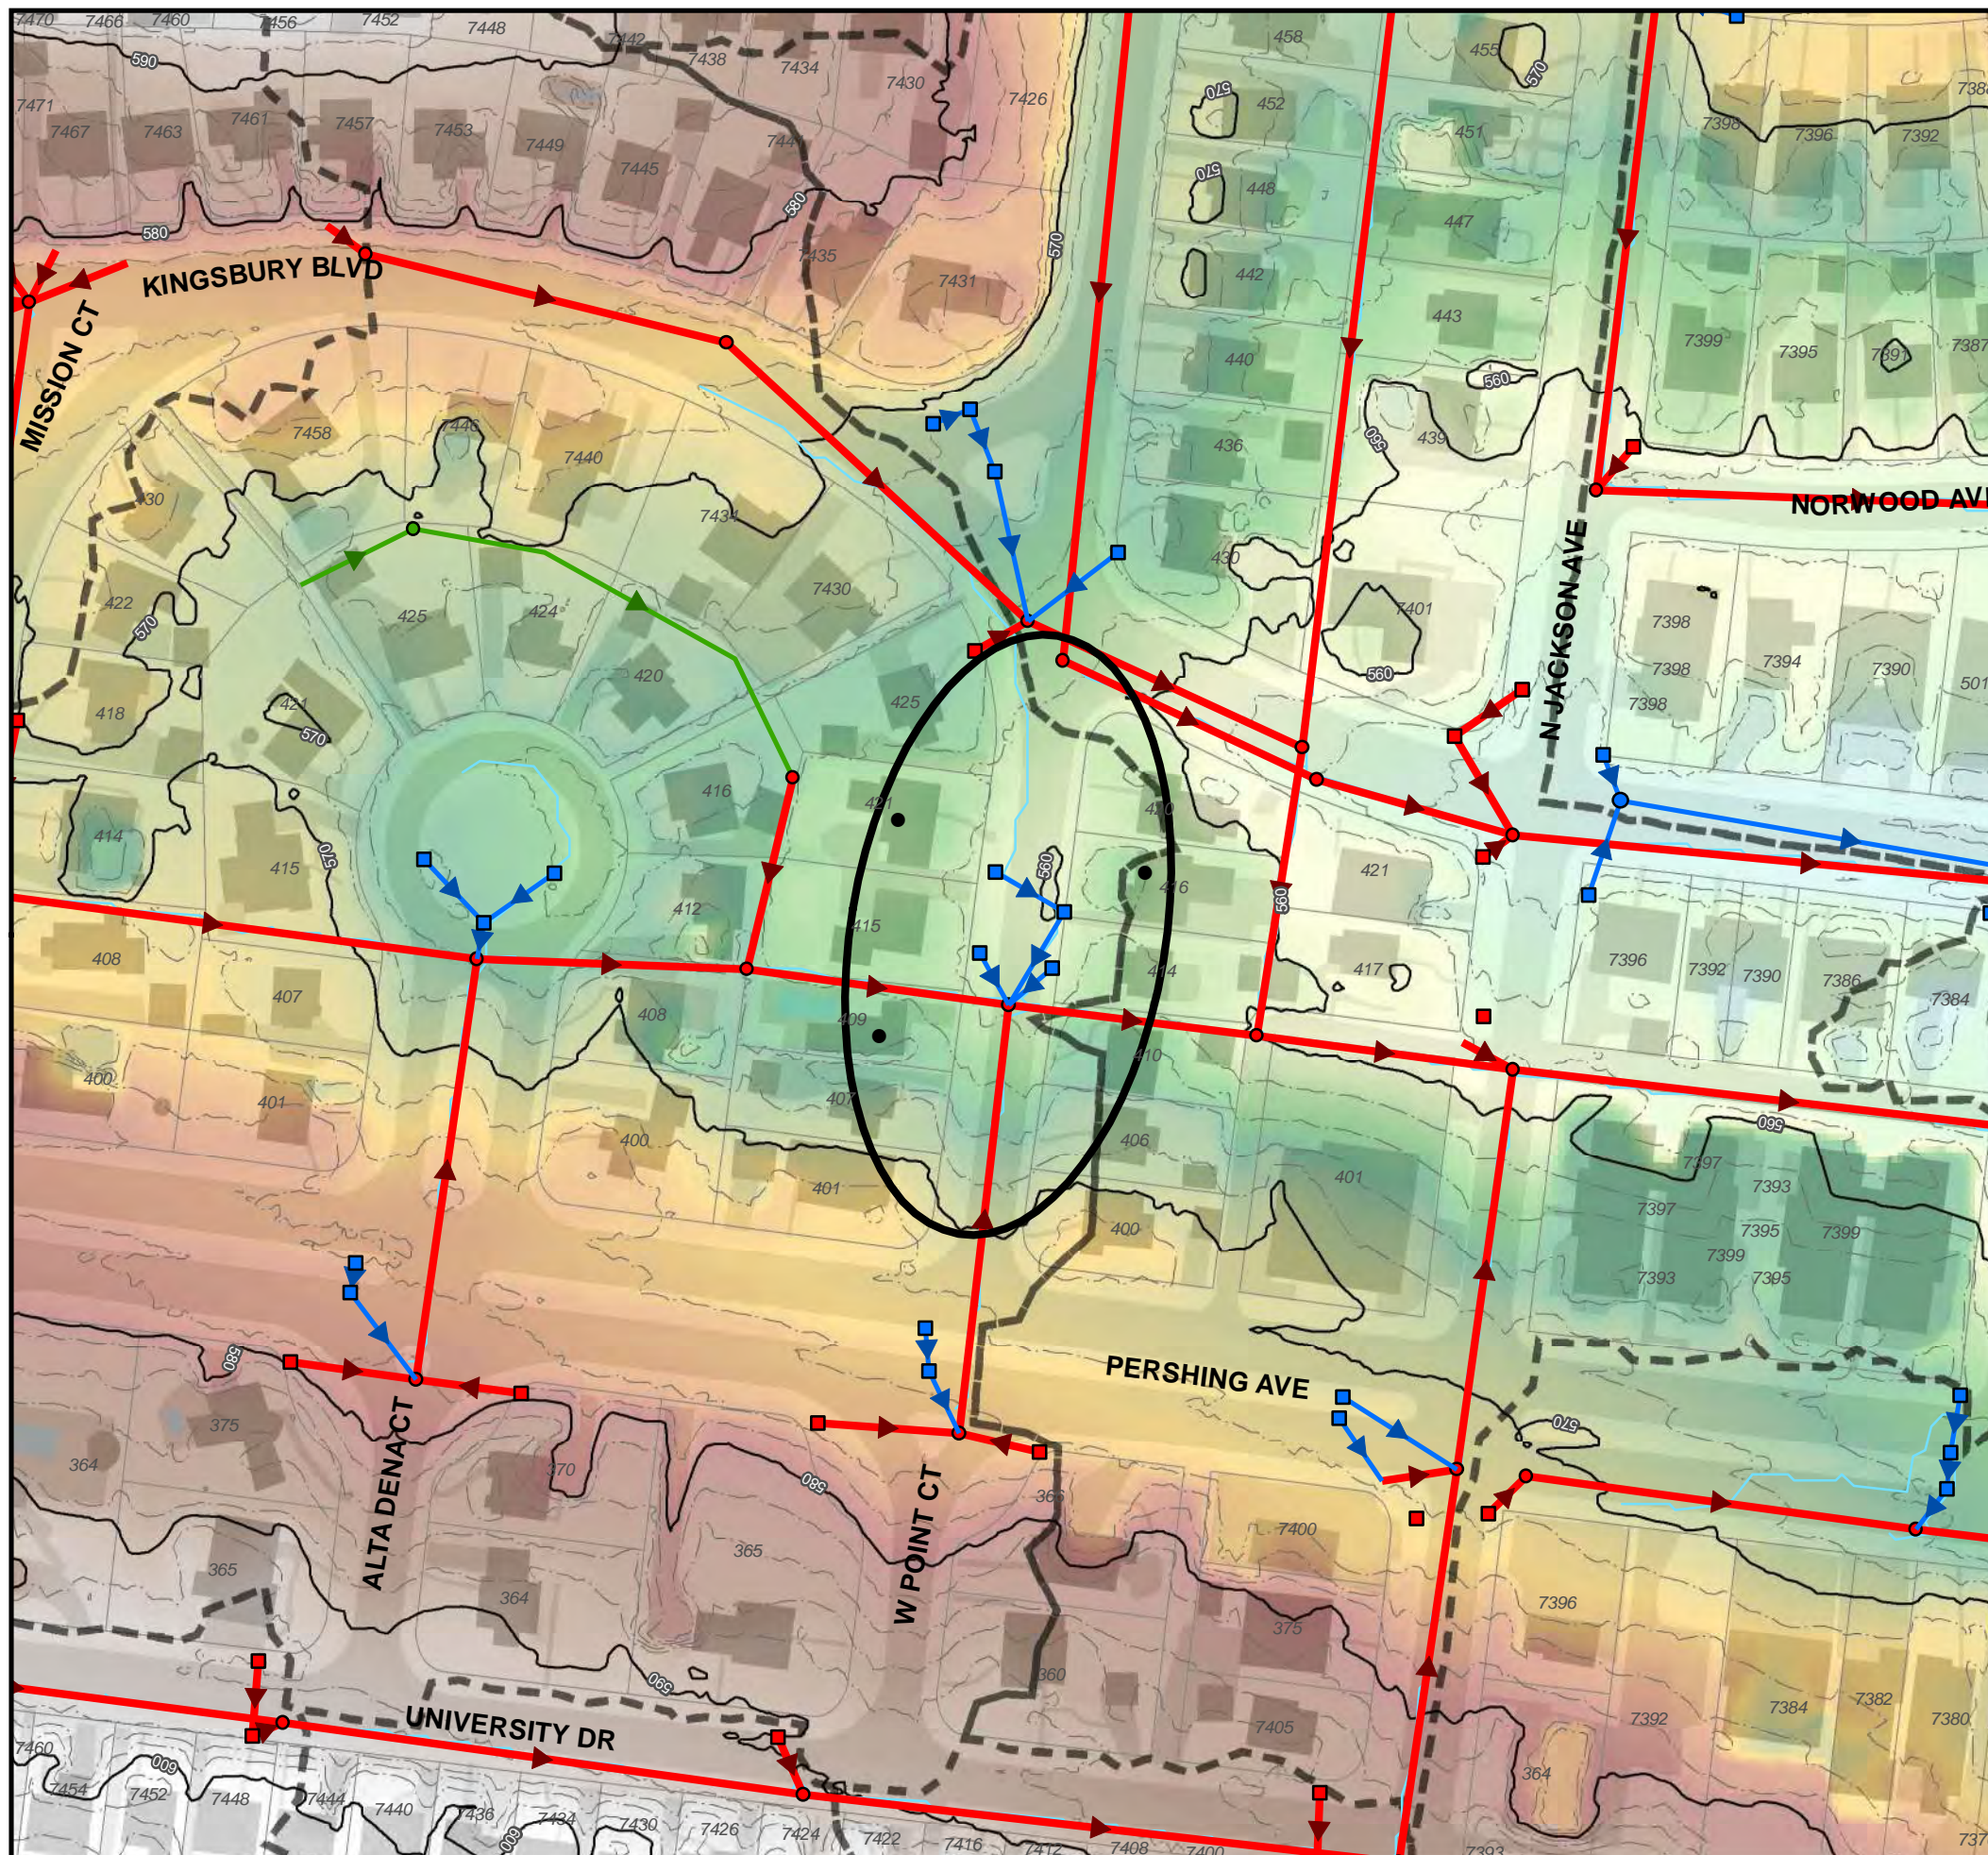
Old Bonhomme Rd
Ranked #2 in the Street Category

Residents say that the low point on W Point Ct floods constantly. The street does not have a distinct crown. Asphalt patching has made the street uneven in some places. There are 4 inlets near the low point, but non appear very efficient. There is not a well-defined sag and inlets appear to clog easily with leaves.

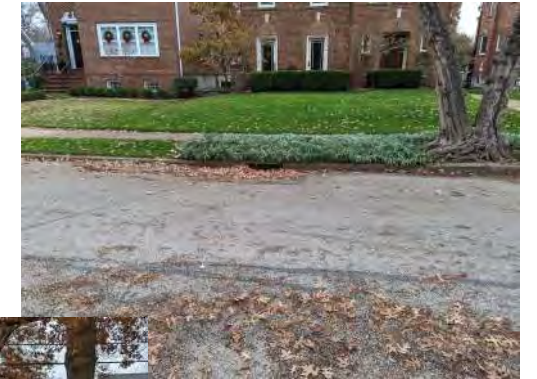
Looking towards the grated curb inlet with side intake between #416 and 414. The side intake is rather narrow and the grate is clogged with leaves.

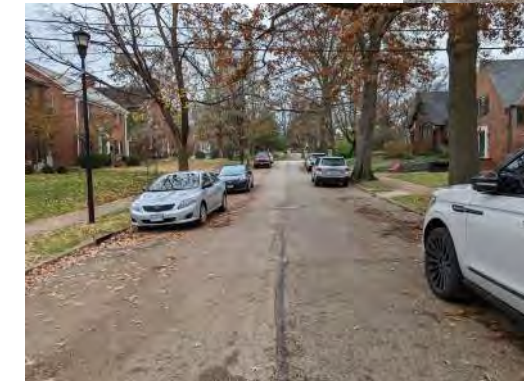
Looking south towards the inlets in front of #414 and 415. Both of these inlets are grated with a side intake.

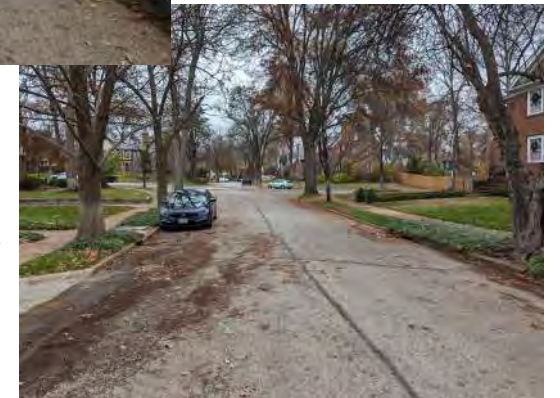
Looking north towards the northern two inlets on W Point Ct. Both are grated inlets with side intakes.

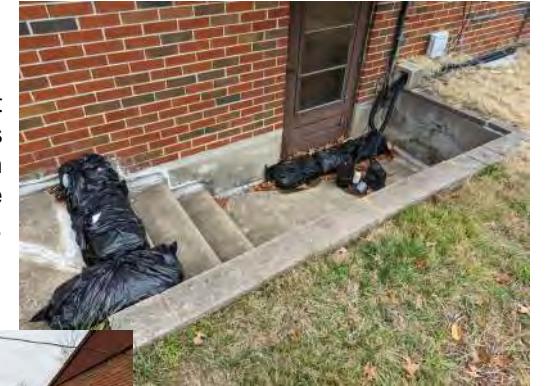
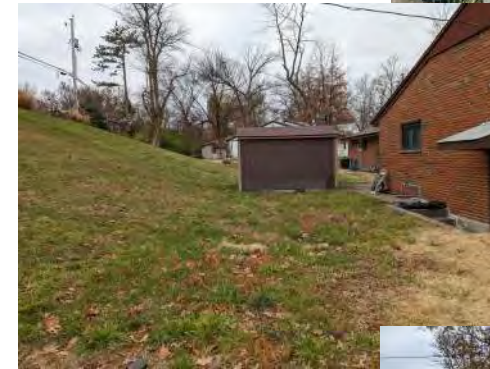
The basement stairwell at 7838 Balson Ave. Sand bags and sump pumps have been added to try to keep the basement from flooding.

Looking west in the backyard of 7838 Balson Ave. The house is on the right.

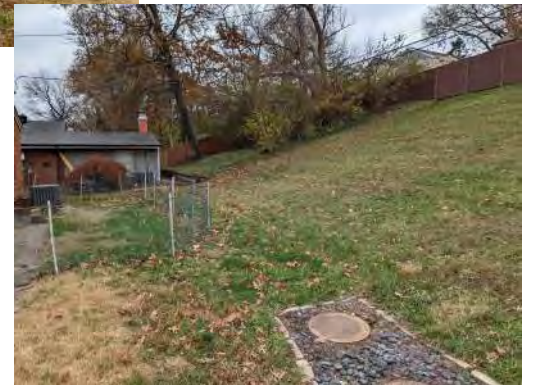
Looking east towards the backyards of two homes; 7832 Balson Ave is the house with the fence and 7828 Balson Ave is the house with the retaining wall.

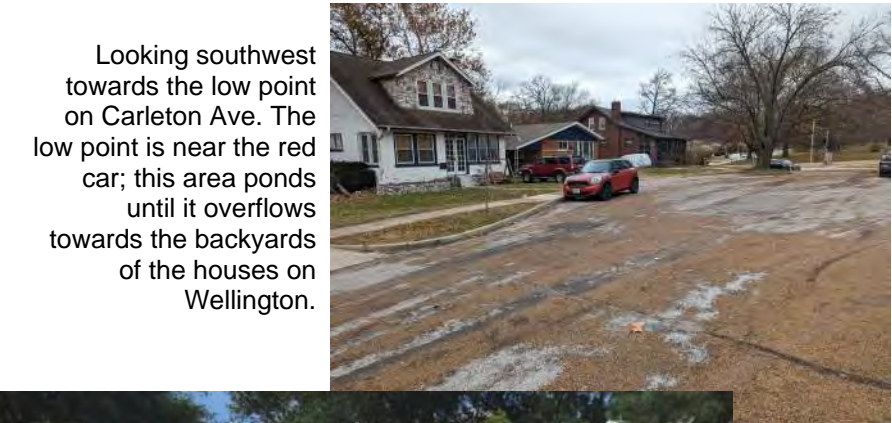
Looking southwest towards the low point on Carleton Ave. The low point is near the red car; this area ponds until it overflows towards the backyards of the houses on Wellington.

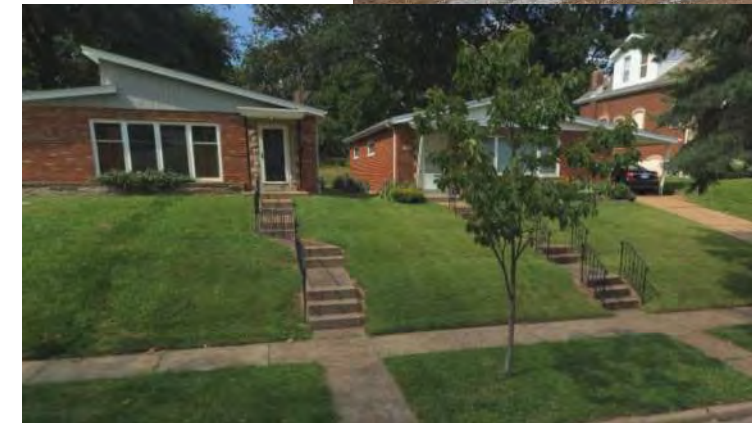
Looking north between #7423 (on the left) and #7419 (on the right). The space between houses may convey some of the runoff from the backyards, but the grading and available space is insufficient.

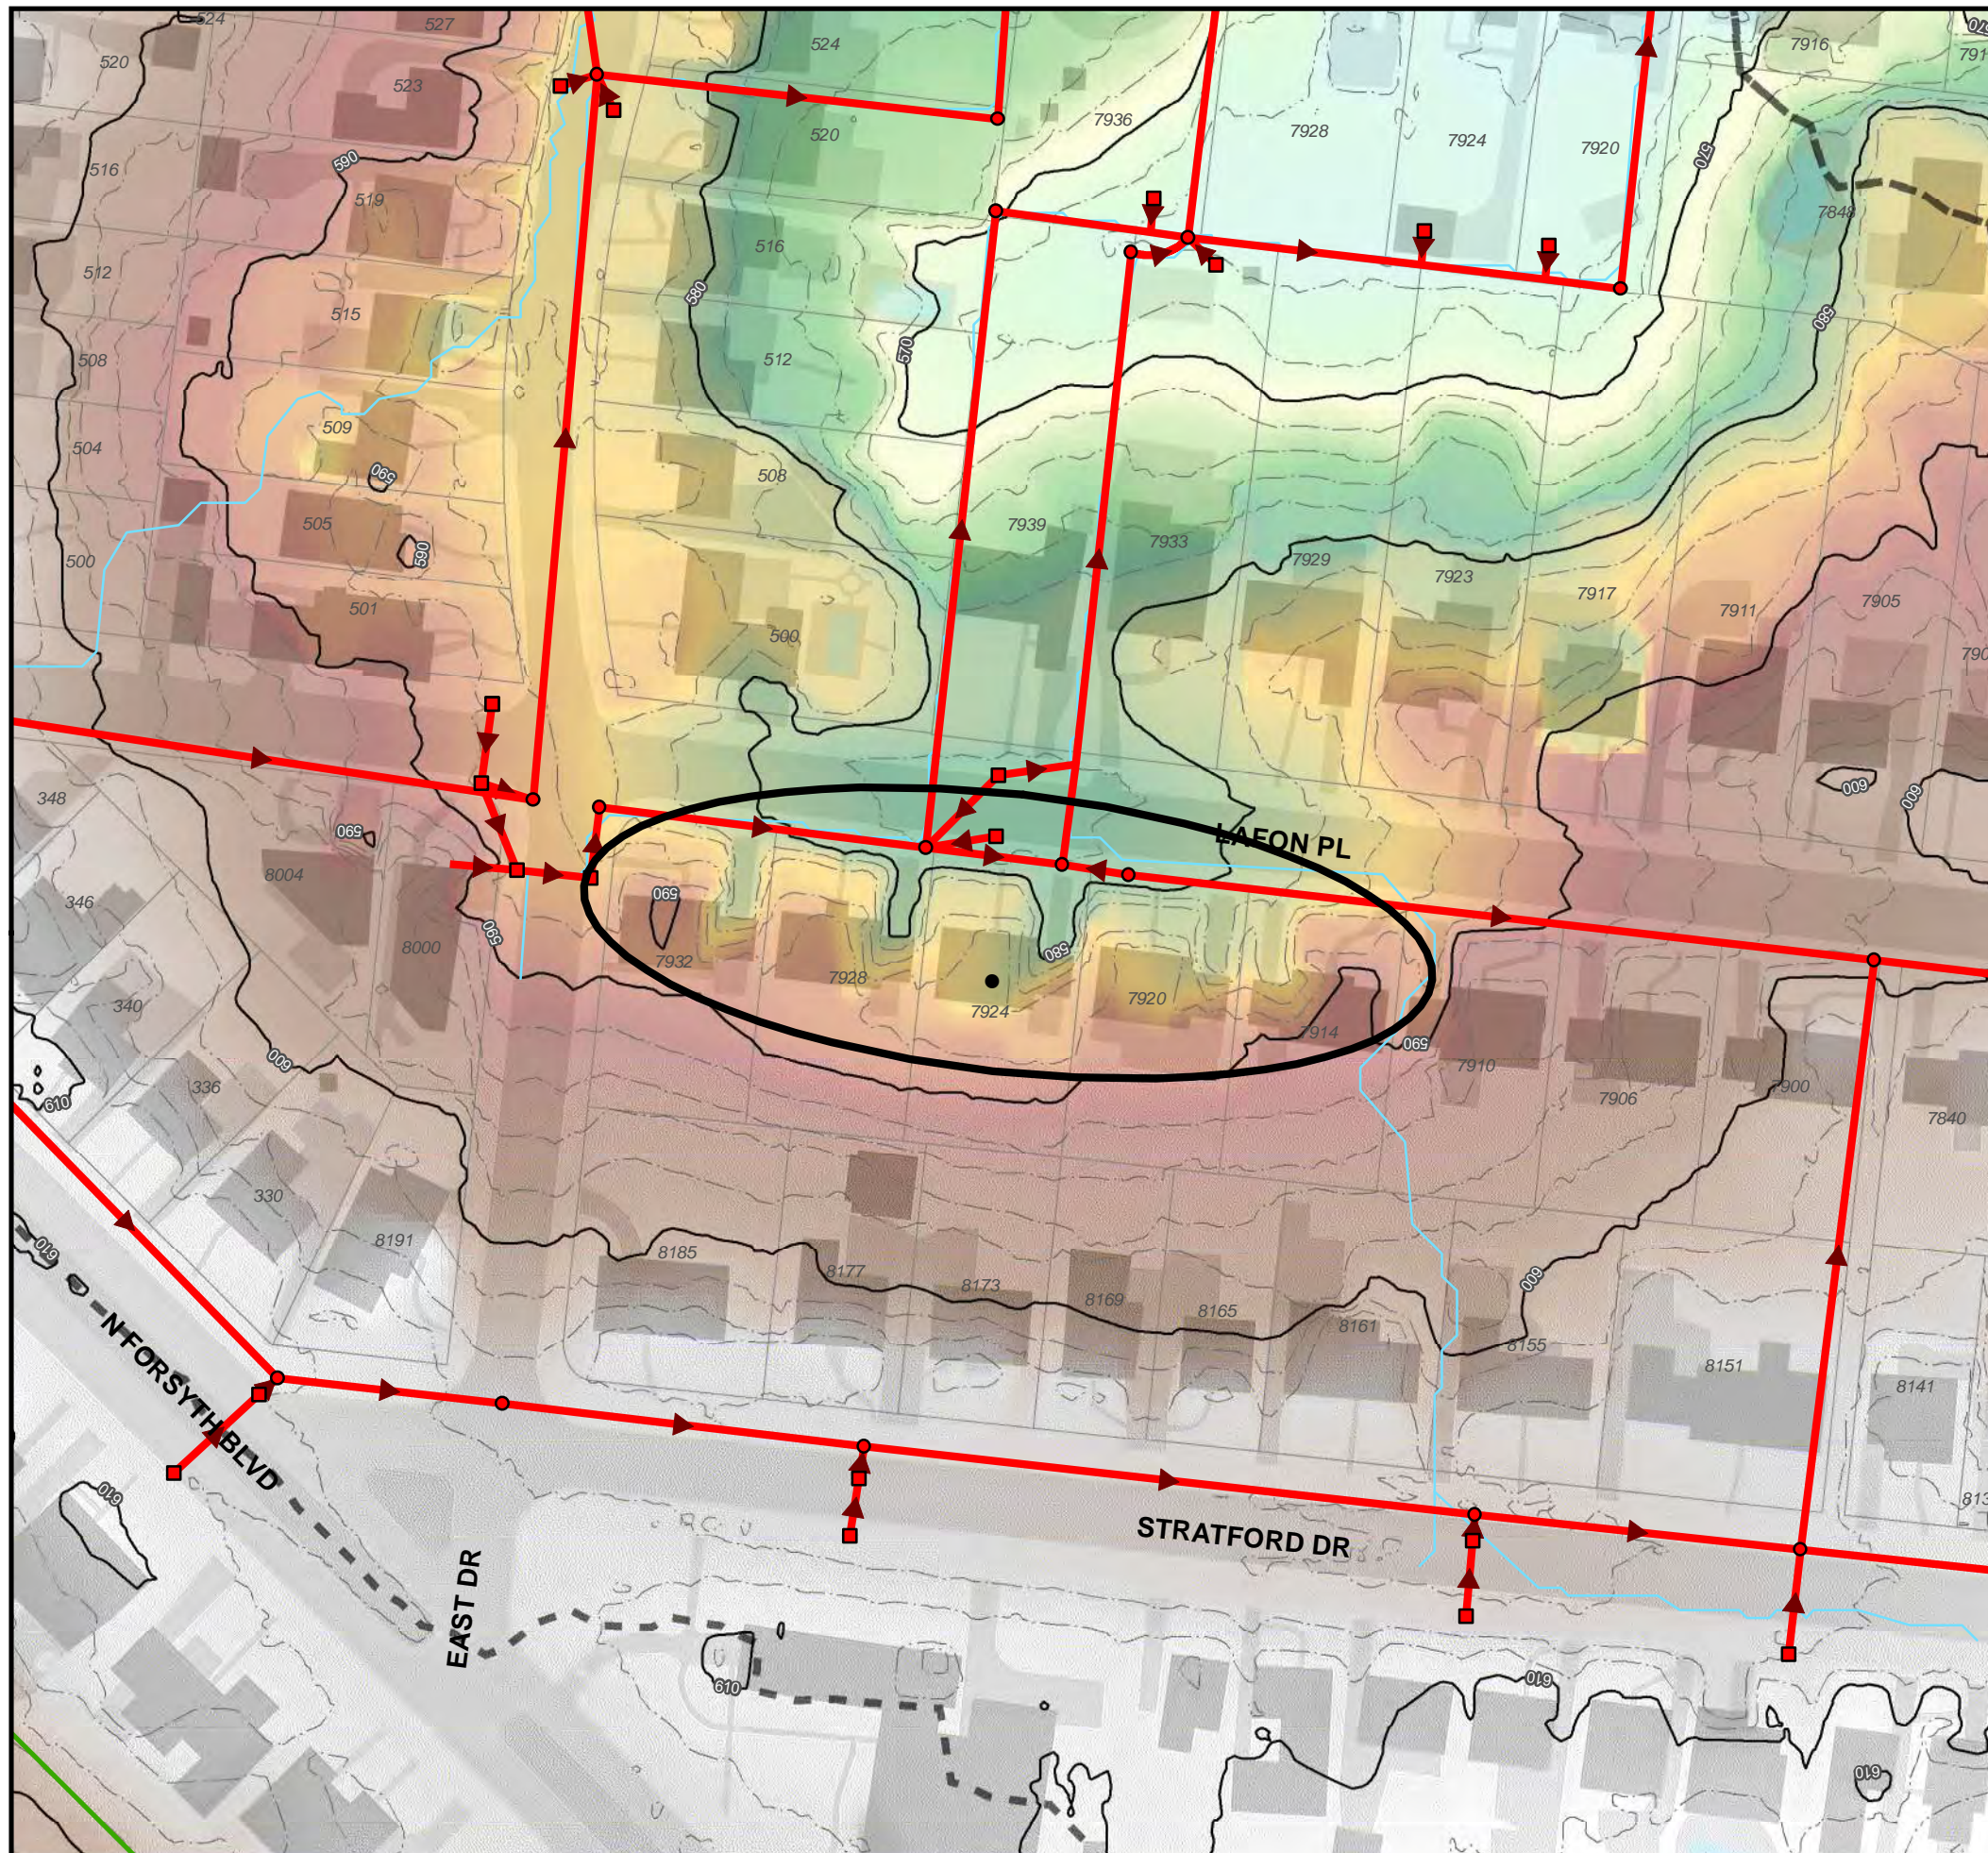
Wellington Ave

About 2.3 acres of drainage flows to the backyards of three houses, causing flooding to yards and basements. There is no flow path to carry runoff past the houses and to the inlets in the street.

The houses in this area have basement tuck-under garages. The street and sidewalk flood but the basement garages have not flooded.

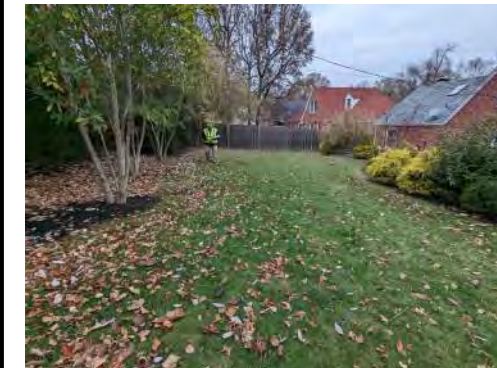
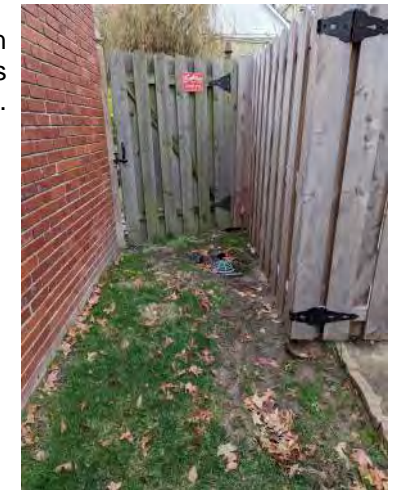
Looking north between #7924 and 7928 towards erosion and a yard drain.

Looking west in the backyard of 7924 Lafon Pl. The house is out of frame on the right. The yard slopes towards the back of the house.

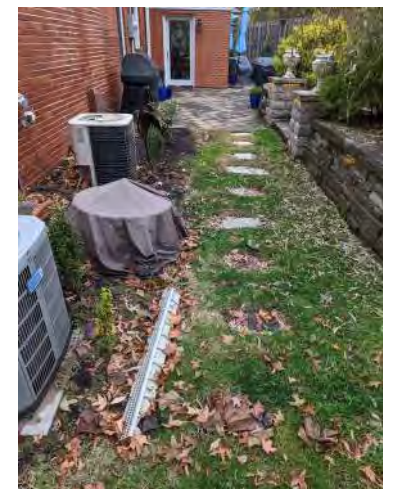
Looking east along the back of 7924 Lafon Pl. A yard drain was installed in an attempt to reduce ponding near the house.

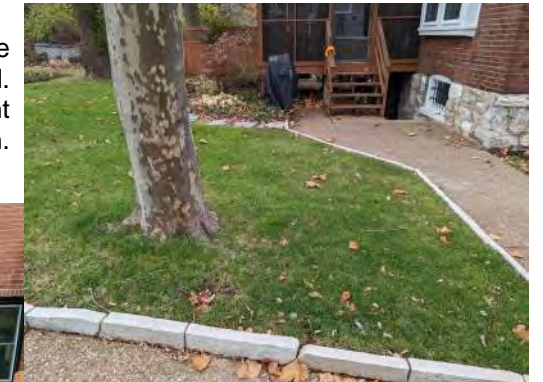
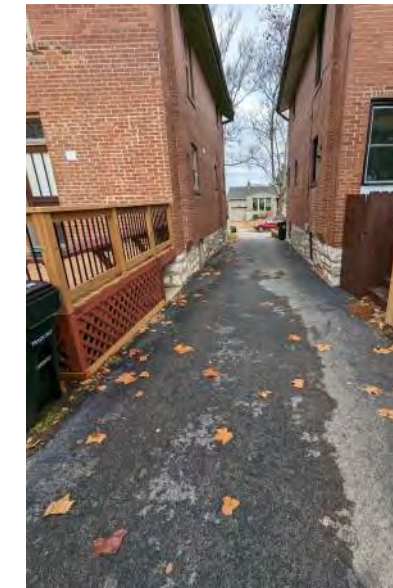
Looking west towards the backyard at 7258 Lindell Blvd. The stairwell to the basement is under the porch.

Looking north between #7252 (on the left) and #7250 (on the right). Basement windows are within 1-3 inches of the driveway - a potential source of flooding to the basements.

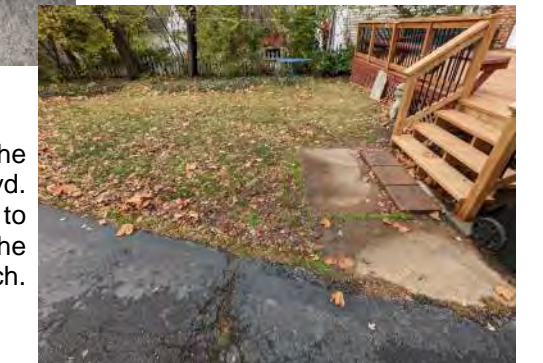
Looking west towards the backyard at 7252 Lindell Blvd. Ponding occurs near the steps to the patio. There is a stairwell to the basement under the porch.

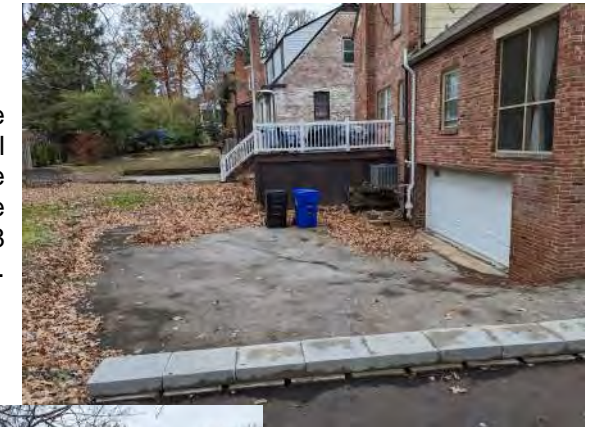
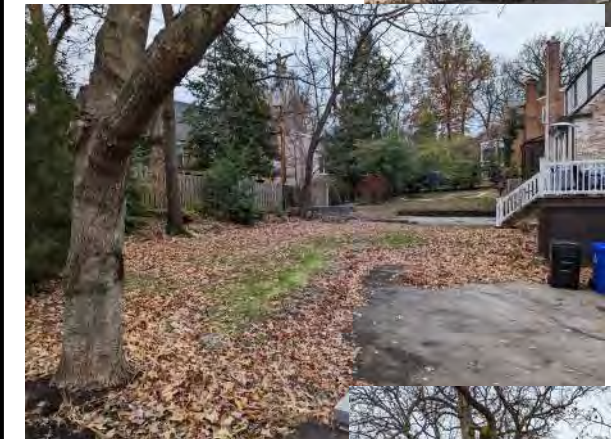
Looking towards the backyard of 8132 Cornell Ct; the basement garage has flooded since it is the low point of about 1.8 acres.

Looking west towards the backyard of #8132.

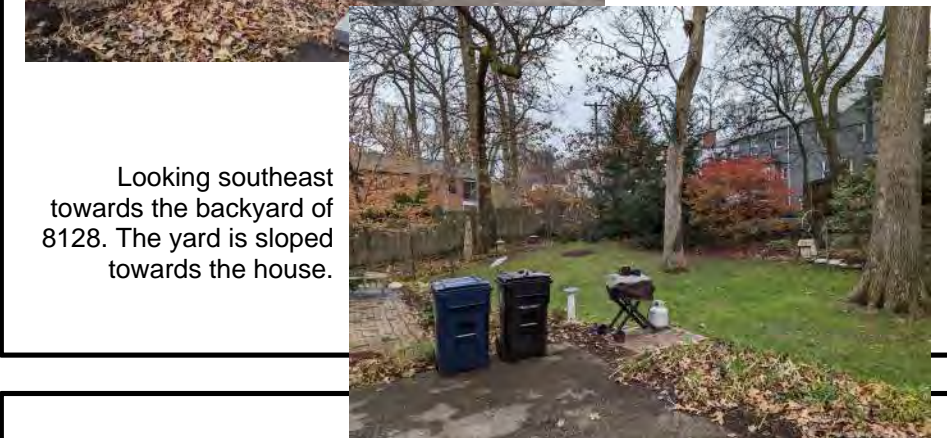
Looking southeast towards the backyard of 8128. The yard is sloped towards the house.

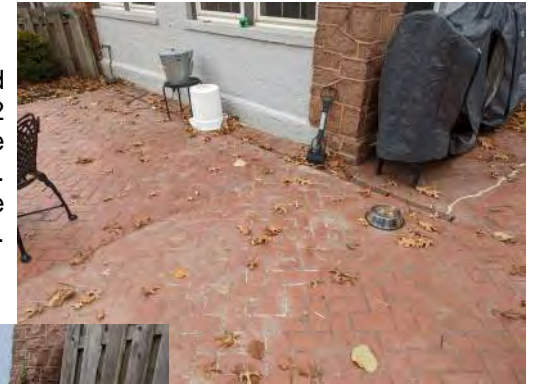
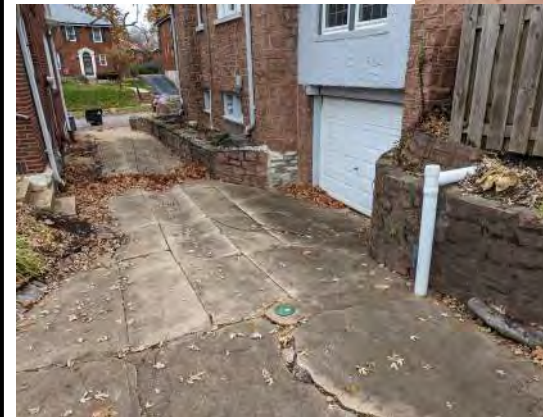
A slotted drain was installed by the homeowner at 7232 Northmoor Dr to reduce ponding against the house. This type of private drainage is common in the area.

Looking north between #7236 (on the left) and #7232 (on the right). The tuck-under garage is at risk of flooding since the main flow path for water in the backyards is to flow down this driveway.

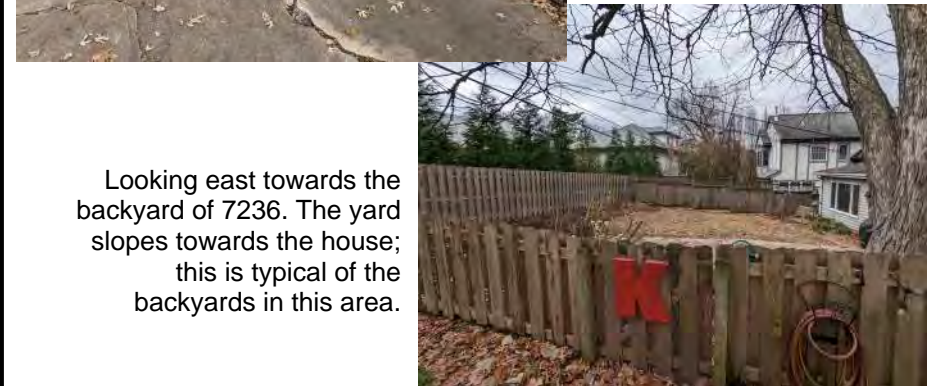
Looking east towards the backyard of 7236. The yard slopes towards the house; this is typical of the backyards in this area.
