AGENDA
COMMISSION ON STORM WATER ISSUES MEETING
HEMAN PARK COMMUNITY CENTER
975 PENNSYLVANIA
Tuesday, March 7, 2023,
6:30 PM

Draft: MINUTES OF THE STORMWATER COMMISSION
February 7, 2023

TO: Darren Girdler, Director of Public Works
 Mirela Celaj, CFM, Assistant Director of Public Works
 FROM: Stormwater Master Plan Team (HR Green and Reitz & Jens)
 SUBJECT: University City Stormwater Master Plan
Public versus Private – Recommended Definition Scope of work Task 2.2
 DATE: February 28, 2023

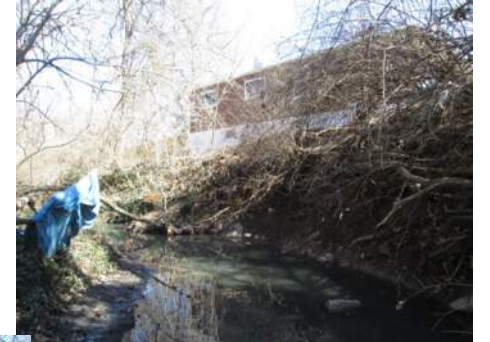
The 13-foot high eroding bank at 7591 Amherst is 20 feet from the home (measured from the toe of bank), and has not advanced significantly since 2006, but is considered severe by MSD's bank erosion rating (V/H=1.46). The July 26, 2022 flood was above the basement floor of 7591 Amherst and collapsed their fence.

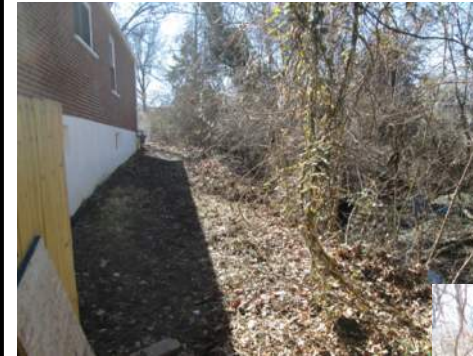
The 13-foot high eroding bank at 7591 Amherst is 9 feet from the home (measured from the top of bank).

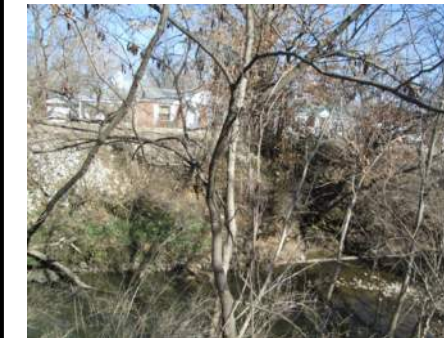
Over-steepened channel banks, and the remains of riprap placed by MSD that has since eroded and slid off the bank.

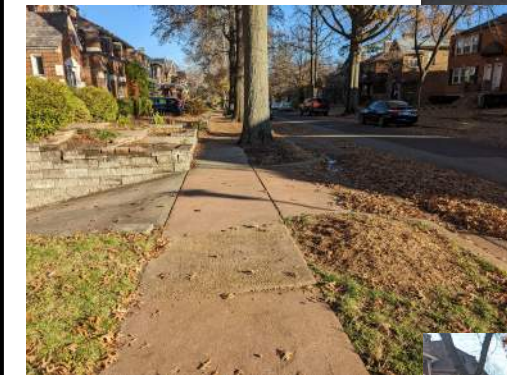
The driveway at 7037 Amherst Ave.

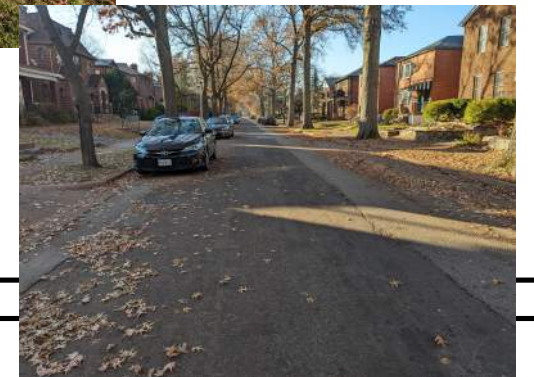
Looking east along Amherst Ave towards the inlets between 7033/7029 Amherst Ave.

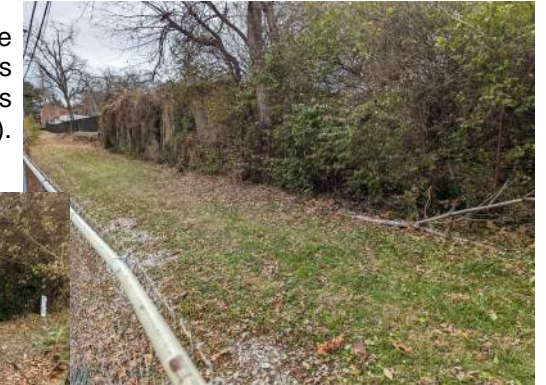
There is an inlet behind 1561, but only about half of a side is able to accept water due to grading issues. Note the inlet appears to be in a strip of ROW between the houses and business.

Looking northwest towards the strip of ROW between homes (on the left) and the business to the north (on the right).

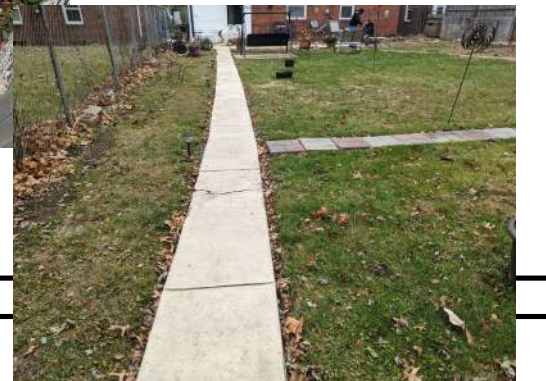
Looking towards the inlet north of #1561. Due to grading, the inlet does not appear to collect much runoff.

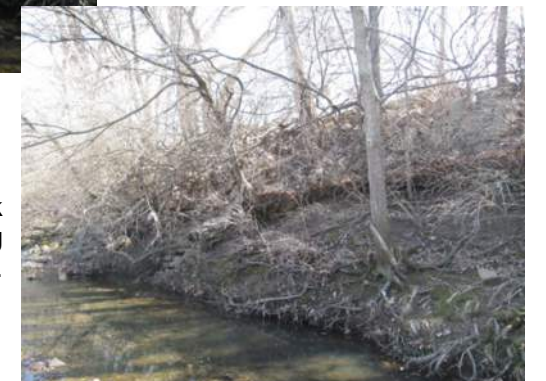
The foundation of a 6-foot high mid-slope fence is eroded and the fence is collapsing. It appears that riprap was added from the top of slope to address an area of gulley erosion, but this riprap is sliding down the bank. The weight of this riprap is contributing to the fence failure.

On the right descending bank are the eroding bank, collapsing fence, and sliding riprap.

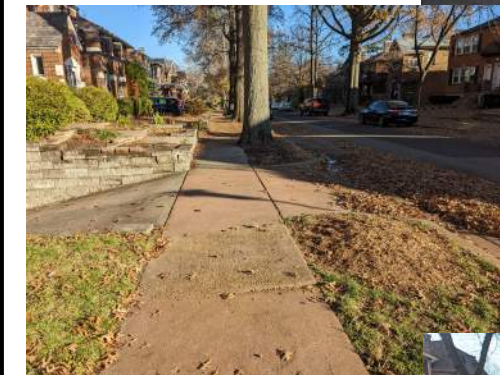
The driveway at 7037 Amherst Ave.

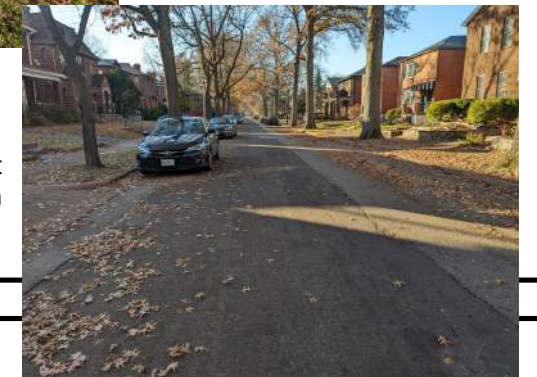
Looking east along Amherst Ave towards the inlets between 7033/7029 Amherst Ave.

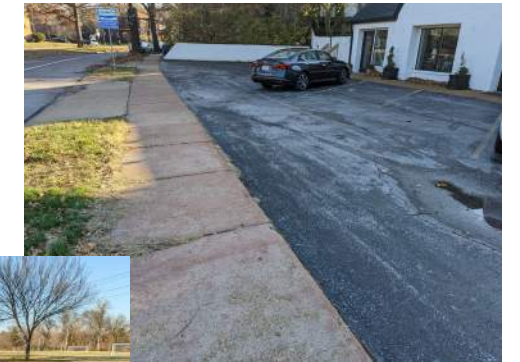
The parking lot in front of 941 Midland Blvd.

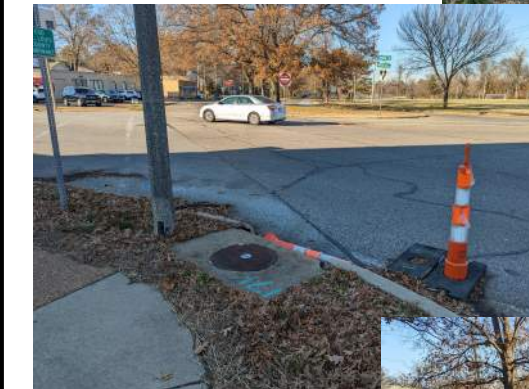
Looking north towards the inlet at the southwest corner of Midland Blvd and Balson Ave.

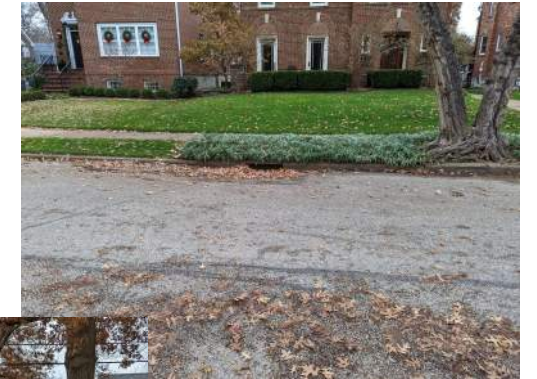
Looking towards the grated curb inlet with side intake between #416 and 414. The side intake is rather narrow and the grate is clogged with leaves.

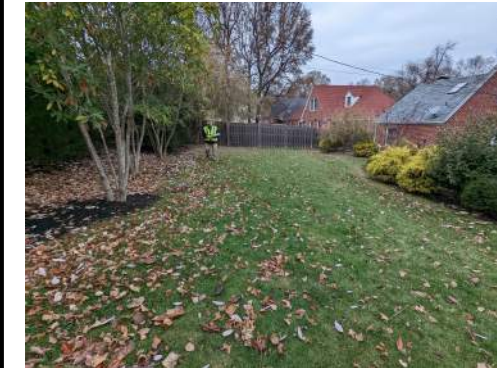
Looking north between #7924 and 7928 towards erosion and a yard drain.

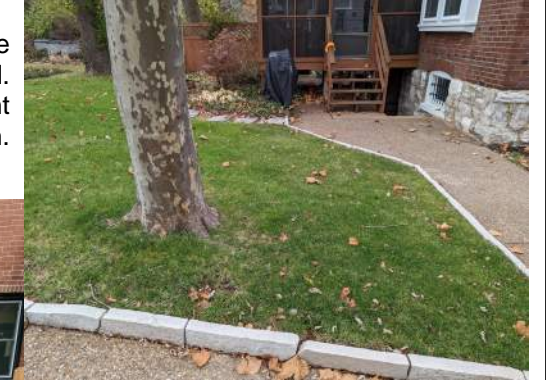
Looking west towards the backyard at 7258 Lindell Blvd. The stairwell to the basement is under the porch.

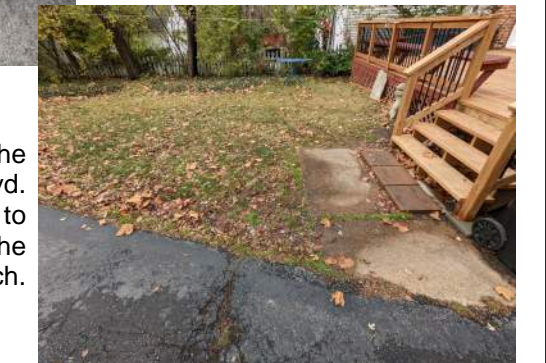
Looking west towards the backyard at 7252 Lindell Blvd. Ponding occurs near the steps to the patio. There is a stairwell to the basement under the porch.
