AGENDA
COMMISSION ON STORM WATER ISSUES
SPECIAL MEETING
HEMAN PARK COMMUNITY CENTER
975 PENNSYLVANIA
Tuesday, March 21, 2023,
3:00 PM

SUBJECT: University City Stormwater Master Plan
City Code – Review and Suggest Improvements Scope of work Task 2.5

TO: Darren Girdler, Director of Public Works
 Mirela Celaj, CFM, Assistant Director of Public Works
 FROM: Stormwater Master Plan Team (HR Green and Reitz & Jens)
 SUBJECT: University City Stormwater Master Plan
Public versus Private – Recommended Definition Scope of work Task 2.2
 DATE: February 28, 2023

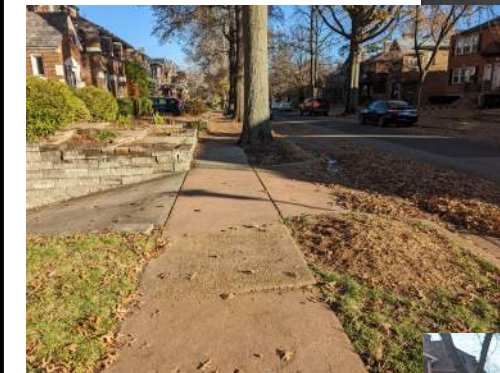
Looking east along Amherst Ave towards the inlets between 7033/7029 Amherst Ave.

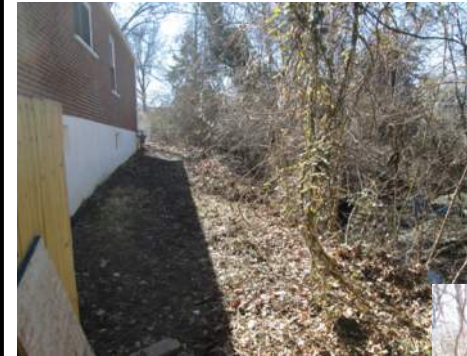
Creek erosion along 7587 Amherst is undermining their fence. The erosion rating at 7587 Amherst is considered a threat to the home (V/H=0.25).

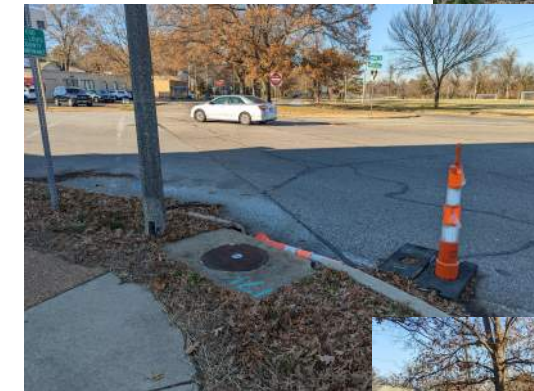
Looking north towards the inlet at the southwest corner of Midland Blvd and Balson Ave.
