Storm Water Commission  
6801 Delmar Boulevard, University City, Missouri 63130,  
Phone: (314) 505-8560, Fax: (314) 862-0694

## MINUTES OF THE STORMWATER COMMISSION April 4, 2023

TO: Darren Girdler, Director of Public Works  
 Mirela Celaj, CFM, Assistant Director of Public Works  
 FROM: Stormwater Master Plan Team (HR Green and Reitz & Jens)  
 SUBJECT: University City Stormwater Master Plan  
*Public versus Private – Recommended Definition* Scope of work Task 2.2  
 DATE: February 28, 2023

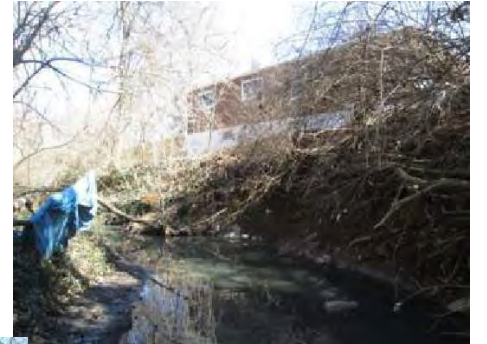
The 13-foot high eroding bank at 7591 Amherst is 20 feet from the home (measured from the toe of bank), and has not advanced significantly since 2006, but is considered severe by MSD's bank erosion rating (V/H=1.46). The July 26, 2022 flood was above the basement floor of 7591 Amherst and collapsed their fence.

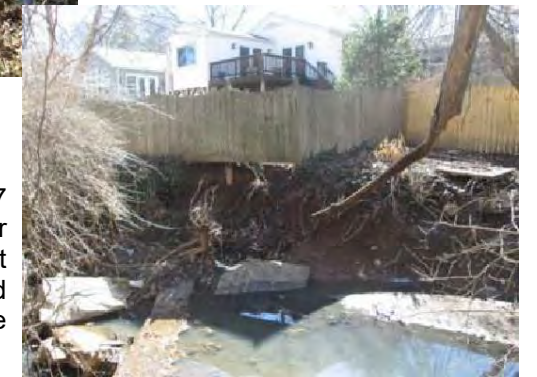
The 13-foot high eroding bank at 7591 Amherst is 9 feet from the home (measured from the top of bank).

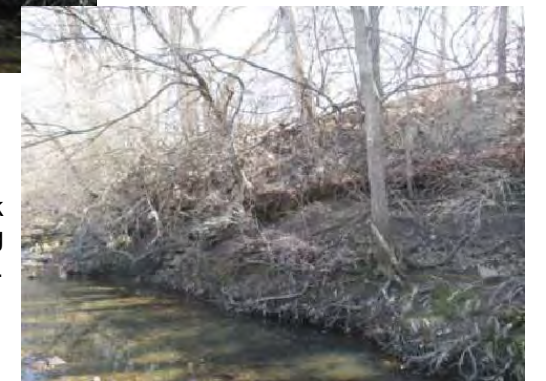
On the right descending bank are the eroding bank, collapsing fence, and sliding riprap.

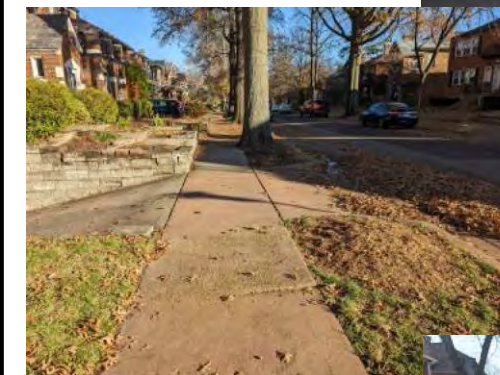
The driveway at 7037 Amherst Ave.

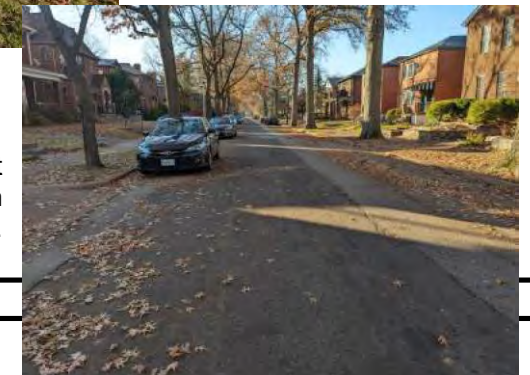
Looking east along Amherst Ave towards the inlets between 7033/7029 Amherst Ave.

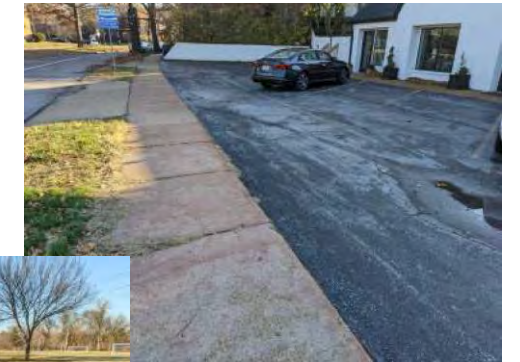
The parking lot in front of 941 Midland Blvd.

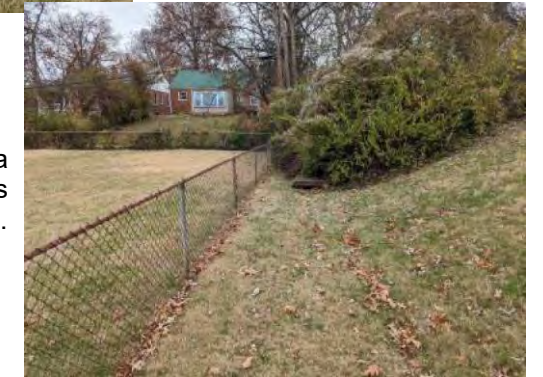
Looking north towards the area inlet in the backyards. #7353's backyard is on the left.

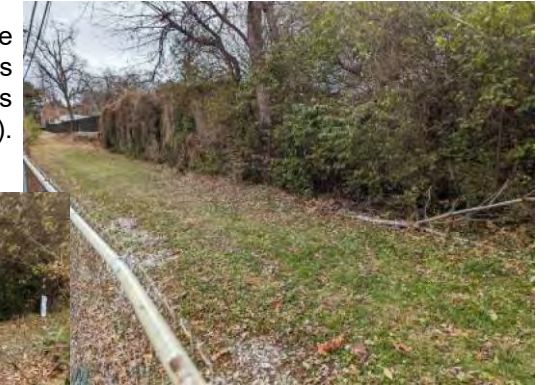
Looking northwest towards the strip of ROW between homes (on the left) and the business to the north (on the right).

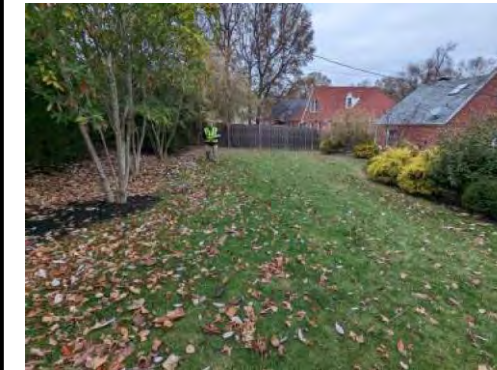
Looking north between #7924 and 7928 towards erosion and a yard drain.

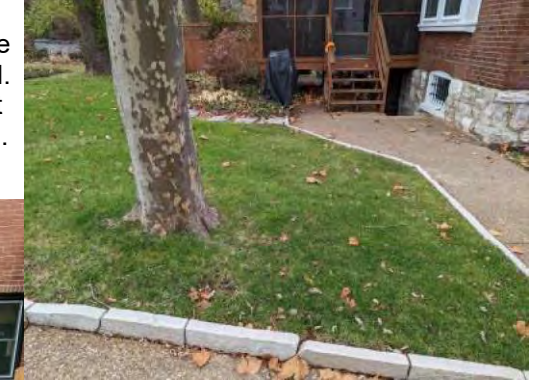
Looking west towards the backyard at 7258 Lindell Blvd. The stairwell to the basement is under the porch.

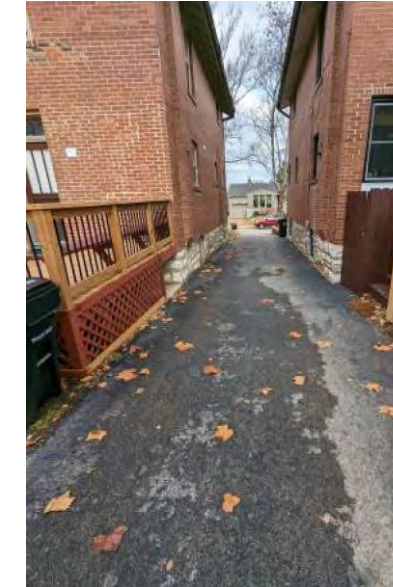
Looking north between #7252 (on the left) and #7250 (on the right). Basement windows are within 1-3 inches of the driveway - a potential source of flooding to the basements.

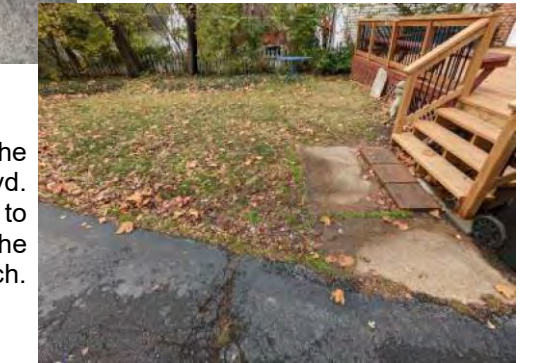
Looking west towards the backyard at 7252 Lindell Blvd. Ponding occurs near the steps to the patio. There is a stairwell to the basement under the porch.

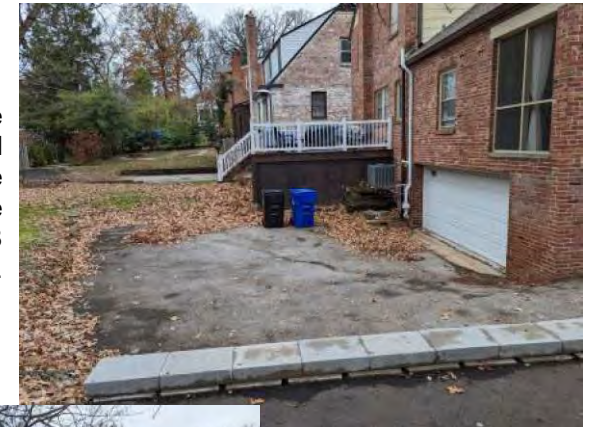
Looking towards the backyard of 8132 Cornell Ct; the basement garage has flooded since it is the low point of about 1.8 acres.

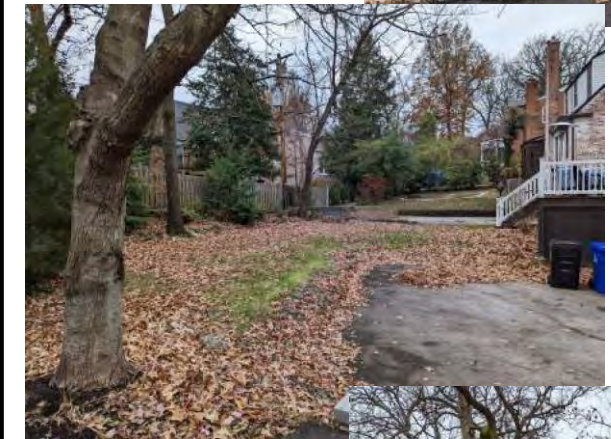
Looking west towards the backyard of #8132.

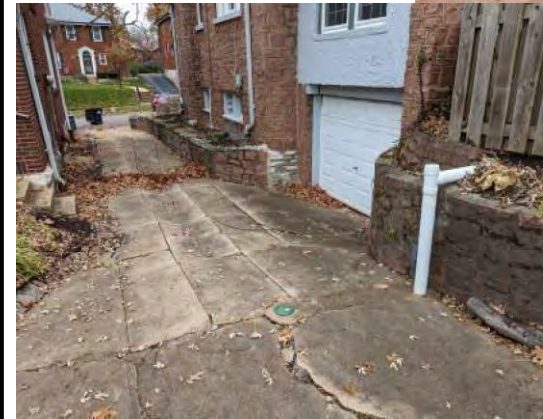
Looking north between #7236 (on the left) and #7232 (on the right). The tuck-under garage is at risk of flooding since the main flow path for water in the backyards is to flow down this driveway.
